Manhole Inspection Report

Date:	03/20/2018	Weather:		Coding:	RZMACP
MH#:	M-108-028	Owner:	NA	Len. Surveyed:	8.6
P.O.#:		Surveyor:	John Kuglmaier	Rim to Invert:	8.1
Customer:		Cert. #:	U-1215-07002349	Wall Material:	Concrete (reinforced)

Street:	93' South of 57th Ave. West of Alab	Project:	Hobart, IN
City:	Hobart, IN	GPS Northing:	2889463.341
Location:		GPS Easting:	2889463.341
Drain Area:	Southwest	GPS Accuracy:	Sub-Meter
Cover Shape:	Circular	Evidence of Surcharge:	Yes
Cover Size:	22.5	Potential for Runoff:	None
Comments:

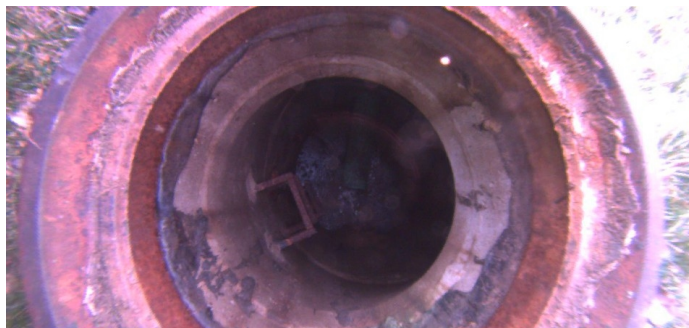
Code: **MGP**
Description: **General Photo**

Distance (ft): **.0**
Structural Grade: **0**
O&M Grade: **0**
Clock Start/From:
Clock To:
1st Value:
2nd Value:
Value Percent:
Step: **NO**
Remarks:

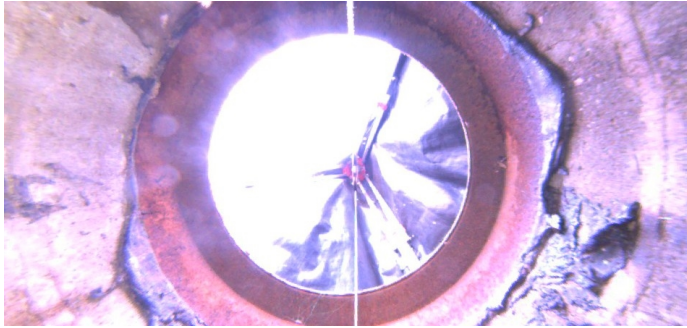
Code: **MGP**
Description: **General Photo**

Distance (ft): **3.0**
Structural Grade: **0**
O&M Grade: **0**
Clock Start/From:
Clock To:
1st Value:
2nd Value:
Value Percent:
Step: **NO**
Remarks:

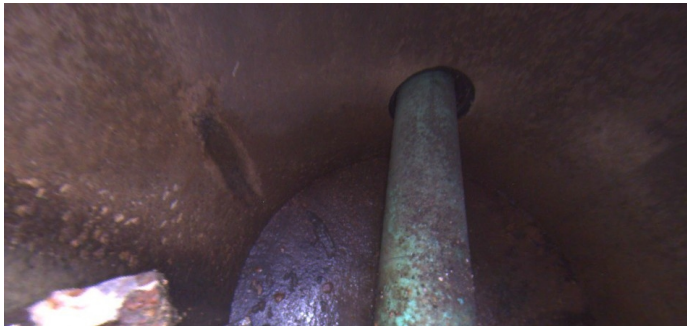
Code: **IS**
Description: **Infil Stain**

Distance (ft): **5.3**
Structural Grade: **0**
O&M Grade: **0**
Clock Start/From: **10**
Clock To:
1st Value:
2nd Value:
Value Percent:
Step: **NO**
Remarks:

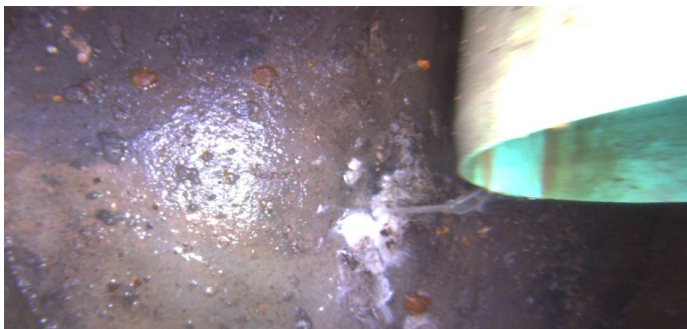
Code: **MGO**
Description: **General Observation**

Distance (ft): **7.2**
Structural Grade: **0**
O&M Grade: **0**
Clock Start/From:
Clock To:
1st Value:
2nd Value:
Value Percent:
Step: **NO**
Remarks: **Ins. Comp.**
