# Manhole Inspection Report

| MH#: | <b>M-108-029</b> | Owner: | <b>NA</b> | Len. Surveyed: | <b>9.0</b> |

| Street: | <b>370' South of 57th Ave. West of Swif</b> | Project: | <b>Hobart, IN</b> |

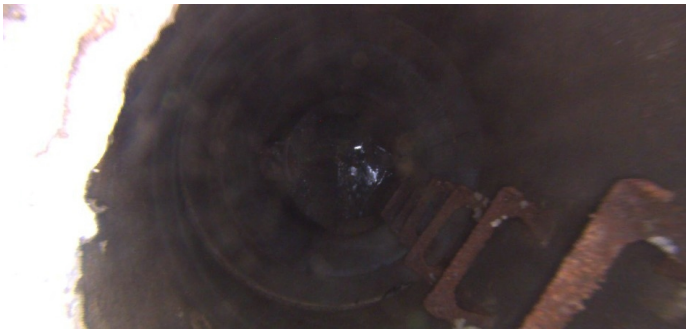
| Distance (ft): | .0 |

| Description: | <b>General Photo</b> |

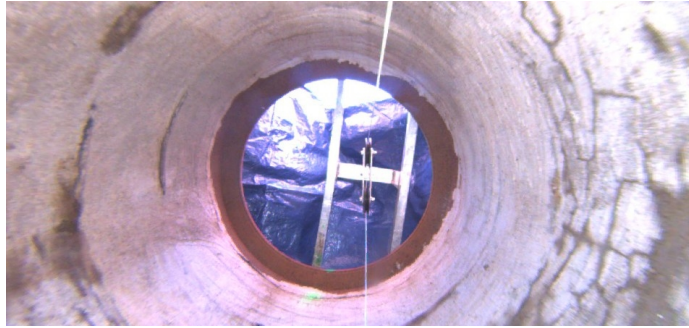
Distance (ft): **.9**  
Structural Grade: **0**  
O&M Grade: **0**  
Clock Start/From:  
Clock To:  
1st Value:  
2nd Value:  
Value Percent:  
Step: **NO**  
Remarks:

Code: **MGP**  
Description: **General Photo**

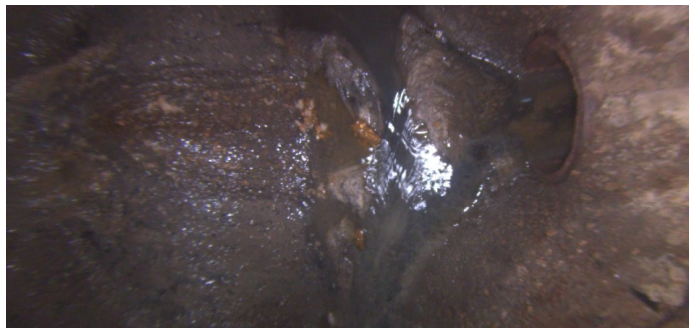
Code: **MGO**  
Description: **General Observation**

Distance (ft): **6.9**  
Structural Grade: **0**  
O&M Grade: **0**  
Clock Start/From:  
Clock To:  
1st Value:  
2nd Value:  
Value Percent:  
Step: **NO**  
Remarks: **Ins. Comp.**
