Manhole Inspection Report

Date:	03/22/2018	Weather:		Coding:	RZMACP
MH#:	M-108-033	Owner:	NA	Len. Surveyed:	7.3
P.O.#:		Surveyor:	John Kuglmaier	Rim to Invert:	7.1
Customer:		Cert. #:	U-1215-07002349	Wall Material:	Concrete (reinforced)

Street:	99' North of West 15th Pl. West of S	Project:	Hobart, IN
City:	Hobart, IN	GPS Northing:	0.0
Location:		GPS Easting:	0.0
Drain Area:	Southwest	GPS Accuracy:	Nearest Meter
Cover Shape:	Circular	Evidence of Surcharge:	No
Cover Size:	22.5	Potential for Runoff:	None
Comments:

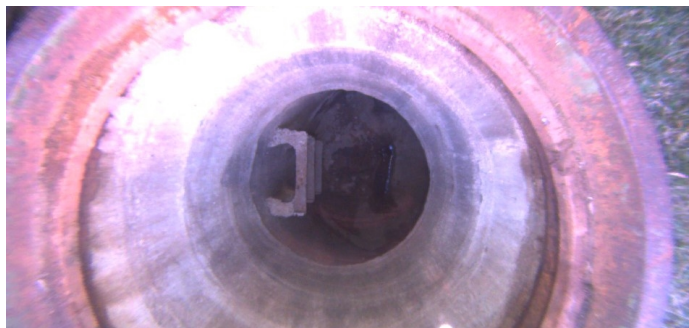
Code: **MGP**
Description: **General Photo**

Distance (ft): **.0**
Structural Grade: **0**
O&M Grade: **0**
Clock Start/From:
Clock To:
1st Value:
2nd Value:
Value Percent:
Step: **NO**
Remarks:

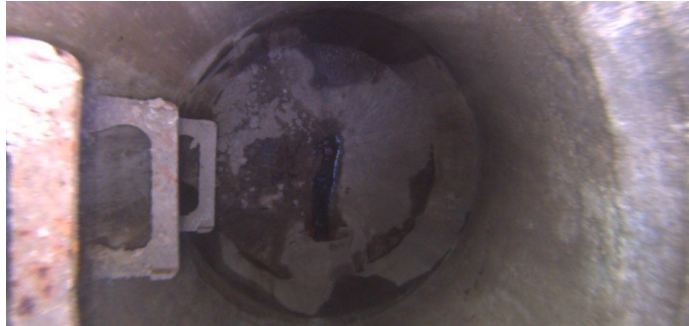
Code: **IS**
Description: **Infil Stain**

Distance (ft): **2.7**
Structural Grade: **0**
O&M Grade: **0**
Clock Start/From: **12**
Clock To: **12**
1st Value:
2nd Value:
Value Percent:
Step: **NO**
Remarks:

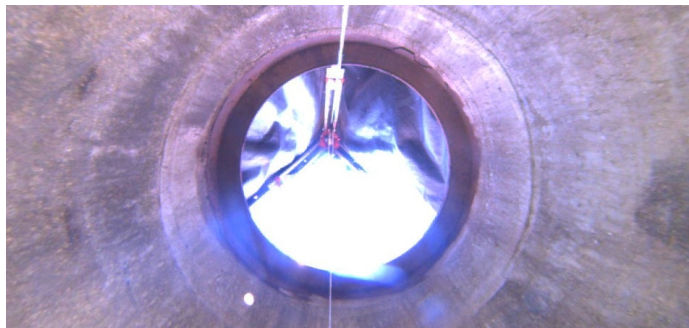
Code: **MGP**
Description: **General Photo**

Distance (ft): **3.5**
Structural Grade: **0**
O&M Grade: **0**
Clock Start/From:
Clock To:
1st Value:
2nd Value:
Value Percent:
Step: **NO**
Remarks:

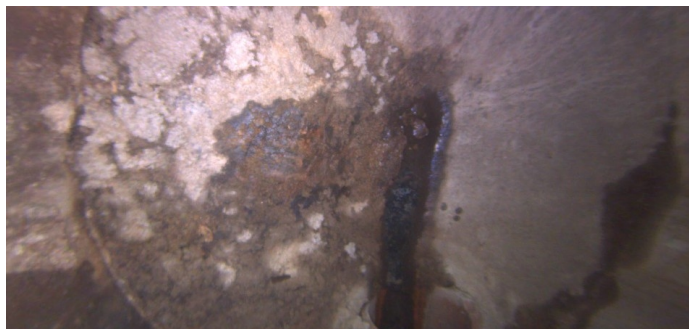
Code: **MGO**
Description: **General Observation**

Distance (ft): **5.8**
Structural Grade: **0**
O&M Grade: **0**
Clock Start/From:
Clock To:
1st Value:
2nd Value:
Value Percent:
Step: **NO**
Remarks: **Ins. Comp.**
