Manhole Inspection Report

Date:	03/21/2018	Weather:		Coding:	RZMACP
MH#:	M-108-034	Owner:	NA	Len. Surveyed:	11.6
P.O.#:		Surveyor:	John Kuglmaier	Rim to Invert:	11.9
Customer:		Cert. #:	U-1215-07002349	Wall Material:	Concrete (reinforced)

Street:	Mississippi St. 370' South of 57th Av	Project:	Hobart, IN
City:	Hobart, IN	GPS Northing:	0.0
Location:		GPS Easting:	0.0
Drain Area:	Southwest	GPS Accuracy:	Nearest Meter
Cover Shape:	Circular	Evidence of Surcharge:	Yes
Cover Size:	22.5	Potential for Runoff:	None
Comments:

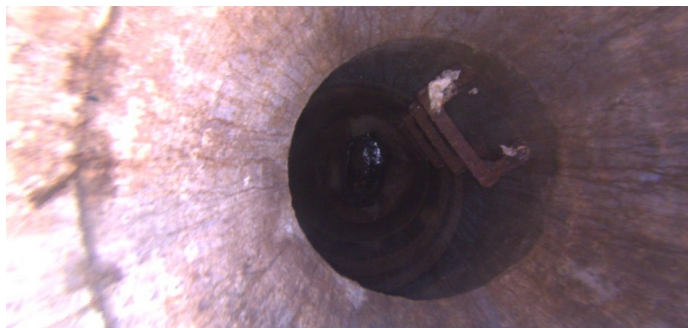
Code: **MGP**
Description: **General Photo**

Distance (ft): **.0**
Structural Grade: **0**
O&M Grade: **0**
Clock Start/From:
Clock To:
1st Value:
2nd Value:
Value Percent:
Step: **NO**
Remarks:

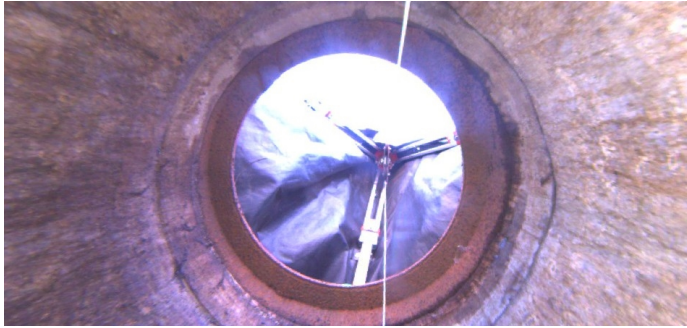
Code: **MGP**
Description: **General Photo**

Distance (ft): **2.3**
Structural Grade: **0**
O&M Grade: **0**
Clock Start/From:
Clock To:
1st Value:
2nd Value:
Value Percent:
Step: **NO**
Remarks:

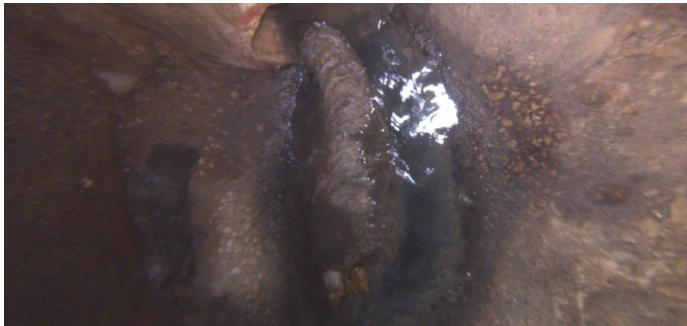
Code: **MGO**
Description: **General Observation**

Distance (ft): **9.9**
Structural Grade: **0**
O&M Grade: **0**
Clock Start/From:
Clock To:
1st Value:
2nd Value:
Value Percent:
Step: **NO**
Remarks: **Ins. Comp.**
