Manhole Inspection Report

Date:	03/21/2018	Weather:		Coding:	RZMACP
MH#:	M-108-035	Owner:	NA	Len. Surveyed:	11.9
P.O.#:		Surveyor:	John Kuglmaier	Rim to Invert:	12.2
Customer:		Cert. #:	U-1215-07002349	Wall Material:	Concrete (reinforced)

Street:	348' South of 57th Ave. Mississippi S	Project:	Hobart, IN
City:	Hobart, IN	GPS Northing:	0.0
Location:		GPS Easting:	0.0
Drain Area:	Southwest	GPS Accuracy:	Nearest Meter
Cover Shape:	Circular	Evidence of Surcharge:	Yes
Cover Size:	22.5	Potential for Runoff:	None
Comments:

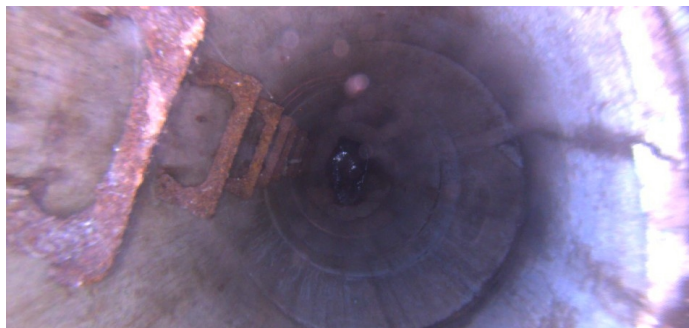
Code: **MGP**
 Description: **General Photo**

Distance (ft): **.0**
 Structural Grade: **0**
 O&M Grade: **0**
 Clock Start/From:
 Clock To:
 1st Value:
 2nd Value:
 Value Percent:
 Step: **NO**
 Remarks:

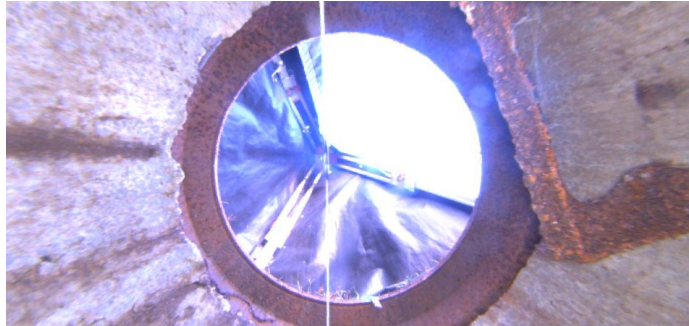
Code: **MGP**
Description: **General Photo**

Distance (ft): **2.2**
Structural Grade: **0**
O&M Grade: **0**
Clock Start/From:
Clock To:
1st Value:
2nd Value:
Value Percent:
Step: **NO**
Remarks:

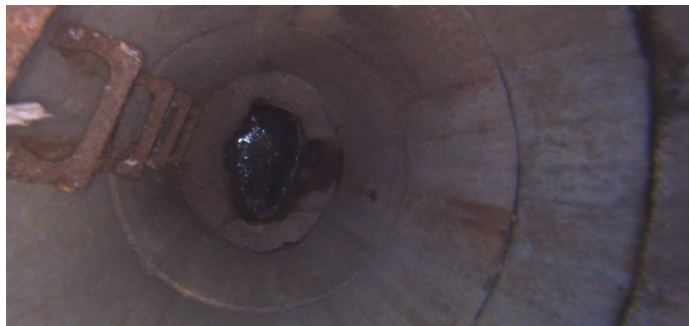
Code: **IS**
Description: **Infil Stain**

Distance (ft): **5.0**
Structural Grade: **0**
O&M Grade: **0**
Clock Start/From: **4**
Clock To:
1st Value:
2nd Value:
Value Percent:
Step: **NO**
Remarks:

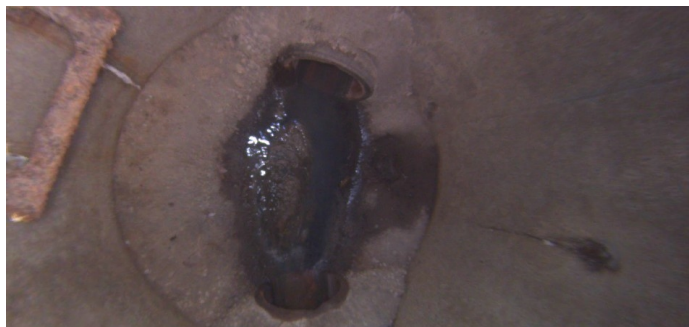
Code: **IS**
Description: **Infil Stain**

Distance (ft): **8.6**
Structural Grade: **0**
O&M Grade: **0**
Clock Start/From: **3**
Clock To:
1st Value:
2nd Value:
Value Percent:
Step: **NO**
Remarks:

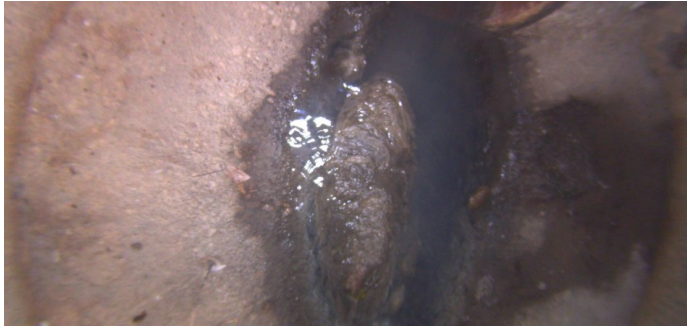
Code:	MGO
Description:	General Observation
Distance (ft):	10.7
Structural Grade:	0
O&M Grade:	0
Clock Start/From:	
Clock To:	
1st Value:	
2nd Value:	
Value Percent:	
Step:	NO
Remarks:	Ins. Comp.
