# Manhole Inspection Report

| MH#: | <b>M-108-037</b> | Owner: | <b>NA</b> | Len. Surveyed: | <b>3.9</b> |

| Street: | <b>West 15th Pl. Maple St. to the South</b> | Project: | <b>Hobart, IN</b> |

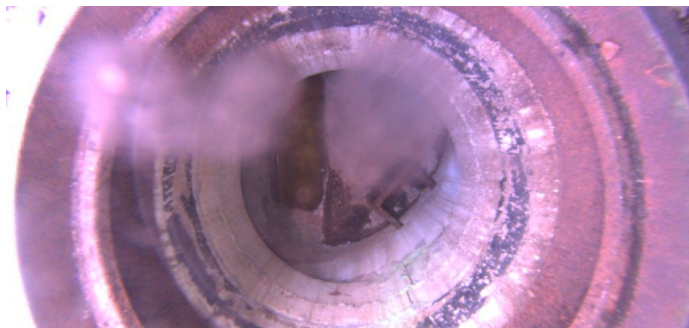
Code: **MGP**  
Description: **General Photo**

Distance (ft): **.0**  
Structural Grade: **0**  
O&M Grade: **0**  
Clock Start/From:  
Clock To:  
1st Value:  
2nd Value:  
Value Percent:  
Step: **NO**  
Remarks:

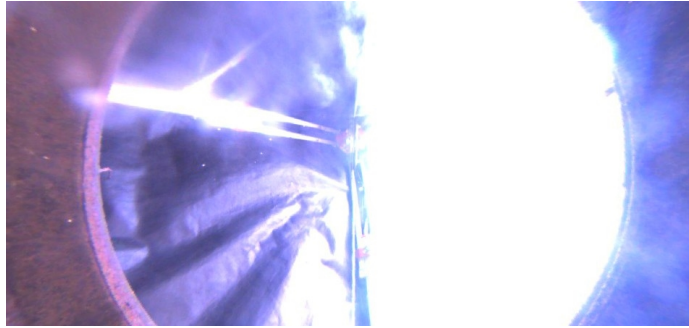
Code: **MGP**  
Description: **General Photo**

Distance (ft): **2.0**  
Structural Grade: **0**  
O&M Grade: **0**  
Clock Start/From:  
Clock To:  
1st Value:  
2nd Value:  
Value Percent:  
Step: **NO**  
Remarks:

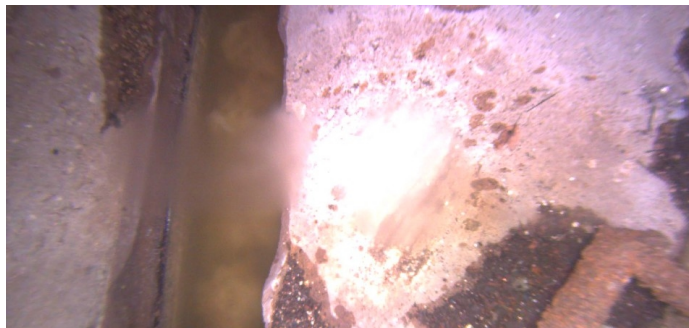
Code: **MGO**  
Description: **General Observation**

Distance (ft): **2.9**  
Structural Grade: **0**  
O&M Grade: **0**  
Clock Start/From:  
Clock To:  
1st Value:  
2nd Value:  
Value Percent:  
Step: **NO**  
Remarks: **Ins. Comp.**
