Manhole Inspection Report

Date:	03/22/2018	Weather:		Coding:	RZMACP
MH#:	M-108-038	Owner:	NA	Len. Surveyed:	4.2
P.O.#:		Surveyor:	John Kuglmaier	Rim to Invert:	5.0
Customer:		Cert. #:	U-1215-07002349	Wall Material:	Concrete (reinforced)

Street:	143' South of West 15th Pl. West of	Project:	Hobart, IN
City:	Hobart, IN	GPS Northing:	0.0
Location:		GPS Easting:	0.0
Drain Area:	Southwest	GPS Accuracy:	Nearest Meter
Cover Shape:	Circular	Evidence of Surcharge:	No
Cover Size:	22.5	Potential for Runoff:	None
Comments:

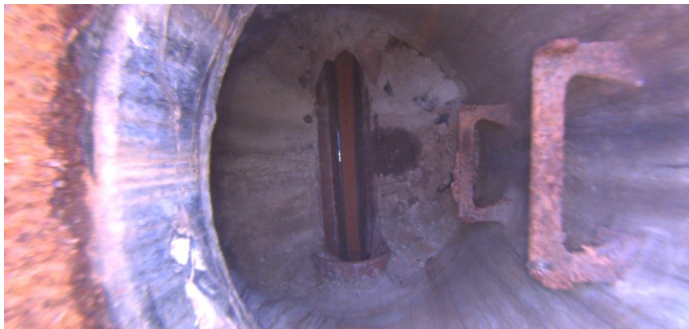
Code: **MGP**
Description: **General Photo**

Distance (ft): **.0**
Structural Grade: **0**
O&M Grade: **0**
Clock Start/From:
Clock To:
1st Value:
2nd Value:
Value Percent:
Step: **NO**
Remarks:

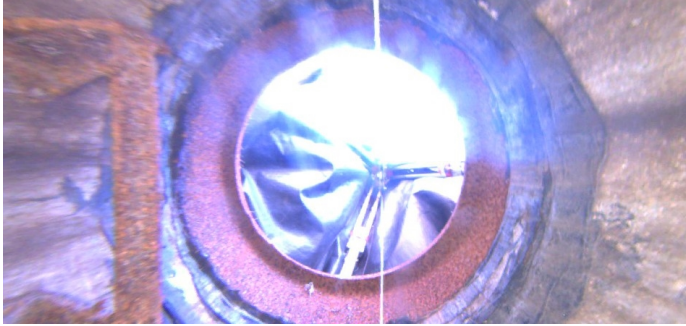
Code: **MGP**
Description: **General Photo**

Distance (ft): **2.4**
Structural Grade: **0**
O&M Grade: **0**
Clock Start/From:
Clock To:
1st Value:
2nd Value:
Value Percent:
Step: **NO**
Remarks:

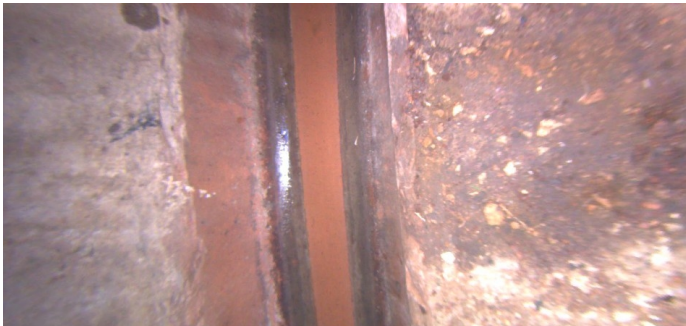
Code: **MGO**
Description: **General Observation**

Distance (ft): **3.5**
Structural Grade: **0**
O&M Grade: **0**
Clock Start/From:
Clock To:
1st Value:
2nd Value:
Value Percent:
Step: **NO**
Remarks: **Ins. Comp.**
