Manhole Inspection Report

Date:	03/21/2018	Weather:		Coding:	RZMACP
MH#:	M-108-040	Owner:	NA	Len. Surveyed:	6.0
P.O.#:		Surveyor:	John Kuglmaier	Rim to Invert:	6.6
Customer:		Cert. #:	U-1215-07002349	Wall Material:	Concrete (reinforced)

Street:	West 15th Pl. Swift St. to the Southe	Project:	Hobart, IN
City:	Hobart, IN	GPS Northing:	0.0
Location:		GPS Easting:	0.0
Drain Area:	Southwest	GPS Accuracy:	Nearest Meter
Cover Shape:	Circular	Evidence of Surcharge:	No
Cover Size:	22.5	Potential for Runoff:	None
Comments:

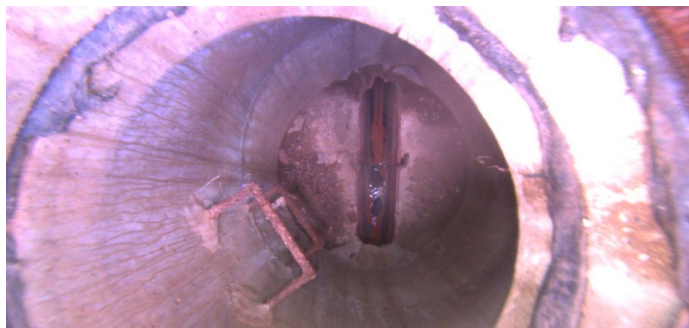
Code: **MGP**
Description: **General Photo**

Distance (ft): **.0**
Structural Grade: **0**
O&M Grade: **0**
Clock Start/From:
Clock To:
1st Value:
2nd Value:
Value Percent:
Step: **NO**
Remarks:

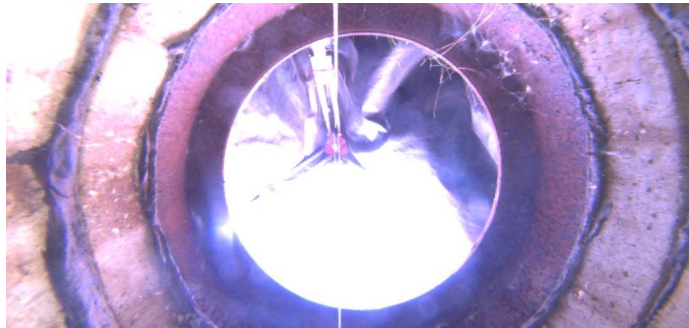
Code: **MGP**
Description: **General Photo**

Distance (ft): **2.1**
Structural Grade: **0**
O&M Grade: **0**
Clock Start/From:
Clock To:
1st Value:
2nd Value:
Value Percent:
Step: **NO**
Remarks:

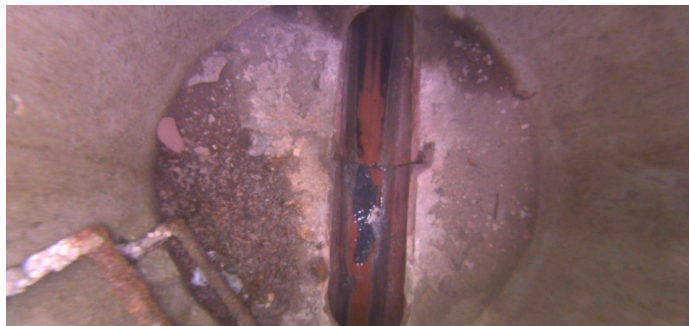
Code: **DAZ**
Description: **Deposits Attached Other**

Distance (ft): **3.1**
Structural Grade: **0**
O&M Grade: **2**
Clock Start/From: **12**
Clock To: **12**
1st Value:
2nd Value:
Value Percent: **5.000**
Step: **NO**
Remarks: **Mixed materials**

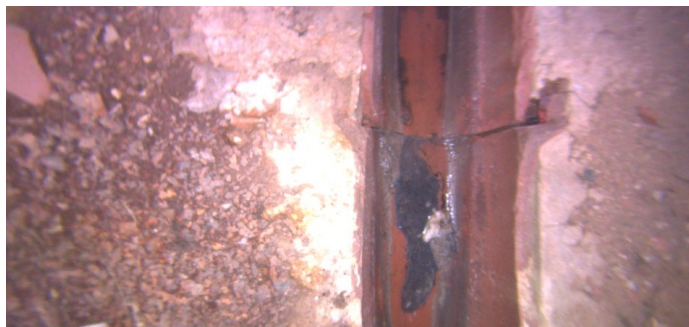
Code: **MGO**
Description: **General Observation**

Distance (ft): **4.7**
Structural Grade: **0**
O&M Grade: **0**
Clock Start/From:
Clock To:
1st Value:
2nd Value:
Value Percent:
Step: **NO**
Remarks: **Ins. Comp.**
