# Manhole Inspection Report

Date:	<b>03/21/2018</b>	Weather:		Coding:	<b>RZMACP</b>
MH#:	<b>M-108-042</b>	Owner:	<b>NA</b>	Len. Surveyed:	<b>5.2</b>
P.O.#:		Surveyor:	<b>John Kuglmaier</b>	Rim to Invert:	<b>8.0</b>
Customer:		Cert. #:	<b>U-1215-07002349</b>	Wall Material:	<b>Concrete (reinforced)</b>

Street:	<b>West 15th Pl. and Mississippi St. to t</b>	Project:	<b>Hobart, IN</b>
City:	<b>Hobart, IN</b>	GPS Northing:	<b>0.0</b>
Location:		GPS Easting:	<b>0.0</b>
Drain Area:	<b>Southwest</b>	GPS Accuracy:	<b>Nearest Meter</b>
Cover Shape:	<b>Circular</b>	Evidence of Surcharge:	<b>No</b>
Cover Size:	<b>22.5</b>	Potential for Runoff:	<b>None</b>
Comments:

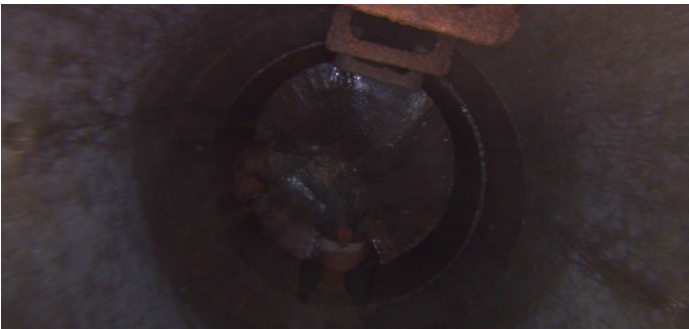
Code: **MGP**  
Description: **General Photo**

Distance (ft): **.0**  
Structural Grade: **0**  
O&M Grade: **0**  
Clock Start/From:  
Clock To:  
1st Value:  
2nd Value:  
Value Percent:  
Step: **NO**  
Remarks:

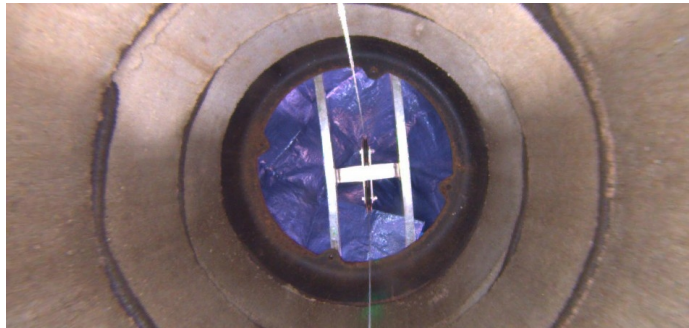
Code: **MGP**  
Description: **General Photo**

Distance (ft): **.7**  
Structural Grade: **0**  
O&M Grade: **0**  
Clock Start/From:  
Clock To:  
1st Value:  
2nd Value:  
Value Percent:  
Step: **NO**  
Remarks:

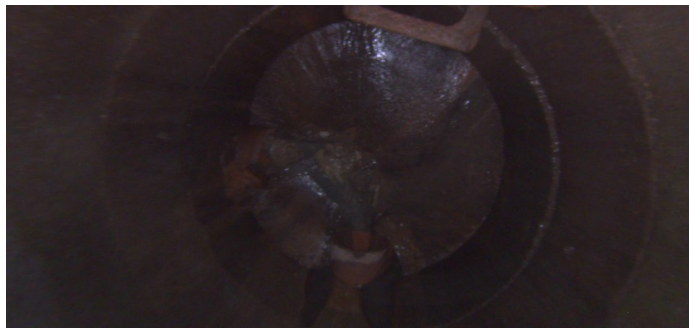
Code: **IS**  
Description: **Infil Stain**

Distance (ft): **1.0**  
Structural Grade: **0**  
O&M Grade: **0**  
Clock Start/From: **12**  
Clock To: **12**  
1st Value:  
2nd Value:  
Value Percent:  
Step: **NO**  
Remarks:

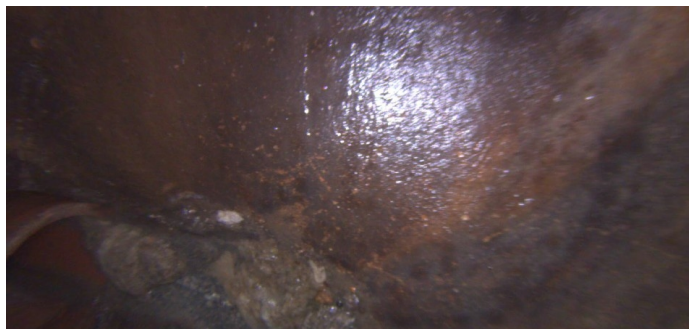
Code: **MGO**  
Description: **General Observation**

Distance (ft): **4.0**  
Structural Grade: **0**  
O&M Grade: **0**  
Clock Start/From:  
Clock To:  
1st Value:  
2nd Value:  
Value Percent:  
Step: **NO**  
Remarks: **Ins. Comp.**
