Manhole Inspection Report

Date:	03/22/2018	Weather:		Coding:	RZMACP
MH#:	M-108-043	Owner:	NA	Len. Surveyed:	8.5
P.O.#:		Surveyor:	John Kuglmaier	Rim to Invert:	8.9
Customer:		Cert. #:	U-1215-07002349	Wall Material:	Concrete (reinforced)

Street:	West 15th Pl. Mississippi St. to the	Project:	Hobart, IN
City:	Hobart, IN	GPS Northing:	0.0
Location:		GPS Easting:	0.0
Drain Area:	Southwest	GPS Accuracy:	Nearest Meter
Cover Shape:	Circular	Evidence of Surcharge:	Yes
Cover Size:	22.5	Potential for Runoff:	None
Comments:

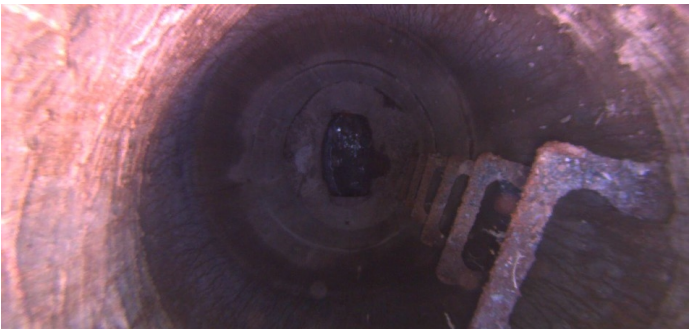
Code: **MGP**
Description: **General Photo**

Distance (ft): **.0**
Structural Grade: **0**
O&M Grade: **0**
Clock Start/From:
Clock To:
1st Value:
2nd Value:
Value Percent:
Step: **NO**
Remarks:

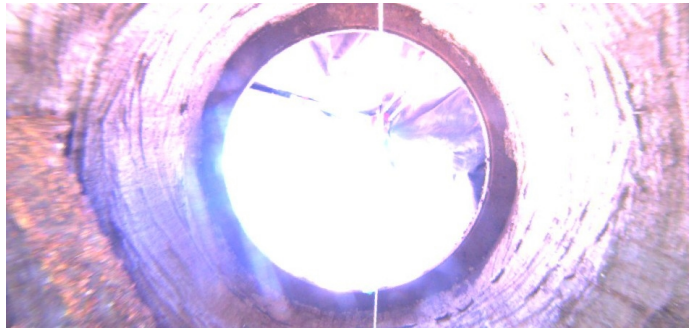
Code: **MGP**
Description: **General Photo**

Distance (ft): **2.1**
Structural Grade: **0**
O&M Grade: **0**
Clock Start/From:
Clock To:
1st Value:
2nd Value:
Value Percent:
Step: **NO**
Remarks:

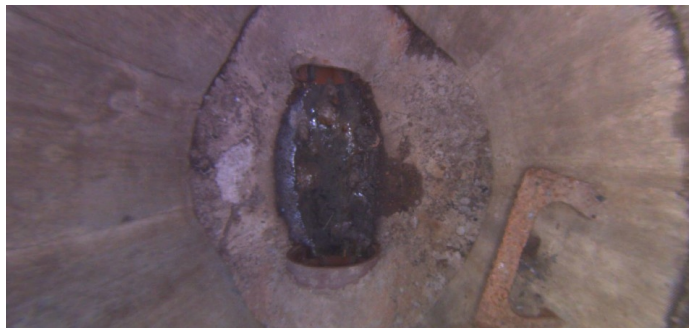
Code: **DAZ**
Description: **Deposits Attached Other**

Distance (ft): **4.8**
Structural Grade: **0**
O&M Grade: **2**
Clock Start/From: **12**
Clock To: **12**
1st Value:
2nd Value:
Value Percent: **5.000**
Step: **NO**
Remarks: **Mixed materials**

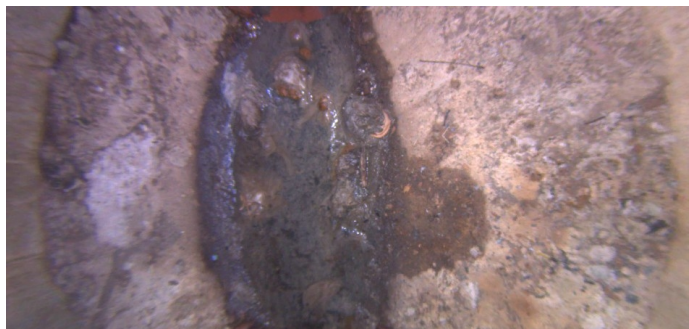
Code: **MGO**
Description: **General Observation**

Distance (ft): **6.9**
Structural Grade: **0**
O&M Grade: **0**
Clock Start/From:
Clock To:
1st Value:
2nd Value:
Value Percent:
Step: **NO**
Remarks: **Ins. Comp.**
