# Manhole Inspection Report

Date:	<b>03/21/2018</b>	Weather:		Coding:	<b>RZMACP</b>
MH#:	<b>M-108-044</b>	Owner:	<b>NA</b>	Len. Surveyed:	<b>9.3</b>
P.O.#:		Surveyor:	<b>John Kuglmaier</b>	Rim to Invert:	<b>8.8</b>
Customer:		Cert. #:	<b>U-1215-07002349</b>	Wall Material:	<b>Concrete (reinforced)</b>

Street:	<b>Mississippi St. 825' South of 57th Av</b>	Project:	<b>Hobart, IN</b>
City:	<b>Hobart, IN</b>	GPS Northing:	<b>0.0</b>
Location:		GPS Easting:	<b>0.0</b>
Drain Area:	<b>Southwest</b>	GPS Accuracy:	<b>Nearest Meter</b>
Cover Shape:	<b>Circular</b>	Evidence of Surcharge:	<b>No</b>
Cover Size:	<b>22.5</b>	Potential for Runoff:	<b>None</b>
Comments:

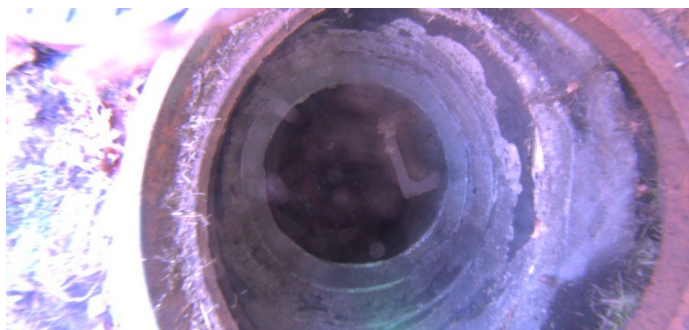
Code: **MGP**  
Description: **General Photo**

Distance (ft): **.0**  
Structural Grade: **0**  
O&M Grade: **0**  
Clock Start/From:  
Clock To:  
1st Value:  
2nd Value:  
Value Percent:  
Step: **NO**  
Remarks:

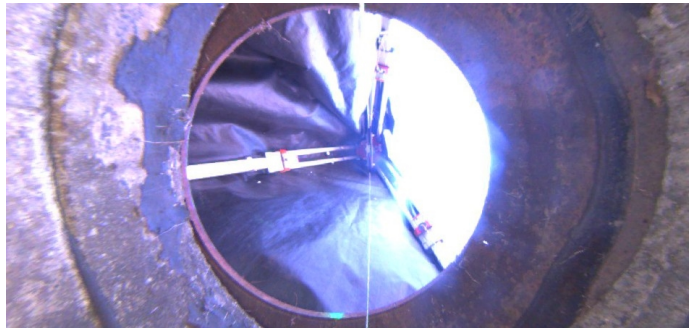
Code: **MGP**  
Description: **General Photo**

Distance (ft): **2.8**  
Structural Grade: **0**  
O&M Grade: **0**  
Clock Start/From:  
Clock To:  
1st Value:  
2nd Value:  
Value Percent:  
Step: **NO**  
Remarks:

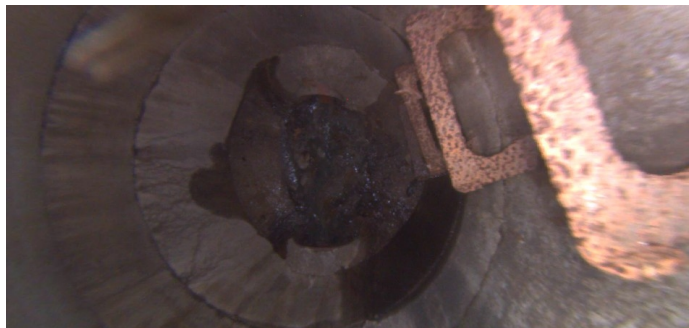
Code: **IS**  
Description: **Infil Stain**

Distance (ft): **3.9**  
Structural Grade: **0**  
O&M Grade: **0**  
Clock Start/From: **2**  
Clock To: **6**  
1st Value:  
2nd Value:  
Value Percent:  
Step: **NO**  
Remarks:

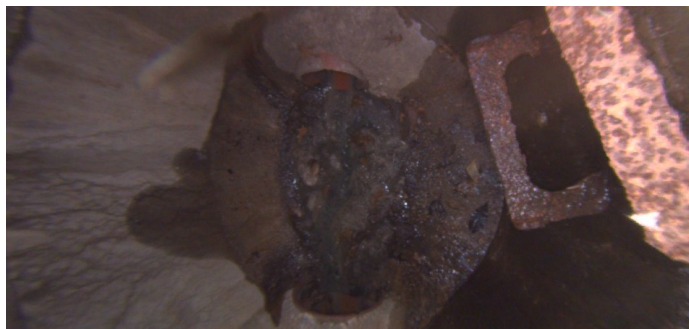
Code: **DAZ**  
Description: **Deposits Attached Other**

Distance (ft): **5.8**  
Structural Grade: **0**  
O&M Grade: **2**  
Clock Start/From: **12**  
Clock To: **12**  
1st Value:  
2nd Value:  
Value Percent: **5.000**  
Step: **NO**  
Remarks: **Mixed materials**

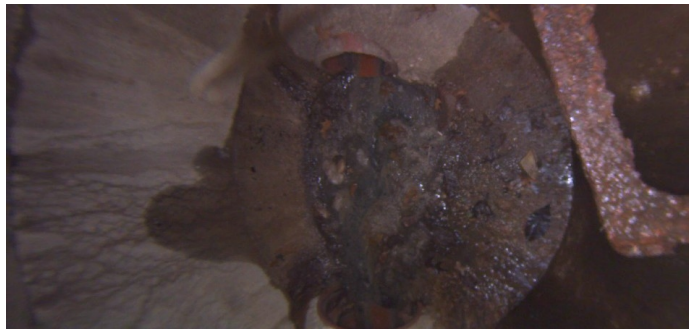
Code: **IS**  
Description: **Infil Stain**

Distance (ft): **6.2**  
Structural Grade: **0**  
O&M Grade: **0**  
Clock Start/From: **9**  
Clock To:  
1st Value:  
2nd Value:  
Value Percent:  
Step: **NO**  
Remarks:

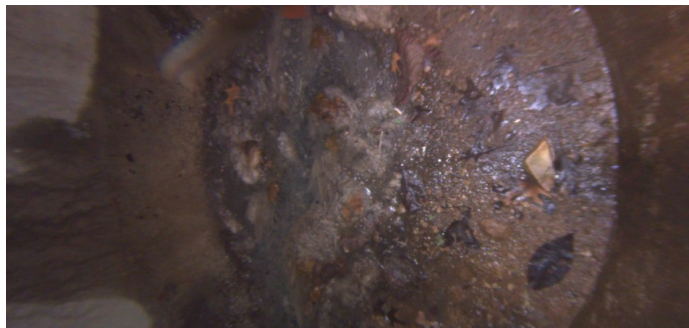
Code: **MGO**  
Description: **General Observation**

Distance (ft): **7.7**  
Structural Grade: **0**  
O&M Grade: **0**  
Clock Start/From:  
Clock To:  
1st Value:  
2nd Value:  
Value Percent:  
Step: **NO**  
Remarks: **Ins. Comp.**
