Manhole Inspection Report

Date:	03/21/2018	Weather:		Coding:	RZMACP
MH#:	M-108-045	Owner:	NA	Len. Surveyed:	11.2
P.O.#:		Surveyor:	John Kuglmaier	Rim to Invert:	11.4
Customer:		Cert. #:	U-1215-07002349	Wall Material:	Concrete (reinforced)

Street:	Mississippi St. 584' South of 57th Av	Project:	Hobart, IN
City:	Hobart, IN	GPS Northing:	0.0
Location:		GPS Easting:	0.0
Drain Area:	Southwest	GPS Accuracy:	Nearest Meter
Cover Shape:	Circular	Evidence of Surcharge:	Yes
Cover Size:	22.5	Potential for Runoff:	None
Comments:

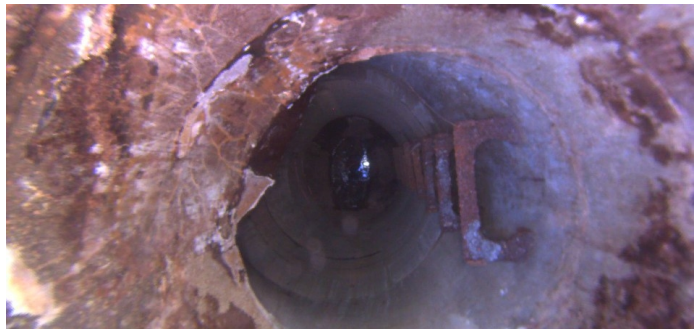
Code: **MGP**
Description: **General Photo**

Distance (ft): **.0**
Structural Grade: **0**
O&M Grade: **0**
Clock Start/From:
Clock To:
1st Value:
2nd Value:
Value Percent:
Step: **NO**
Remarks:

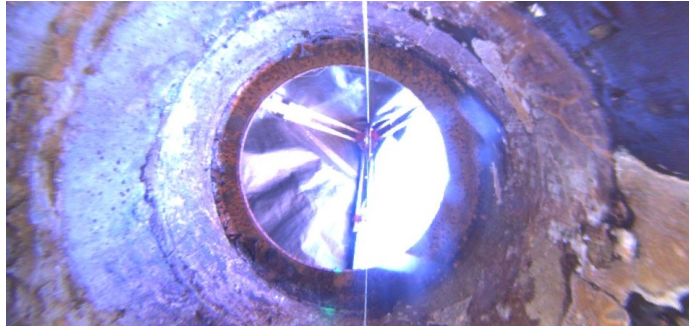
Code: **MGP**
Description: **General Photo**

Distance (ft): **2.7**
Structural Grade: **0**
O&M Grade: **0**
Clock Start/From:
Clock To:
1st Value:
2nd Value:
Value Percent:
Step: **NO**
Remarks:

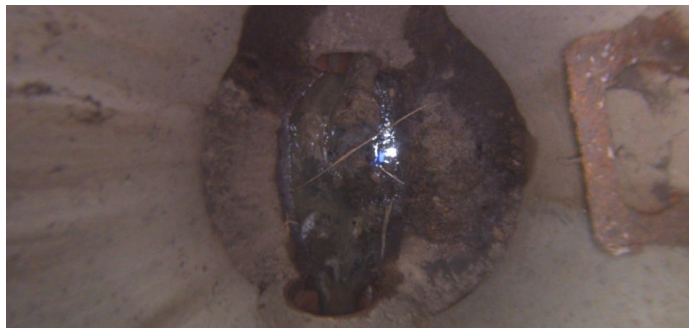
Code: **DAZ**
Description: **Deposits Attached Other**

Distance (ft): **7.9**
Structural Grade: **0**
O&M Grade: **2**
Clock Start/From: **12**
Clock To: **12**
1st Value:
2nd Value:
Value Percent: **5.000**
Step: **NO**
Remarks: **Mixed materials**

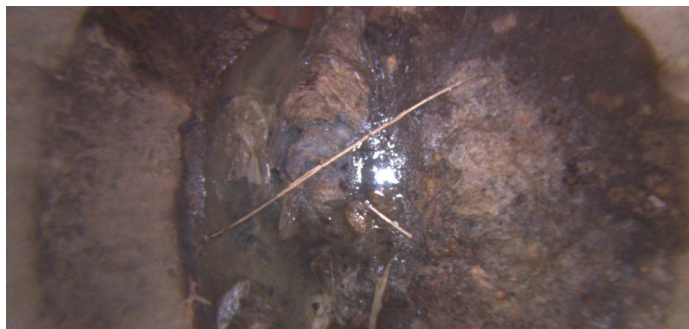
Code: **MGO**
Description: **General Observation**

Distance (ft): **9.6**
Structural Grade: **0**
O&M Grade: **0**
Clock Start/From:
Clock To:
1st Value:
2nd Value:
Value Percent:
Step: **NO**
Remarks: **Ins. Comp.**
