Manhole Inspection Report

Date:	03/21/2018	Weather:		Coding:	RZMACP
MH#:	M-108-046	Owner:	NA	Len. Surveyed:	11.5
P.O.#:		Surveyor:	John Kuglmaier	Rim to Invert:	12.6
Customer:		Cert. #:	U-1215-07002349	Wall Material:	Concrete (reinforced)

Street:	Mississippi St. 349' South of 57th Av	Project:	Hobart, IN
City:	Hobart, IN	GPS Northing:	0.0
Location:		GPS Easting:	0.0
Drain Area:	Southwest	GPS Accuracy:	Nearest Meter
Cover Shape:	Circular	Evidence of Surcharge:	Yes
Cover Size:	22.5	Potential for Runoff:	None
Comments:	AGAINST A FENCE

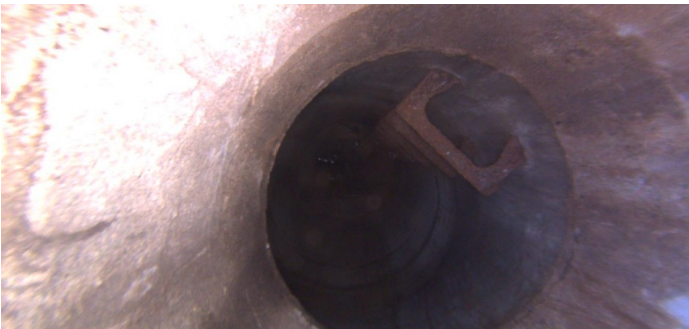
Code: **MGP**
 Description: **General Photo**

Distance (ft): **.0**
 Structural Grade: **0**
 O&M Grade: **0**
 Clock Start/From:
 Clock To:
 1st Value:
 2nd Value:
 Value Percent:
 Step: **NO**
 Remarks:

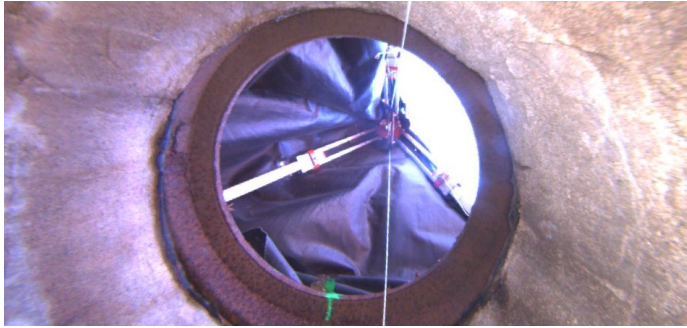
Code: **MGP**
Description: **General Photo**

Distance (ft): **2.0**
Structural Grade: **0**
O&M Grade: **0**
Clock Start/From:
Clock To:
1st Value:
2nd Value:
Value Percent:
Step: **NO**
Remarks:

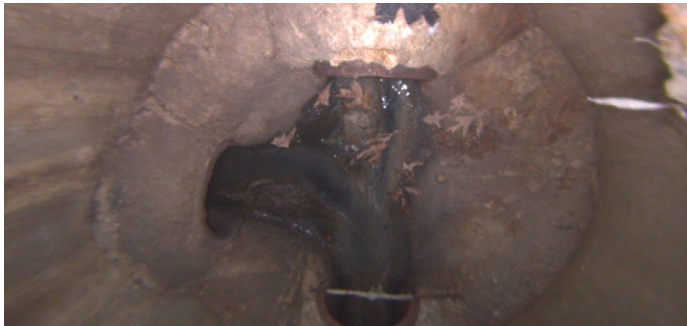
Code: **MGO**
Description: **General Observation**

Distance (ft): **9.9**
Structural Grade: **0**
O&M Grade: **0**
Clock Start/From:
Clock To:
1st Value:
2nd Value:
Value Percent:
Step: **NO**
Remarks: **Ins. Comp.**
