Manhole Inspection Report

Date:	03/21/2018	Weather:		Coding:	RZMACP
MH#:	M-108-047	Owner:	NA	Len. Surveyed:	12.5
P.O.#:		Surveyor:	John Kuglmaier	Rim to Invert:	20.5
Customer:		Cert. #:	U-1215-07002349	Wall Material:	Concrete (reinforced)

Street:	57th Ave. and Mississippi St. to the	Project:	Hobart, IN
City:	Hobart, IN	GPS Northing:	0.0
Location:		GPS Easting:	0.0
Drain Area:	Southwest	GPS Accuracy:	Nearest Meter
Cover Shape:	Circular	Evidence of Surcharge:	Yes
Cover Size:	22.5	Potential for Runoff:	None
Comments:

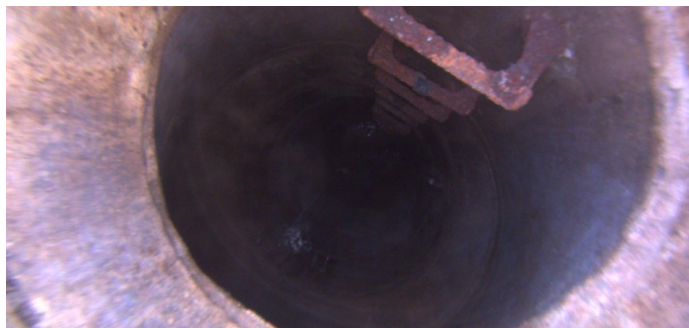
Code: **MGP**
Description: **General Photo**

Distance (ft): **.0**
Structural Grade: **0**
O&M Grade: **0**
Clock Start/From:
Clock To:
1st Value:
2nd Value:
Value Percent:
Step: **NO**
Remarks:

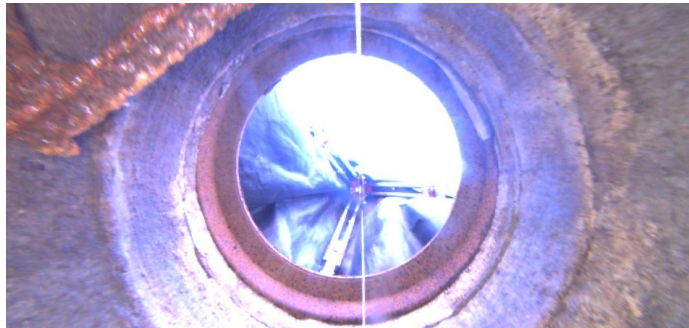
Code: **MGP**
Description: **General Photo**

Distance (ft): **2.5**
Structural Grade: **0**
O&M Grade: **0**
Clock Start/From:
Clock To:
1st Value:
2nd Value:
Value Percent:
Step: **NO**
Remarks:

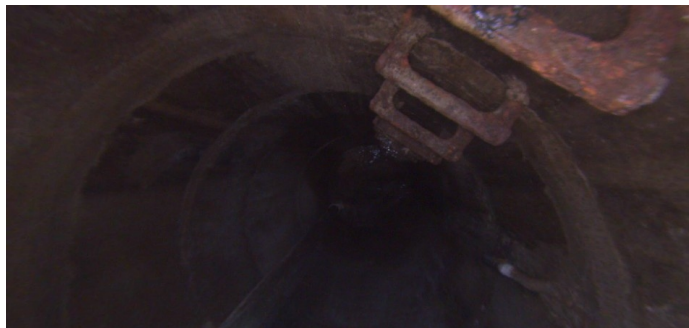
Code: **IS**
Description: **Infil Stain**

Distance (ft): **4.0**
Structural Grade: **0**
O&M Grade: **0**
Clock Start/From: **10**
Clock To: **2**
1st Value:
2nd Value:
Value Percent:
Step: **NO**
Remarks:

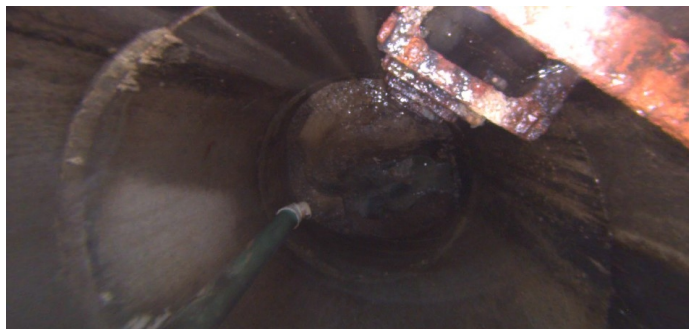
Code: **MGO**
Description: **General Observation**

Distance (ft): **12.5**
Structural Grade: **0**
O&M Grade: **0**
Clock Start/From:
Clock To:
1st Value:
2nd Value:
Value Percent:
Step: **NO**
Remarks: **Ins. Comp.**
