# Manhole Inspection Report

Date:	03/20/2018	Weather:		Coding:	RZMACP
MH#:	M-108-049	Owner:	NA	Len. Surveyed:	2.1
P.O.#:		Surveyor:	John Kuglmaier	Rim to Invert:	3.5
Customer:		Cert. #:	U-1215-07002349	Wall Material:	Concrete (reinforced)

Street:	14th Ln. 387' Northwest of Howard	Project:	Hobart, IN
City:	Hobart, IN	GPS Northing:	2890572.407
Location:		GPS Easting:	2890572.407
Drain Area:	Southwest	GPS Accuracy:	Sub-Meter
Cover Shape:	Circular	Evidence of Surcharge:	Yes
Cover Size:	29.0	Potential for Runoff:	None
Comments:

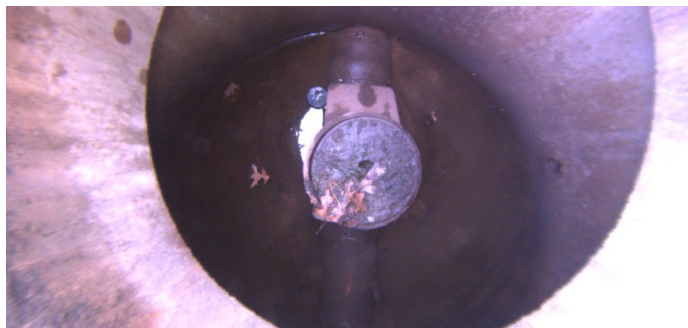
Code: **MGP**  
Description: **General Photo**

Distance (ft): **.0**  
Structural Grade: **0**  
O&M Grade: **0**  
Clock Start/From:  
Clock To:  
1st Value:  
2nd Value:  
Value Percent:  
Step: **NO**  
Remarks:

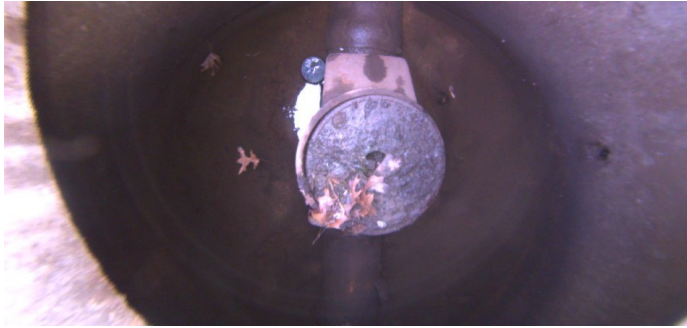
Code: **MGO**  
Description: **General Observation**

Distance (ft): **.5**  
Structural Grade: **0**  
O&M Grade: **0**  
Clock Start/From:  
Clock To:  
1st Value:  
2nd Value:  
Value Percent:  
Step: **NO**  
Remarks: **Surcharge**

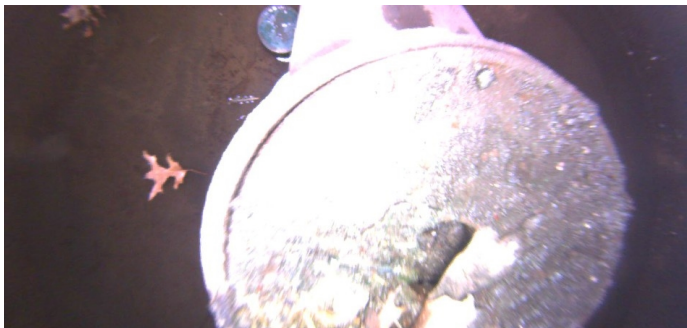
Code: **MGO**  
Description: **General Observation**

Distance (ft): **1.7**  
Structural Grade: **0**  
O&M Grade: **0**  
Clock Start/From:  
Clock To:  
1st Value:  
2nd Value:  
Value Percent:  
Step: **NO**  
Remarks: **Ins. Comp.**
