Manhole Inspection Report

Date:	03/20/2018	Weather:		Coding:	RZMACP
MH#:	M-108-050	Owner:	NA	Len. Surveyed:	4.9
P.O.#:		Surveyor:	John Kuglmaier	Rim to Invert:	6.3
Customer:		Cert. #:	U-1215-07002349	Wall Material:	Concrete (reinforced)

Street:	57th Ave. West of Alabama St.	Project:	Hobart, IN
City:	Hobart, IN	GPS Northing:	2889474.466
Location:		GPS Easting:	2889474.466
Drain Area:	Southwest	GPS Accuracy:	Sub-Meter
Cover Shape:	Circular	Evidence of Surcharge:	No
Cover Size:	22.5	Potential for Runoff:	None
Comments:

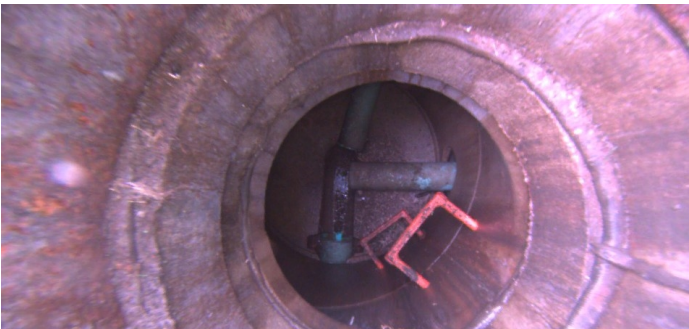
Code: **MGP**
Description: **General Photo**

Distance (ft): **.0**
Structural Grade: **0**
O&M Grade: **0**
Clock Start/From:
Clock To:
1st Value:
2nd Value:
Value Percent:
Step: **NO**
Remarks:

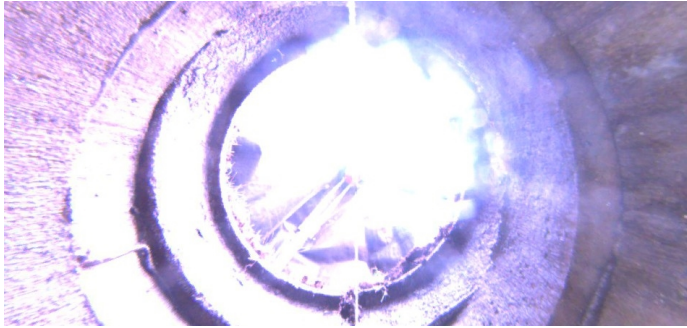
Code: **MGP**
Description: **General Photo**

Distance (ft): **2.8**
Structural Grade: **0**
O&M Grade: **0**
Clock Start/From:
Clock To:
1st Value:
2nd Value:
Value Percent:
Step: **NO**
Remarks:

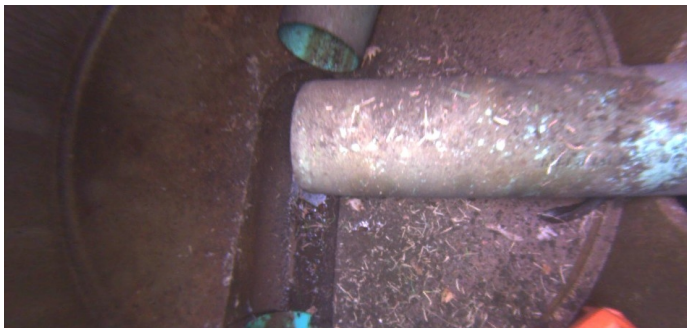
Code: **MGO**
Description: **General Observation**

Distance (ft): **4.1**
Structural Grade: **0**
O&M Grade: **0**
Clock Start/From:
Clock To:
1st Value:
2nd Value:
Value Percent:
Step: **NO**
Remarks: **Ins. Comp.**
