Manhole Inspection Report

Date:	03/25/2018	Weather:		Coding:	RZMACP
MH#:	M-108-051	Owner:	NA	Len. Surveyed:	6.4
P.O.#:		Surveyor:	John Kuglmaier	Rim to Invert:	7.2
Customer:		Cert. #:	U-1215-07002349	Wall Material:	Concrete (reinforced)

Street:	61st Ave. 594' East of Marcella Blvd.	Project:	Hobart, IN
City:	Hobart, IN	GPS Northing:	0.0
Location:		GPS Easting:	0.0
Drain Area:	Southwest	GPS Accuracy:	Nearest Meter
Cover Shape:	Circular	Evidence of Surcharge:	No
Cover Size:	22.5	Potential for Runoff:	None
Comments:

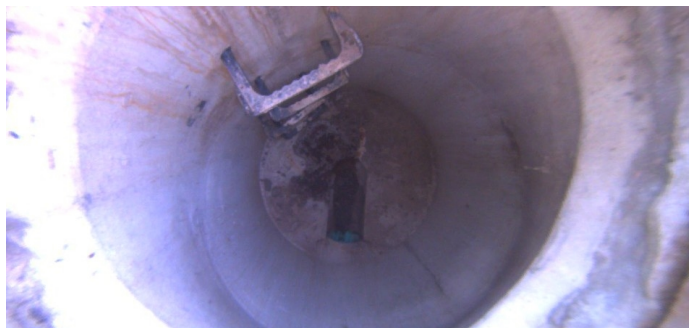
Code: **MGP**
Description: **General Photo**

Distance (ft): **.0**
Structural Grade: **0**
O&M Grade: **0**
Clock Start/From:
Clock To:
1st Value:
2nd Value:
Value Percent:
Step: **NO**
Remarks:

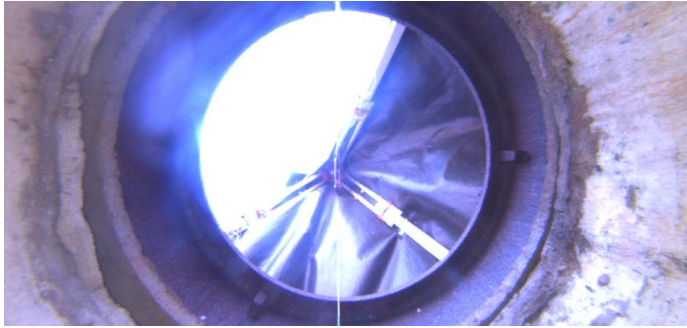
Code: **MGP**
Description: **General Photo**

Distance (ft): **2.1**
Structural Grade: **0**
O&M Grade: **0**
Clock Start/From:
Clock To:
1st Value:
2nd Value:
Value Percent:
Step: **NO**
Remarks:

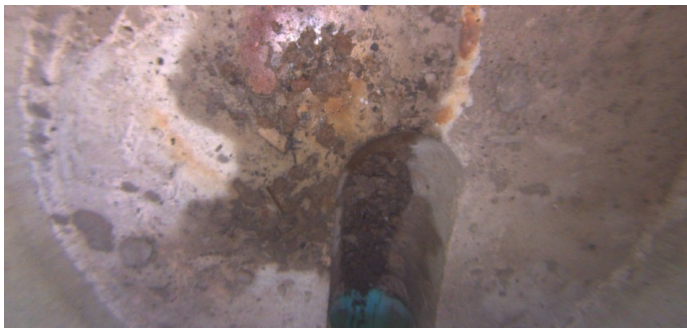
Code: **MGO**
Description: **General Observation**

Distance (ft): **5.1**
Structural Grade: **0**
O&M Grade: **0**
Clock Start/From:
Clock To:
1st Value:
2nd Value:
Value Percent:
Step: **NO**
Remarks: **Ins. Comp.**
