Manhole Inspection Report

Date:	03/25/2018	Weather:		Coding:	RZMACP
MH#:	M-108-054	Owner:	NA	Len. Surveyed:	12.1
P.O.#:		Surveyor:	John Kuglmaier	Rim to Invert:	13.0
Customer:		Cert. #:	U-1215-07002349	Wall Material:	Concrete (reinforced)

Street:	194' West of 61st Ave. and Liverpool	Project:	Hobart, IN
City:	Hobart, IN	GPS Northing:	0.0
Location:		GPS Easting:	0.0
Drain Area:	Southwest	GPS Accuracy:	Nearest Meter
Cover Shape:	Circular	Evidence of Surcharge:	Yes
Cover Size:	22.5	Potential for Runoff:	None
Comments:

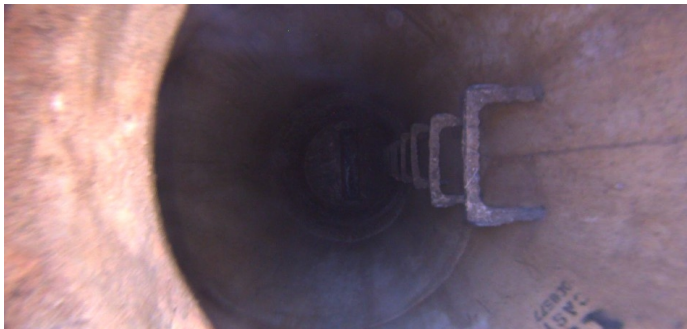
Code: **MGP**
Description: **General Photo**

Distance (ft): **.0**
Structural Grade: **0**
O&M Grade: **0**
Clock Start/From:
Clock To:
1st Value:
2nd Value:
Value Percent:
Step: **NO**
Remarks:

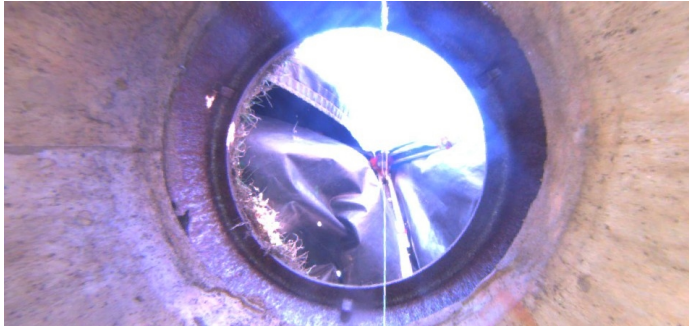
Code: **MGP**
Description: **General Photo**

Distance (ft): **2.3**
Structural Grade: **0**
O&M Grade: **0**
Clock Start/From:
Clock To:
1st Value:
2nd Value:
Value Percent:
Step: **NO**
Remarks:

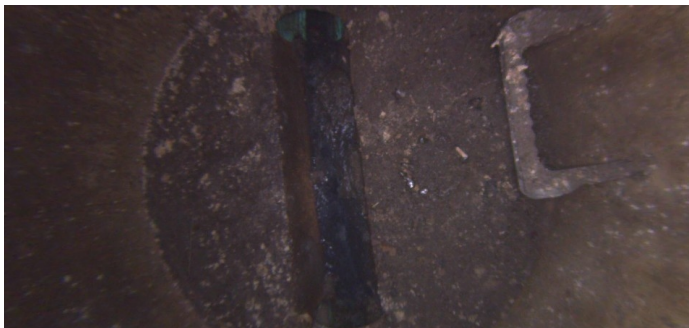
Code: **DSF**
Description: **Deposits Settled Fine**

Distance (ft): **9.9**
Structural Grade: **0**
O&M Grade: **2**
Clock Start/From: **12**
Clock To: **12**
1st Value:
2nd Value:
Value Percent: **10.000**
Step: **NO**
Remarks:

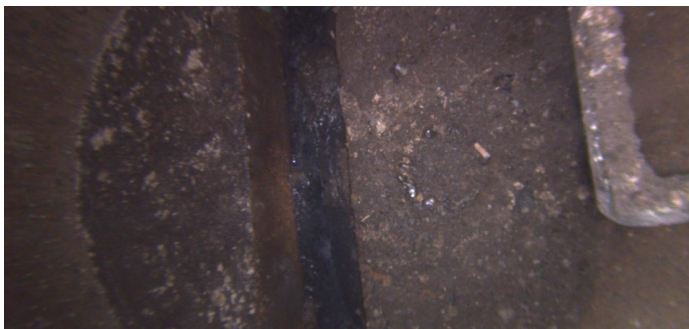
Code: **MGO**
Description: **General Observation**

Distance (ft): **10.6**
Structural Grade: **0**
O&M Grade: **0**
Clock Start/From:
Clock To:
1st Value:
2nd Value:
Value Percent:
Step: **NO**
Remarks: **Ins. Comp.**
