Manhole Inspection Report

Date:	04/18/2018	Weather:		Coding:	RZMACP
MH#:	M-203-011	Owner:	NA	Len. Surveyed:	3.8
P.O.#:		Surveyor:	Jen Costello	Rim to Invert:	4.5
Customer:		Cert. #:	U-907-5518	Wall Material:	Concrete (reinforced)

Street:	Maxwell St. 301' South of 38th Ave.	Project:	Hobart, IN
City:	Hobart, IN	GPS Northing:	2894088.708
Location:		GPS Easting:	2894088.708
Drain Area:	Northwest	GPS Accuracy:	Sub-Meter
Cover Shape:	Circular	Evidence of Surcharge:	No
Cover Size:	23.0	Potential for Runoff:	None
Comments:

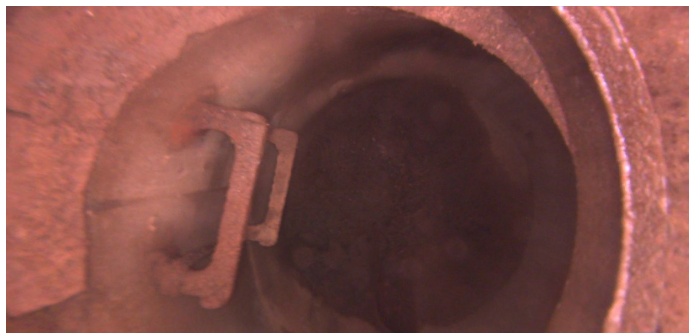
Code: **MGO**
Description: **General Observation**

Distance (ft): **.0**
Structural Grade: **0**
O&M Grade: **0**
Clock Start/From:
Clock To:
1st Value:
2nd Value:
Value Percent:
Step: **NO**
Remarks: **ACCESS MH**

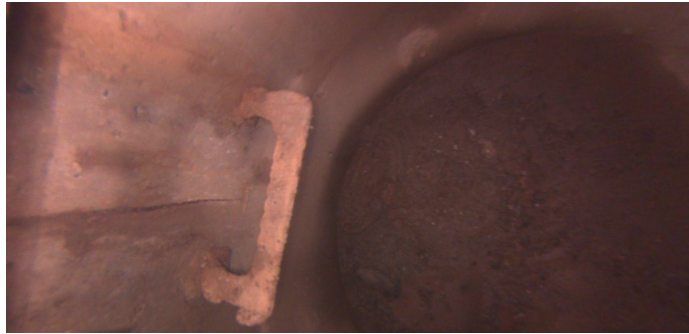
Code: **FL**
Description: **Fracture Longitudinal**

Distance (ft): **1.3**
Structural Grade: **3**
O&M Grade: **0**
Clock Start/From: **9**
Clock To:
1st Value:
2nd Value:
Value Percent:
Step: **NO**
Remarks:

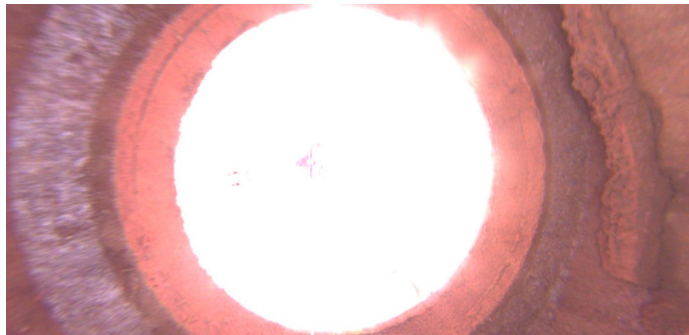
Code: **MGO**
Description: **General Observation**

Distance (ft): **1.3**
Structural Grade: **0**
O&M Grade: **0**
Clock Start/From:
Clock To:
1st Value:
2nd Value:
Value Percent:
Step: **NO**
Remarks: **UNDERSIDE OF FRAME**

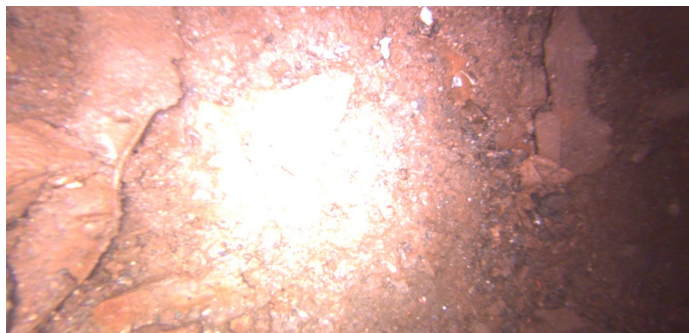
Code: **DSF**
Description: **Deposits Settled Fine**

Distance (ft): **3.8**
Structural Grade: **0**
O&M Grade: **2**
Clock Start/From: **12**
Clock To: **12**
1st Value:
2nd Value:
Value Percent: **10.000**
Step: **NO**
Remarks:
