Manhole Inspection Report

Date:	04/17/2018	Weather:		Coding:	RZMACP
MH#:	M-203-018	Owner:	NA	Len. Surveyed:	5.1
P.O.#:		Surveyor:	Jen Costello	Rim to Invert:	7.5
Customer:		Cert. #:	U-907-5518	Wall Material:	Concrete (reinforced)

Street:	161' South of 37th Ave. 170' West of	Project:	Hobart, IN
City:	Hobart, IN	GPS Northing:	0.0
Location:		GPS Easting:	0.0
Drain Area:	Northwest	GPS Accuracy:	Nearest Meter
Cover Shape:	Circular	Evidence of Surcharge:	No
Cover Size:	23.0	Potential for Runoff:	None
Comments:

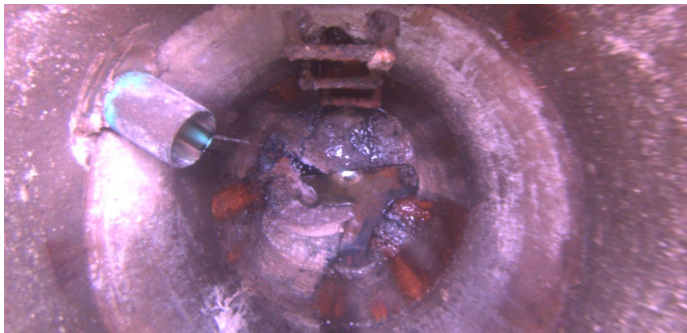
Code: **MGP**
Description: **General Photo**

Distance (ft): **.0**
Structural Grade: **0**
O&M Grade: **0**
Clock Start/From:
Clock To:
1st Value:
2nd Value:
Value Percent:
Step: **NO**
Remarks: **access mh**

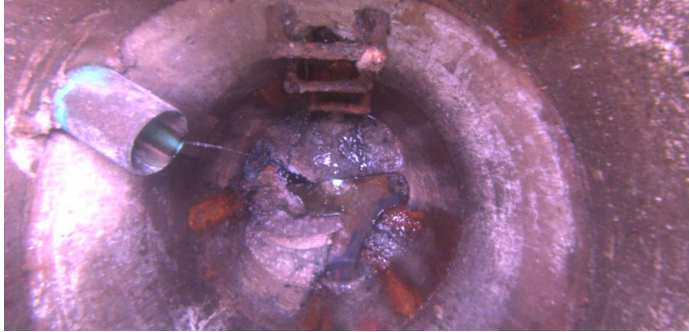
Code: **SAV**
Description: **Surface Aggregate Visible**

Distance (ft): **.2**
Structural Grade: **3**
O&M Grade: **0**
Clock Start/From: **12**
Clock To: **12**
1st Value:
2nd Value:
Value Percent:
Step: **NO**
Remarks:

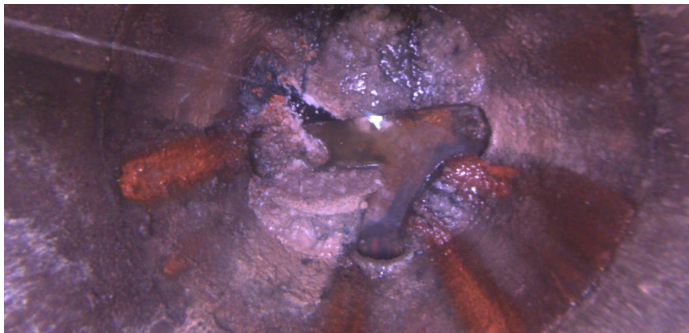
Code: **IW**
Description: **Infil Weeper**

Distance (ft): **2.2**
Structural Grade: **0**
O&M Grade: **2**
Clock Start/From: **12**
Clock To: **12**
1st Value:
2nd Value:
Value Percent:
Step: **NO**
Remarks:

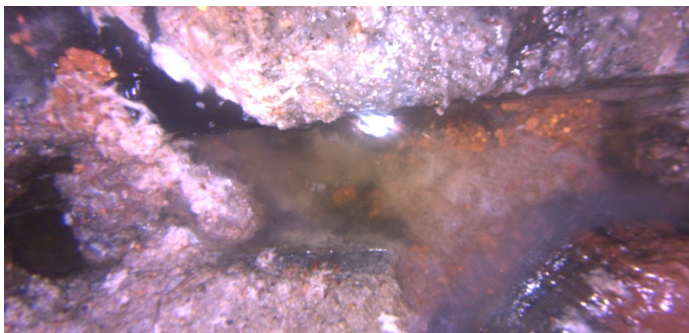
Code: **MGO**
Description: **General Observation**

Distance (ft): **5.1**
Structural Grade: **0**
O&M Grade: **0**
Clock Start/From:
Clock To:
1st Value:
2nd Value:
Value Percent:
Step: **NO**
Remarks: **end survey**
