# Manhole Inspection Report

Date:	<b>09/20/2022</b>	Weather:		Coding:	<b>RZMACP</b>
MH#:	<b>M-203-019</b>	Owner:	<b>NA</b>	Len. Surveyed:	<b>5.2</b>
P.O.#:		Surveyor:	<b>Jen Costello</b>	Rim to Invert:	<b>6.0</b>
Customer:		Cert. #:	<b>U-907-5518</b>	Wall Material:	<b>Concrete (cast in place)</b>

Street:	<b>161' South of 37th Ave. On Parker St</b>	Project:	<b>Hobart, IN</b>
City:	<b>Hobart, IN</b>	GPS Northing:	<b>2295693.883</b>
Location:	<b>Yard</b>	GPS Easting:	<b>2893763.674</b>
Drain Area:	<b>Northwest</b>	GPS Accuracy:	<b>Sub-Meter</b>
Cover Shape:	<b>Circular</b>	Evidence of Surcharge:	<b>Yes</b>
Cover Size:	<b>24.0</b>	Potential for Runoff:	<b>None</b>
Comments:

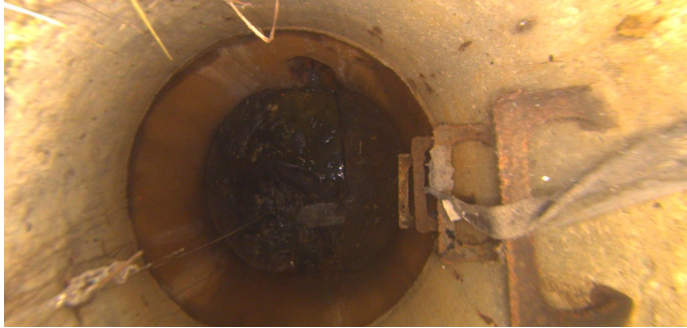
Code: **SRI**  
Description: **Surface Roughness Increased**

Distance (ft): **.0**  
Structural Grade: **1**  
O&M Grade: **0**  
Clock Start/From: **12**  
Clock To: **12**  
1st Value:  
2nd Value:  
Value Percent:  
Step: **NO**  
Remarks:

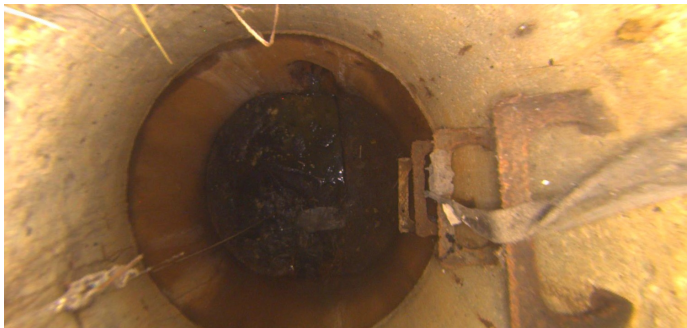
Code: **DAR**  
Description: **Deposits Attached Ragging**

Distance (ft): **.0**  
Structural Grade: **0**  
O&M Grade: **2**  
Clock Start/From: **3**  
Clock To:  
1st Value:  
2nd Value:  
Value Percent: **5.000**  
Step: **NO**  
Remarks:

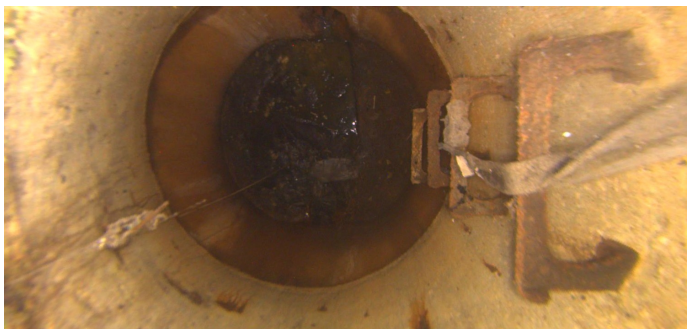
Code: **RFJ**  
Description: **Roots Fine Joint**

Distance (ft): **.0**  
Structural Grade: **0**  
O&M Grade: **1**  
Clock Start/From: **8**  
Clock To:  
1st Value:  
2nd Value:  
Value Percent:  
Step: **NO**  
Remarks:

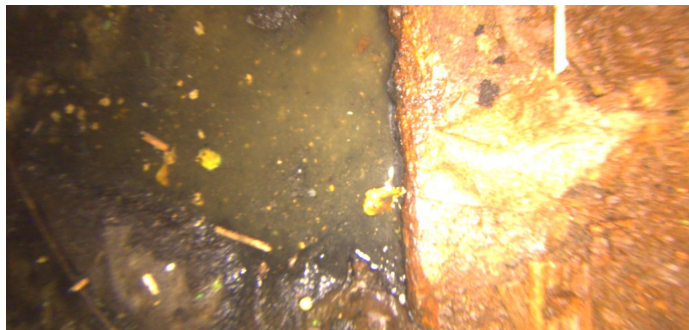
Code: **DSZ**  
Description: **Deposits Settled Other**

Distance (ft): **4.9**  
Structural Grade: **0**  
O&M Grade: **2**  
Clock Start/From: **12**  
Clock To: **12**  
1st Value:  
2nd Value:  
Value Percent: **5.000**  
Step: **NO**  
Remarks: **misc**

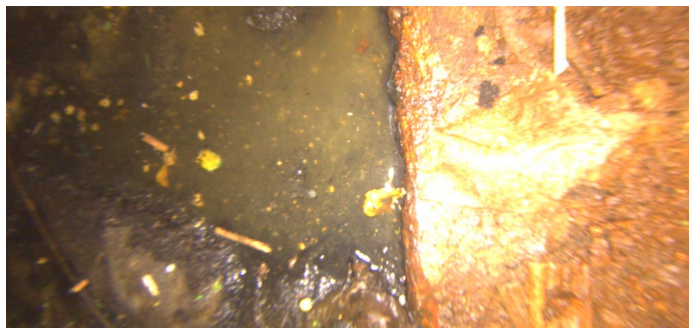
Code: **SRI**  
Description: **Surface Roughness Increased**

Distance (ft): **4.9**  
Structural Grade: **1**  
O&M Grade: **0**  
Clock Start/From: **12**  
Clock To: **12**  
1st Value:  
2nd Value:  
Value Percent:  
Step: **NO**  
Remarks:
