Manhole Inspection Report

Date:	04/18/2018	Weather:		Coding:	RZMACP
MH#:	M-203-023	Owner:	NA	Len. Surveyed:	3.6
P.O.#:		Surveyor:	Jen Costello	Rim to Invert:	4.9
Customer:		Cert. #:	U-907-5518	Wall Material:	Concrete (reinforced)

Street:	38th Ave. 171' East of Barnes St.	Project:	Hobart, IN
City:	Hobart, IN	GPS Northing:	2893585.111
Location:		GPS Easting:	2893585.111
Drain Area:	Northwest	GPS Accuracy:	Sub-Meter
Cover Shape:	Circular	Evidence of Surcharge:	No
Cover Size:	23.0	Potential for Runoff:	None
Comments:

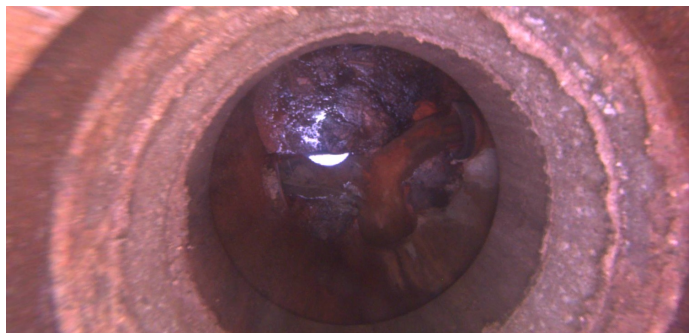
Code: **MGO**
Description: **General Observation**

Distance (ft): **.0**
Structural Grade: **0**
O&M Grade: **0**
Clock Start/From:
Clock To:
1st Value:
2nd Value:
Value Percent:
Step: **NO**
Remarks: **access MH**

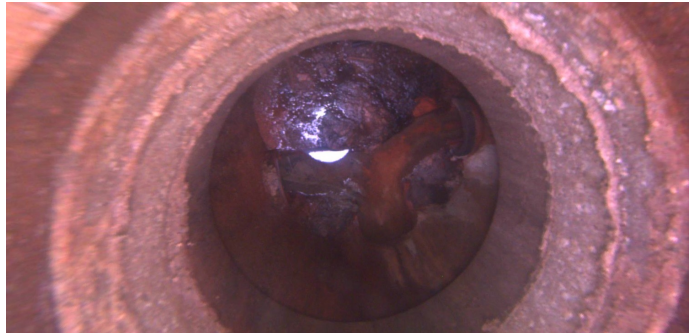
Code:	SRI
Description:	Surface Roughness Increased
Distance (ft):	.0
Structural Grade:	1
O&M Grade:	0
Clock Start/From:	12
Clock To:	12
1st Value:	
2nd Value:	
Value Percent:	
Step:	NO
Remarks:

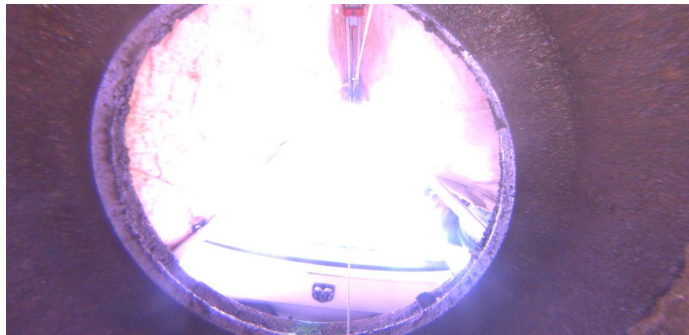
Code:	MGO
Description:	General Observation
Distance (ft):	1.2
Structural Grade:	0
O&M Grade:	0
Clock Start/From:	
Clock To:	
1st Value:	
2nd Value:	
Value Percent:	
Step:	NO
Remarks:	UNDERSIDE OF FRAME

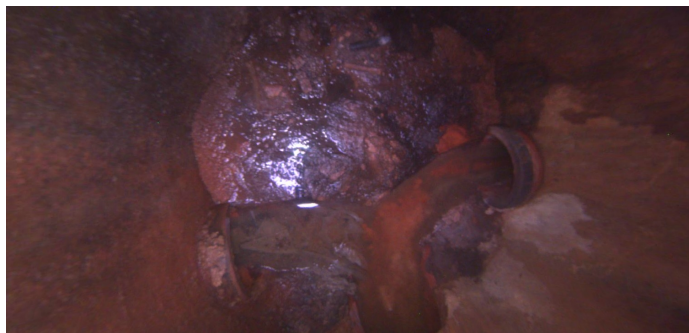
Code:	IW
Description:	Infil Weeper
Distance (ft):	1.7
Structural Grade:	0
O&M Grade:	2
Clock Start/From:	12
Clock To:	12
1st Value:	
2nd Value:	
Value Percent:	
Step:	NO
Remarks:

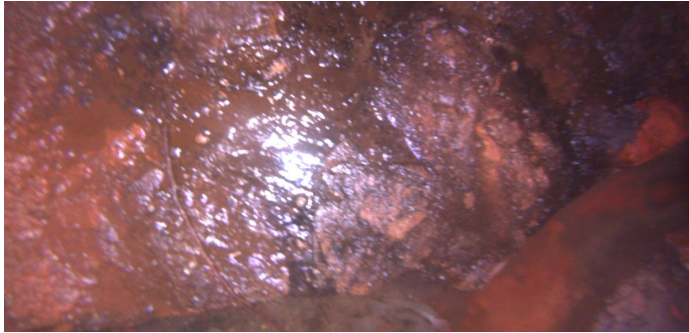
Code:	MGO
Description:	General Observation
Distance (ft):	3.6
Structural Grade:	0
O&M Grade:	0
Clock Start/From:	
Clock To:	
1st Value:	
2nd Value:	
Value Percent:	
Step:	NO
Remarks:	END SURVEY
