Manhole Inspection Report

Date:	04/17/2018	Weather:		Coding:	RZMACP
MH#:	M-203-031	Owner:	NA	Len. Surveyed:	2.2
P.O.#:		Surveyor:	Jen Costello	Rim to Invert:	3.2
Customer:		Cert. #:	U-907-5518	Wall Material:	Concrete (reinforced)

Street:	Sherman St. 494' North of 38th Ave.	Project:	Hobart, IN
City:	Hobart, IN	GPS Northing:	0.0
Location:		GPS Easting:	0.0
Drain Area:	Northwest	GPS Accuracy:	Nearest Meter
Cover Shape:	Circular	Evidence of Surcharge:	No
Cover Size:	23.0	Potential for Runoff:	None
Comments:

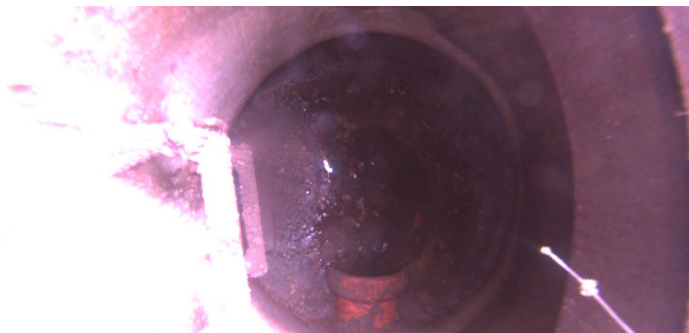
Code: **MGO**
Description: **General Observation**

Distance (ft): **.0**
Structural Grade: **0**
O&M Grade: **0**
Clock Start/From:
Clock To:
1st Value:
2nd Value:
Value Percent:
Step: **NO**
Remarks: **ACCESS MH**

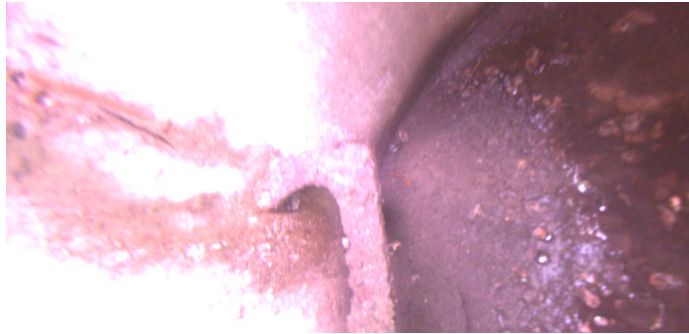
Code: **FL**
Description: **Fracture Longitudinal**

Distance (ft): **1.4**
Structural Grade: **3**
O&M Grade: **0**
Clock Start/From: **10**
Clock To:
1st Value:
2nd Value:
Value Percent:
Step: **NO**
Remarks:

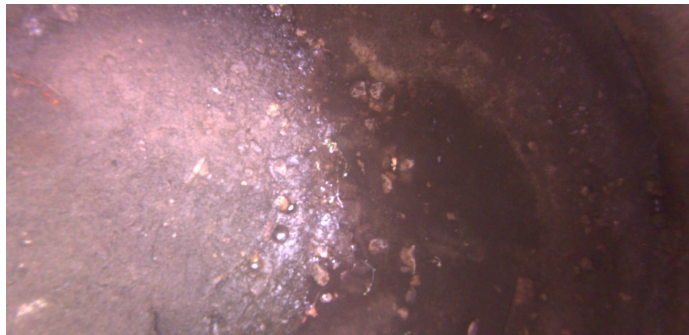
Code: **SAV**
Description: **Surface Aggregate Visible**

Distance (ft): **2.2**
Structural Grade: **3**
O&M Grade: **0**
Clock Start/From: **12**
Clock To: **12**
1st Value:
2nd Value:
Value Percent:
Step: **NO**
Remarks:

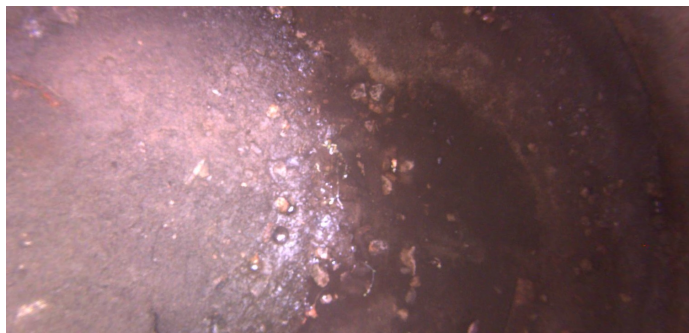
Code: **MGO**
Description: **General Observation**

Distance (ft): **2.2**
Structural Grade: **0**
O&M Grade: **0**
Clock Start/From:
Clock To:
1st Value:
2nd Value:
Value Percent:
Step: **NO**
Remarks: **END SURVEY**
