Manhole Inspection Report

Date:	10/05/2022	Weather:		Coding:	RZMACP
MH#:	M-203-035	Owner:	NA	Len. Surveyed:	5.5
P.O.#:		Surveyor:	Jen Costello	Rim to Invert:	6.7
Customer:		Cert. #:	U-907-5518	Wall Material:	Concrete (cast in place)

Street:	Alley Maitland St. and Montgomery	Project:	Hobart, IN
City:	Hobart, IN	GPS Northing:	2295043.545
Location:	Other	GPS Easting:	2892581.54
Drain Area:	Northwest	GPS Accuracy:	Sub-Meter
Cover Shape:	Circular	Evidence of Surcharge:	No
Cover Size:	24.0	Potential for Runoff:	None
Comments:

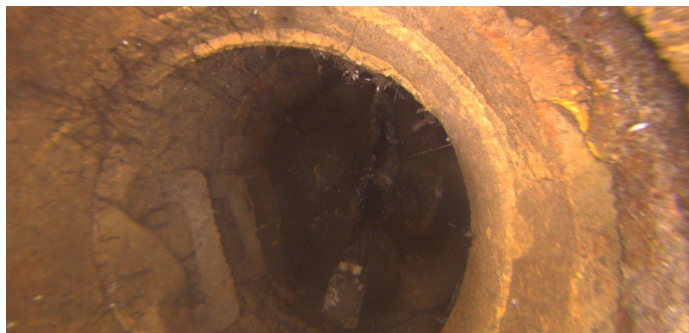
Code: **MGO**
Description: **General Observation**

Distance (ft): **.0**
Structural Grade: **0**
O&M Grade: **0**
Clock Start/From:
Clock To:
1st Value:
2nd Value:
Value Percent:
Step: **NO**
Remarks: **access mh**

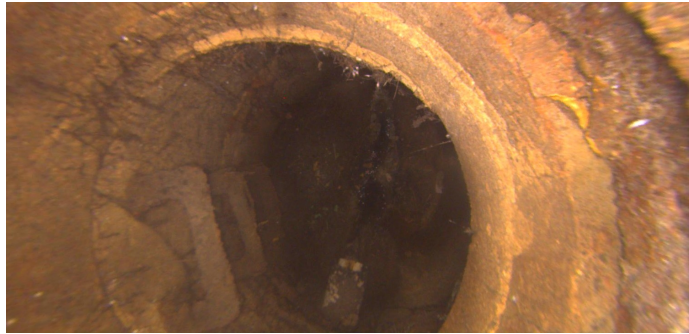
Code: **SRI**
Description: **Surface Roughness Increased**

Distance (ft): **.0**
Structural Grade: **1**
O&M Grade: **0**
Clock Start/From: **12**
Clock To: **12**
1st Value:
2nd Value:
Value Percent:
Step: **NO**
Remarks:

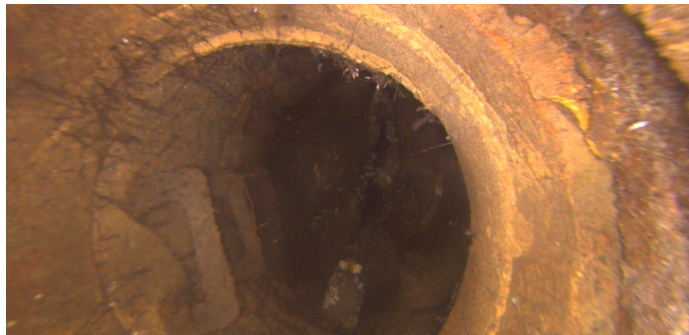
Code: **RFJ**
Description: **Roots Fine Joint**

Distance (ft): **.0**
Structural Grade: **0**
O&M Grade: **1**
Clock Start/From: **12**
Clock To: **12**
1st Value:
2nd Value:
Value Percent:
Step: **NO**
Remarks:

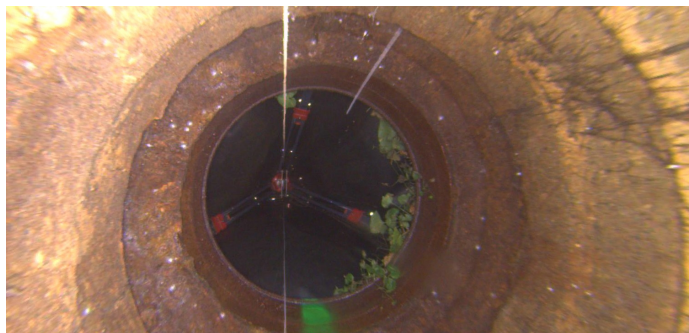
Code: **MGO**
Description: **General Observation**

Distance (ft): **2.4**
Structural Grade: **0**
O&M Grade: **0**
Clock Start/From:
Clock To:
1st Value:
2nd Value:
Value Percent:
Step: **NO**
Remarks: **underside of frame**

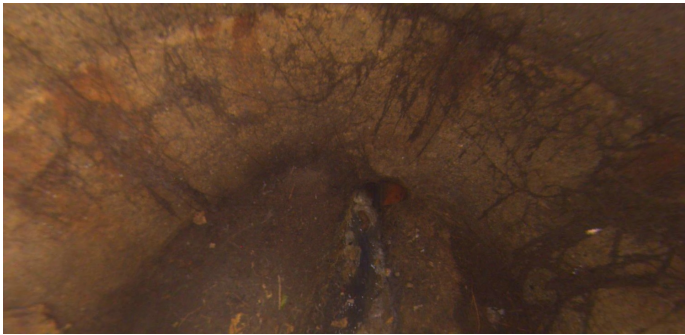
Code: **RFJ**
Description: **Roots Fine Joint**

Distance (ft): **2.4**
Structural Grade: **0**
O&M Grade: **1**
Clock Start/From: **12**
Clock To: **12**
1st Value:
2nd Value:
Value Percent:
Step: **NO**
Remarks:

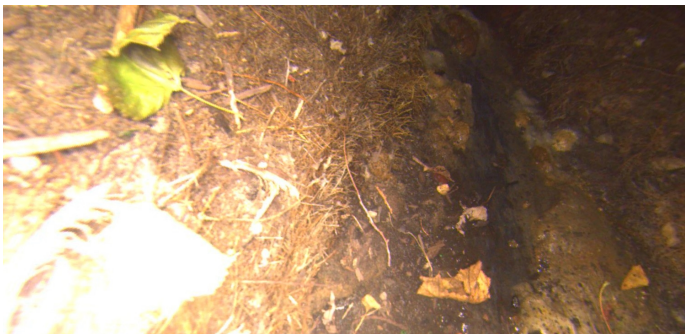
Code: **DSF**
Description: **Deposits Settled Fine**

Distance (ft): **5.5**
Structural Grade: **0**
O&M Grade: **2**
Clock Start/From: **12**
Clock To: **12**
1st Value:
2nd Value:
Value Percent: **5.000**
Step: **NO**
Remarks:

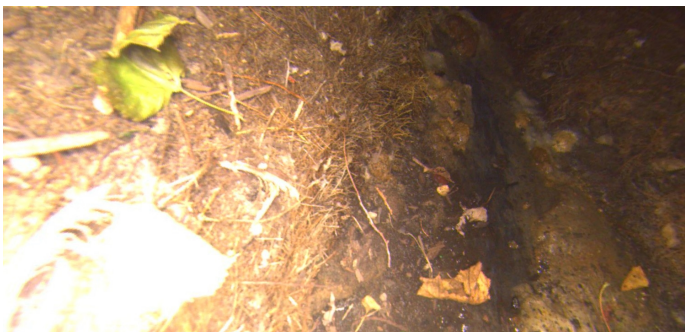
Code: **SRI**
Description: **Surface Roughness Increased**

Distance (ft): **5.5**
Structural Grade: **1**
O&M Grade: **0**
Clock Start/From: **12**
Clock To: **12**
1st Value:
2nd Value:
Value Percent:
Step: **NO**
Remarks:

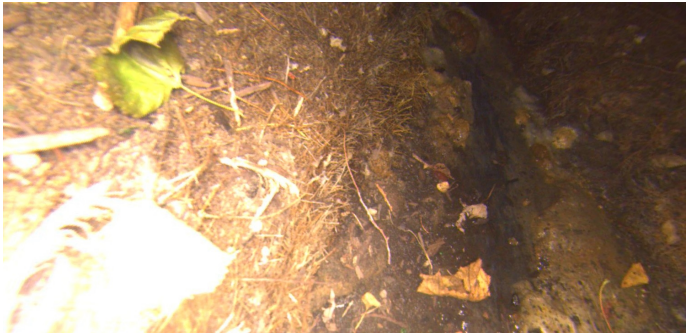
Code:	MGO
Description:	General Observation
Distance (ft):	5.5
Structural Grade:	0
O&M Grade:	0
Clock Start/From:	
Clock To:	
1st Value:	
2nd Value:	
Value Percent:	
Step:	NO
Remarks:	end of survey
