# Manhole Inspection Report

Date:	04/17/2018	Weather:		Coding:	RZMACP
MH#:	M-203-040	Owner:	NA	Len. Surveyed:	2.1
P.O.#:		Surveyor:	Jen Costello	Rim to Invert:	3.0
Customer:		Cert. #:	U-907-5518	Wall Material:	Concrete (reinforced)

Street:	Alley between 37th Ave. and 38th A	Project:	Hobart, IN
City:	Hobart, IN	GPS Northing:	0.0
Location:		GPS Easting:	0.0
Drain Area:	Northwest	GPS Accuracy:	Nearest Meter
Cover Shape:	Circular	Evidence of Surcharge:	No
Cover Size:	23.0	Potential for Runoff:	None
Comments:

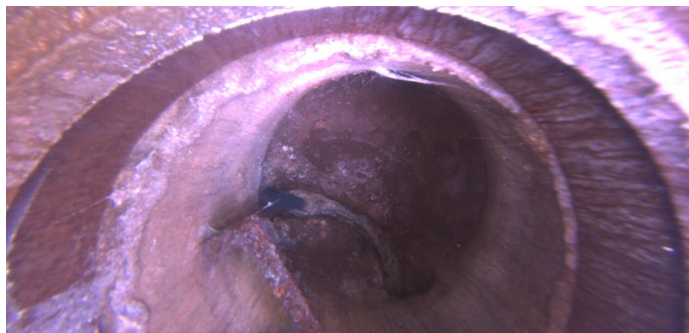
Code: **MGO**  
 Description: **General Observation**

Distance (ft): **.0**  
 Structural Grade: **0**  
 O&M Grade: **0**  
 Clock Start/From:  
 Clock To:  
 1st Value:  
 2nd Value:  
 Value Percent:  
 Step: **NO**  
 Remarks: **ACCESS MH**

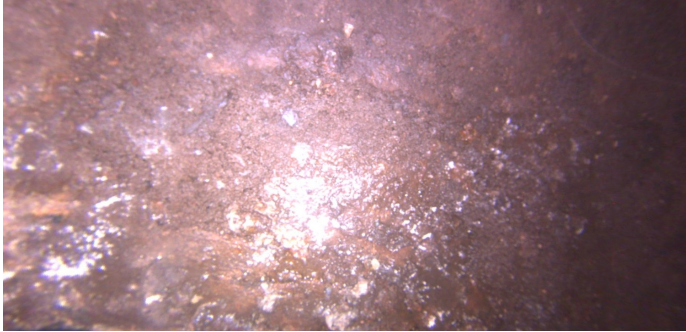
Code:	<b>MGO</b>
Description:	<b>General Observation</b>

Distance (ft):	<b>2.1</b>
Structural Grade:	<b>0</b>
O&M Grade:	<b>0</b>
Clock Start/From:	
Clock To:	
1st Value:	
2nd Value:	
Value Percent:	
Step:	<b>NO</b>
Remarks:	<b>END SURVEY</b>

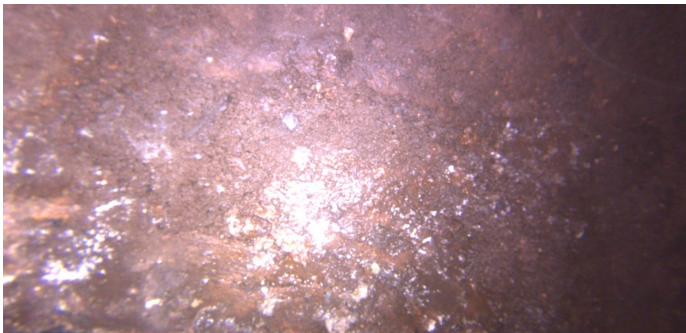
Code:	<b>SAV</b>
Description:	<b>Surface Aggregate Visible</b>

Distance (ft):	<b>2.1</b>
Structural Grade:	<b>3</b>
O&M Grade:	<b>0</b>
Clock Start/From:	<b>12</b>
Clock To:	<b>12</b>
1st Value:	
2nd Value:	
Value Percent:	
Step:	<b>NO</b>
Remarks:
