# Manhole Inspection Report

Date:	04/17/2018	Weather:		Coding:	RZMACP
MH#:	M-203-042	Owner:	NA	Len. Surveyed:	5.6
P.O.#:		Surveyor:	Jen Costello	Rim to Invert:	7.4
Customer:		Cert. #:	U-907-5518	Wall Material:	Concrete (reinforced)

Street:	between Evergreen St. and Maitland	Project:	Hobart, IN
City:	Hobart, IN	GPS Northing:	0.0
Location:		GPS Easting:	0.0
Drain Area:	Northwest	GPS Accuracy:	Nearest Meter
Cover Shape:	Circular	Evidence of Surcharge:	No
Cover Size:	23.0	Potential for Runoff:	None
Comments:

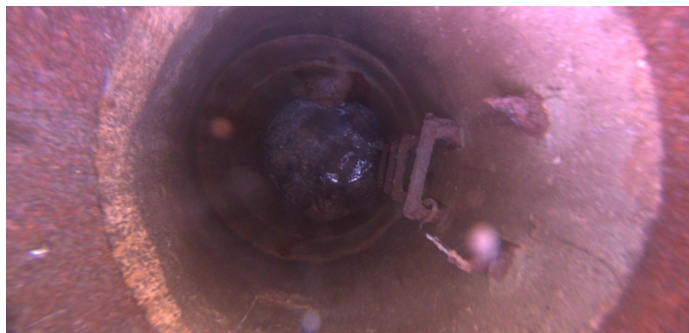
Code: **MGO**  
Description: **General Observation**

Distance (ft): **.0**  
Structural Grade: **0**  
O&M Grade: **0**  
Clock Start/From:  
Clock To:  
1st Value:  
2nd Value:  
Value Percent:  
Step: **NO**  
Remarks: **access MH**

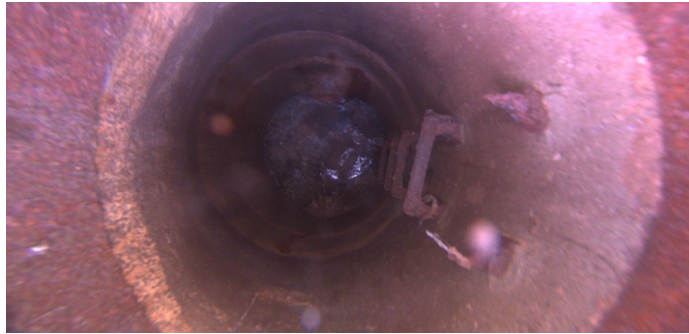
Code:	<b>SAV</b>
Description:	<b>Surface Aggregate Visible</b>
Distance (ft):	<b>.0</b>
Structural Grade:	<b>3</b>
O&M Grade:	<b>0</b>
Clock Start/From:	<b>12</b>
Clock To:	<b>12</b>
1st Value:	
2nd Value:	
Value Percent:	
Step:	<b>NO</b>
Remarks:

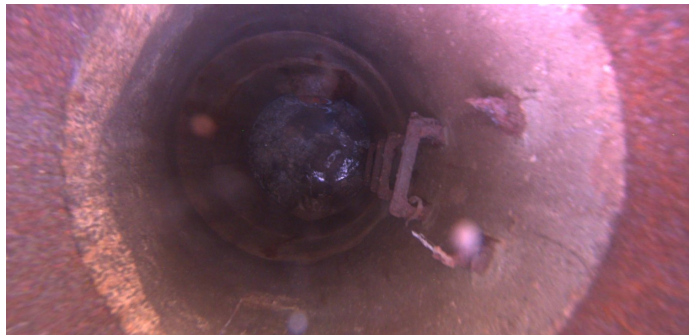
Code:	<b>RFJ</b>
Description:	<b>Roots Fine Joint</b>
Distance (ft):	<b>.0</b>
Structural Grade:	<b>0</b>
O&M Grade:	<b>1</b>
Clock Start/From:	<b>4</b>
Clock To:	
1st Value:	
2nd Value:	
Value Percent:	
Step:	<b>NO</b>
Remarks:

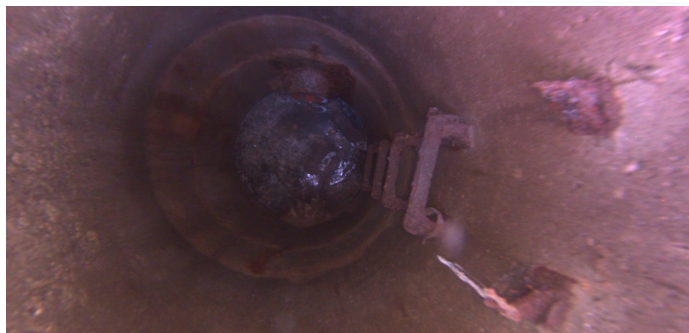
Code:	<b>MGO</b>
Description:	<b>General Observation</b>
Distance (ft):	<b>.4</b>
Structural Grade:	<b>0</b>
O&M Grade:	<b>0</b>
Clock Start/From:	
Clock To:	
1st Value:	
2nd Value:	
Value Percent:	
Step:	<b>NO</b>
Remarks:	<b>BROKEN STEP</b>

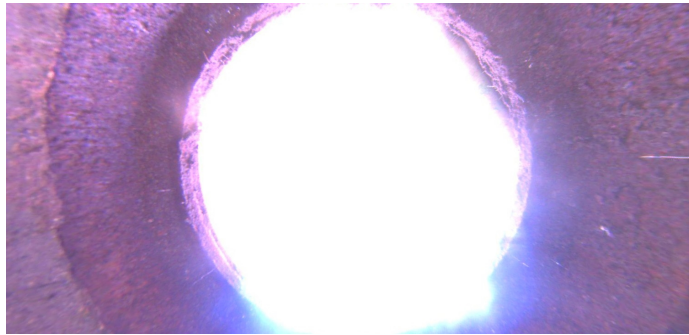
Code: **MGO**  
Description: **General Observation**

Distance (ft): **1.3**  
Structural Grade: **0**  
O&M Grade: **0**  
Clock Start/From:  
Clock To:  
1st Value:  
2nd Value:  
Value Percent:  
Step: **NO**  
Remarks: **UNDERSIDE OF FRAME**

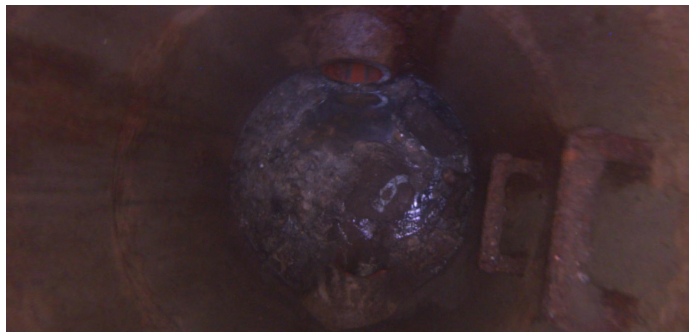
Code: **IS**  
Description: **Infil Stain**

Distance (ft): **2.4**  
Structural Grade: **0**  
O&M Grade: **0**  
Clock Start/From: **12**  
Clock To: **12**  
1st Value:  
2nd Value:  
Value Percent:  
Step: **NO**  
Remarks:

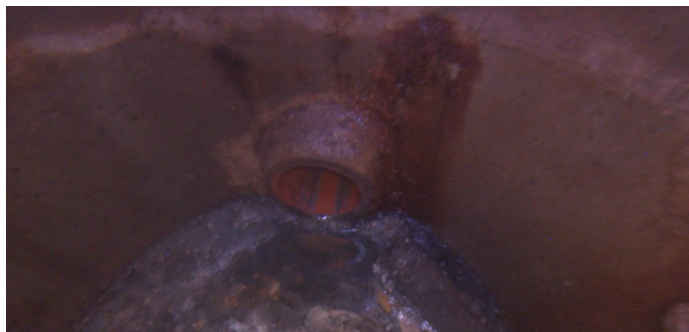
Code: **IW**  
Description: **Infil Weeper**

Distance (ft): **4.0**  
Structural Grade: **0**  
O&M Grade: **2**  
Clock Start/From: **12**  
Clock To:  
1st Value:  
2nd Value:  
Value Percent:  
Step: **NO**  
Remarks:

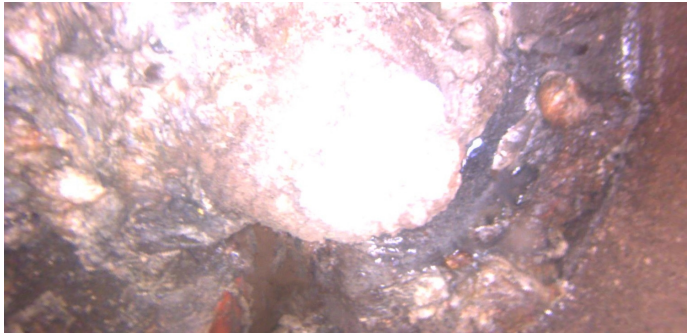
Code: **DSZ**  
Description: **Deposits Settled Other**

Distance (ft): **5.6**  
Structural Grade: **0**  
O&M Grade: **2**  
Clock Start/From: **12**  
Clock To: **12**  
1st Value:  
2nd Value:  
Value Percent: **10.000**  
Step: **NO**  
Remarks: **MISC**

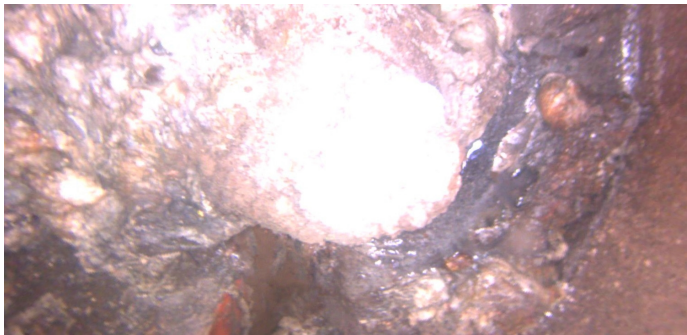
Code: **MGO**  
Description: **General Observation**

Distance (ft): **5.6**  
Structural Grade: **0**  
O&M Grade: **0**  
Clock Start/From:  
Clock To:  
1st Value:  
2nd Value:  
Value Percent:  
Step: **NO**  
Remarks: **END SURVEY**
