Manhole Inspection Report

Date:	04/17/2018	Weather:		Coding:	RZMACP
MH#:	M-203-042	Owner:	NA	Len. Surveyed:	9.0
P.O.#:		Surveyor:	Jen Costello	Rim to Invert:	10.0
Customer:		Cert. #:	U-907-5518	Wall Material:	Concrete (reinforced)

Street:	between Evergreen St. and Maitland	Project:	Hobart, IN
City:	Hobart, IN	GPS Northing:	0.0
Location:		GPS Easting:	0.0
Drain Area:	Northwest	GPS Accuracy:	Nearest Meter
Cover Shape:	Circular	Evidence of Surcharge:	No
Cover Size:	23.0	Potential for Runoff:	None
Comments:

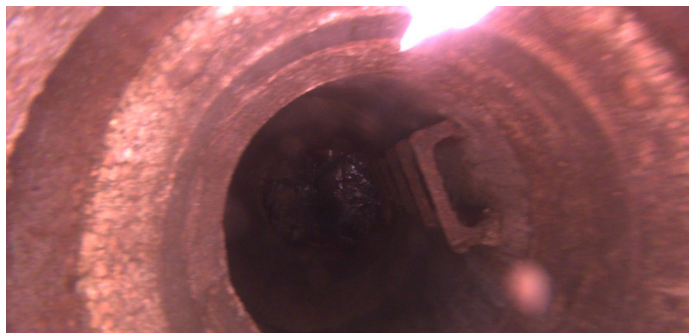
Code: **MGO**
Description: **General Observation**

Distance (ft): **.0**
Structural Grade: **0**
O&M Grade: **0**
Clock Start/From:
Clock To:
1st Value:
2nd Value:
Value Percent:
Step: **NO**
Remarks: **ACCESS MH**

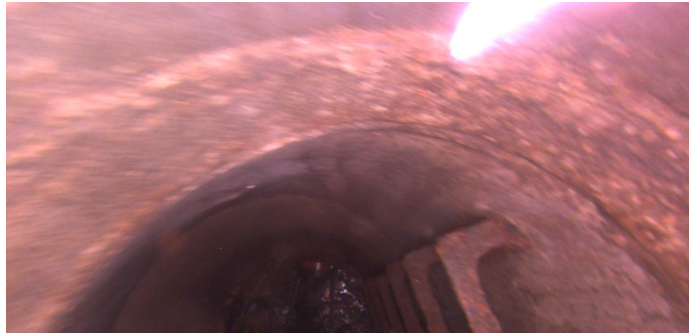
Code:	SAP
Description:	Surface Aggregate Projecting
Distance (ft):	.8
Structural Grade:	3
O&M Grade:	0
Clock Start/From:	12
Clock To:	12
1st Value:	
2nd Value:	
Value Percent:	
Step:	NO
Remarks:

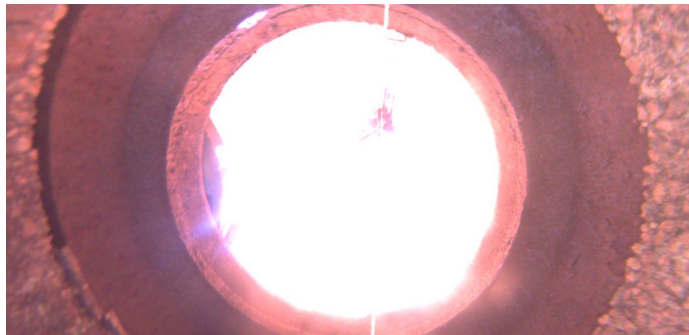
Code:	MGO
Description:	General Observation
Distance (ft):	1.6
Structural Grade:	0
O&M Grade:	0
Clock Start/From:	
Clock To:	
1st Value:	
2nd Value:	
Value Percent:	
Step:	NO
Remarks:	UNDERSIDE OF FRAME

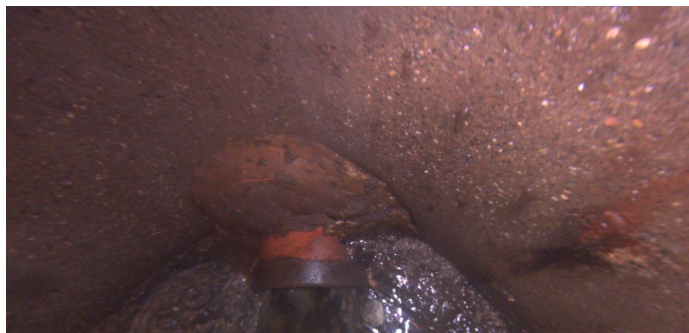
Code:	SAV
Description:	Surface Aggregate Visible
Distance (ft):	7.0
Structural Grade:	3
O&M Grade:	0
Clock Start/From:	12
Clock To:	12
1st Value:	
2nd Value:	
Value Percent:	
Step:	NO
Remarks:

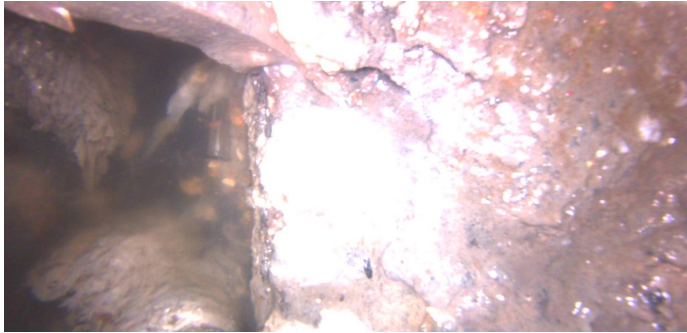
Code: **MGO**
Description: **General Observation**

Distance (ft): **9.0**
Structural Grade: **0**
O&M Grade: **0**
Clock Start/From:
Clock To:
1st Value:
2nd Value:
Value Percent:
Step: **NO**
Remarks: **END SURVEY**
