# Manhole Inspection Report

Date:	<b>04/17/2018</b>	Weather:		Coding:	<b>RZMACP</b>
MH#:	<b>M-203-044</b>	Owner:	<b>NA</b>	Len. Surveyed:	<b>1.5</b>
P.O.#:		Surveyor:	<b>Jen Costello</b>	Rim to Invert:	<b>2.4</b>
Customer:		Cert. #:	<b>U-907-5518</b>	Wall Material:	<b>Concrete (reinforced)</b>

Street:	<b>Maitland St. 150' North of 39th Ave.</b>	Project:	<b>Hobart, IN</b>
City:	<b>Hobart, IN</b>	GPS Northing:	<b>0.0</b>
Location:		GPS Easting:	<b>0.0</b>
Drain Area:	<b>Northwest</b>	GPS Accuracy:	<b>Nearest Meter</b>
Cover Shape:	<b>Circular</b>	Evidence of Surcharge:	<b>No</b>
Cover Size:	<b>23.0</b>	Potential for Runoff:	<b>None</b>
Comments:

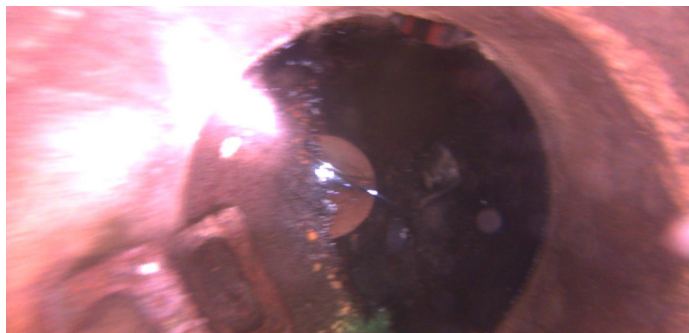
Code: **MGO**  
Description: **General Observation**

Distance (ft): **.0**  
Structural Grade: **0**  
O&M Grade: **0**  
Clock Start/From:  
Clock To:  
1st Value:  
2nd Value:  
Value Percent:  
Step: **NO**  
Remarks: **access MH**

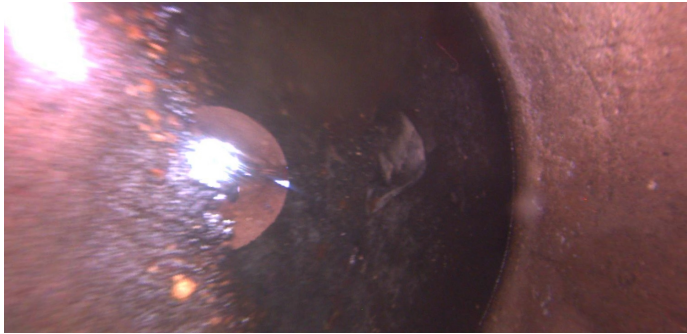
Code:	<b>SAV</b>
Description:	<b>Surface Aggregate Visible</b>
Distance (ft):	<b>1.0</b>
Structural Grade:	<b>3</b>
O&M Grade:	<b>0</b>
Clock Start/From:	<b>12</b>
Clock To:	<b>12</b>
1st Value:	
2nd Value:	
Value Percent:	
Step:	<b>NO</b>
Remarks:

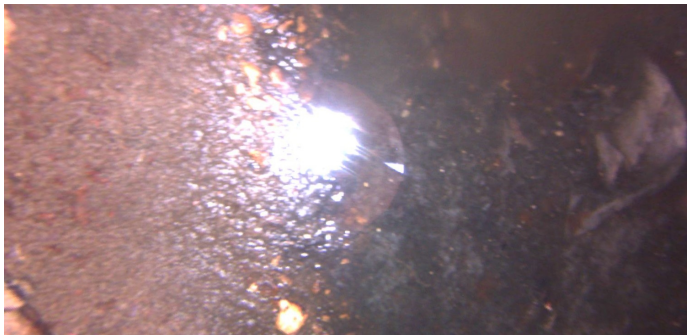
Code:	<b>MGO</b>
Description:	<b>General Observation</b>
Distance (ft):	<b>1.5</b>
Structural Grade:	<b>0</b>
O&M Grade:	<b>0</b>
Clock Start/From:	
Clock To:	
1st Value:	
2nd Value:	
Value Percent:	
Step:	<b>NO</b>
Remarks:	<b>END SURVEY</b>
