Manhole Inspection Report

Date:	04/17/2018	Weather:		Coding:	RZMACP
MH#:	M-203-045	Owner:	NA	Len. Surveyed:	8.2
P.O.#:		Surveyor:	Jen Costello	Rim to Invert:	9.3
Customer:		Cert. #:	U-907-5518	Wall Material:	Concrete (reinforced)

Street:	Alley between 38th Ave and 39th Av	Project:	Hobart, IN
City:	Hobart, IN	GPS Northing:	0.0
Location:		GPS Easting:	0.0
Drain Area:	Northwest	GPS Accuracy:	Nearest Meter
Cover Shape:	Circular	Evidence of Surcharge:	No
Cover Size:	23.0	Potential for Runoff:	None
Comments:

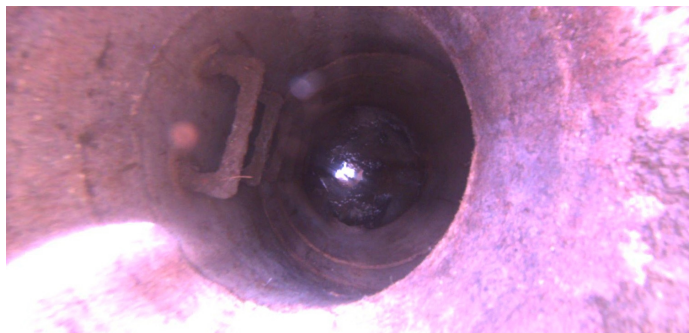
Code: **MGO**
Description: **General Observation**

Distance (ft): **.0**
Structural Grade: **0**
O&M Grade: **0**
Clock Start/From:
Clock To:
1st Value:
2nd Value:
Value Percent:
Step: **NO**
Remarks: **ACCESS MH**

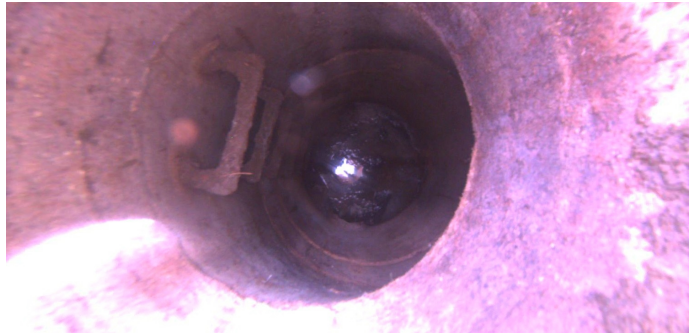
Code: **SRI**
Description: **Surface Roughness Increased**

Distance (ft): **.0**
Structural Grade: **1**
O&M Grade: **0**
Clock Start/From: **12**
Clock To: **12**
1st Value:
2nd Value:
Value Percent:
Step: **NO**
Remarks:

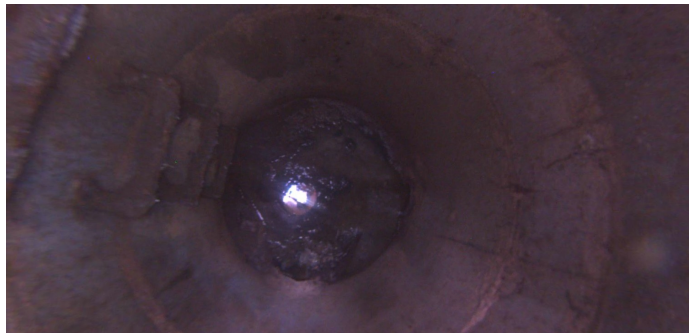
Code: **RFJ**
Description: **Roots Fine Joint**

Distance (ft): **3.1**
Structural Grade: **0**
O&M Grade: **1**
Clock Start/From: **12**
Clock To: **12**
1st Value:
2nd Value:
Value Percent:
Step: **NO**
Remarks:

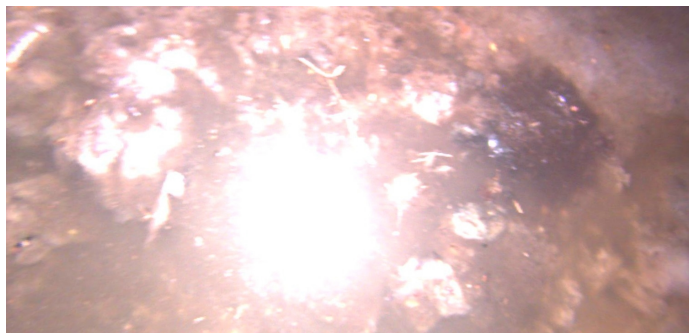
Code: **MGO**
Description: **General Observation**

Distance (ft): **8.2**
Structural Grade: **0**
O&M Grade: **0**
Clock Start/From:
Clock To:
1st Value:
2nd Value:
Value Percent:
Step: **NO**
Remarks: **END SURVEY**
