Manhole Inspection Report

Date:	04/17/2018	Weather:		Coding:	RZMACP
MH#:	M-203-064	Owner:	NA	Len. Surveyed:	7.2
P.O.#:		Surveyor:	Jen Costello	Rim to Invert:	8.7
Customer:		Cert. #:	U-907-5518	Wall Material:	Concrete (reinforced)

Street:	Alley between 38th Ave. and 39th A	Project:	Hobart, IN
City:	Hobart, IN	GPS Northing:	0.0
Location:		GPS Easting:	0.0
Drain Area:	Northwest	GPS Accuracy:	Nearest Meter
Cover Shape:	Circular	Evidence of Surcharge:	No
Cover Size:	23.0	Potential for Runoff:	None
Comments:

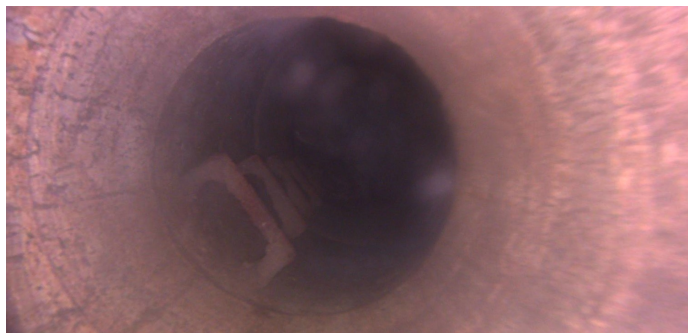
Code: **MGO**
Description: **General Observation**

Distance (ft): **.0**
Structural Grade: **0**
O&M Grade: **0**
Clock Start/From:
Clock To:
1st Value:
2nd Value:
Value Percent:
Step: **NO**
Remarks: **ACCESS MH**

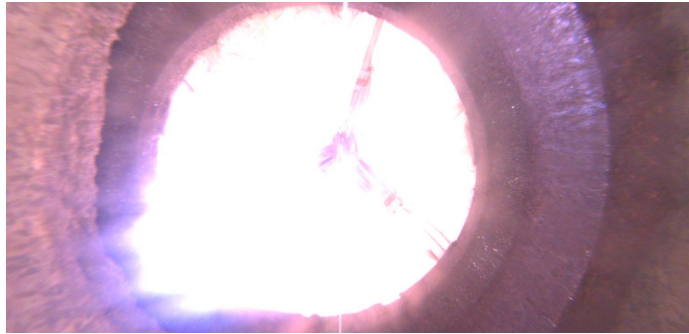
Code:	MGP
Description:	General Photo
Distance (ft):	1.3
Structural Grade:	0
O&M Grade:	0
Clock Start/From:	
Clock To:	
1st Value:	
2nd Value:	
Value Percent:	
Step:	NO
Remarks:	UNDERSIDE OF FRAME

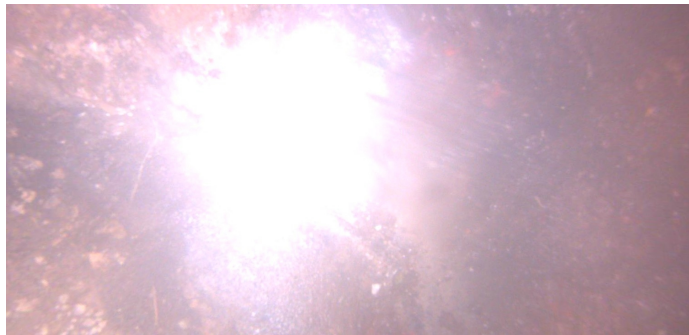
Code:	MGO
Description:	General Observation
Distance (ft):	7.2
Structural Grade:	0
O&M Grade:	0
Clock Start/From:	
Clock To:	
1st Value:	
2nd Value:	
Value Percent:	
Step:	NO
Remarks:	END SURVEY
