Manhole Inspection Report

Date:	04/17/2018	Weather:		Coding:	RZMACP
MH#:	M-203-066	Owner:	NA	Len. Surveyed:	3.3
P.O.#:		Surveyor:	Jen Costello	Rim to Invert:	4.0
Customer:		Cert. #:	U-907-5518	Wall Material:	Concrete (reinforced)

Street:	Sandusky St. and Route 6 to the Sou	Project:	Hobart, IN
City:	Hobart, IN	GPS Northing:	0.0
Location:		GPS Easting:	0.0
Drain Area:	Northwest	GPS Accuracy:	Nearest Meter
Cover Shape:	Circular	Evidence of Surcharge:	No
Cover Size:	23.0	Potential for Runoff:	None
Comments:

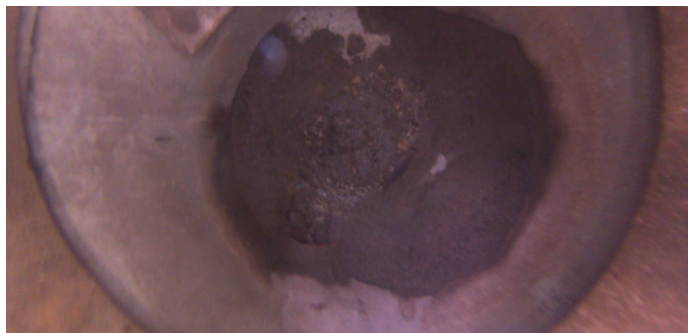
Code: **MGO**
Description: **General Observation**

Distance (ft): **.0**
Structural Grade: **0**
O&M Grade: **0**
Clock Start/From:
Clock To:
1st Value:
2nd Value:
Value Percent:
Step: **NO**
Remarks: **ACCESS MH**

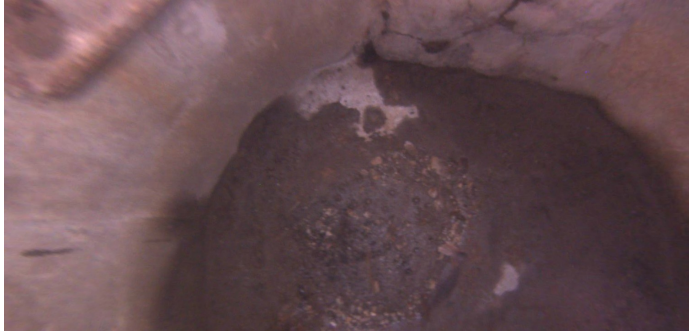
Code:	FM
Description:	Fracture Multiple
Distance (ft):	1.0
Structural Grade:	4
O&M Grade:	0
Clock Start/From:	9
Clock To:	12
1st Value:	
2nd Value:	
Value Percent:	
Step:	NO
Remarks:

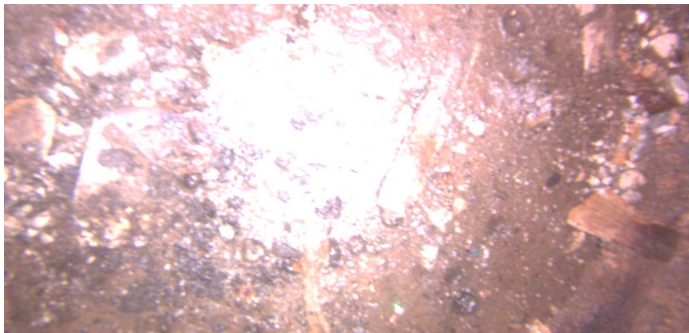
Code:	DSF
Description:	Deposits Settled Fine
Distance (ft):	3.3
Structural Grade:	0
O&M Grade:	2
Clock Start/From:	12
Clock To:	12
1st Value:	
2nd Value:	
Value Percent:	5.000
Step:	NO
Remarks:
