Manhole Inspection Report

Date:	04/17/2018	Weather:		Coding:	RZMACP
MH#:	M-203-067	Owner:	NA	Len. Surveyed:	4.4
P.O.#:		Surveyor:	Jen Costello	Rim to Invert:	6.3
Customer:		Cert. #:	U-907-5518	Wall Material:	Concrete (reinforced)

Street:	Sandusky St. and Route 6 to the Sou	Project:	Hobart, IN
City:	Hobart, IN	GPS Northing:	0.0
Location:		GPS Easting:	0.0
Drain Area:	Northwest	GPS Accuracy:	Nearest Meter
Cover Shape:	Circular	Evidence of Surcharge:	No
Cover Size:	23.0	Potential for Runoff:	None
Comments:

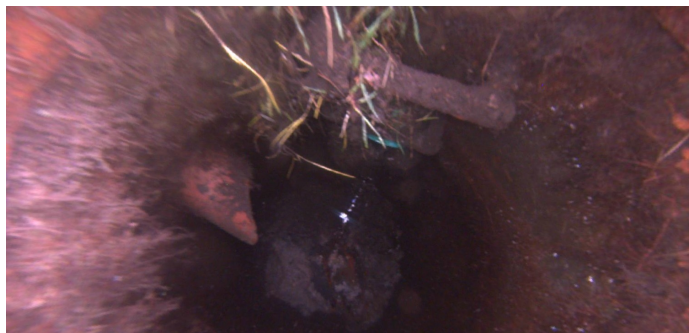
Code: **MGO**
Description: **General Observation**

Distance (ft): **.0**
Structural Grade: **0**
O&M Grade: **0**
Clock Start/From:
Clock To:
1st Value:
2nd Value:
Value Percent:
Step: **NO**
Remarks: **ACCESS MH**

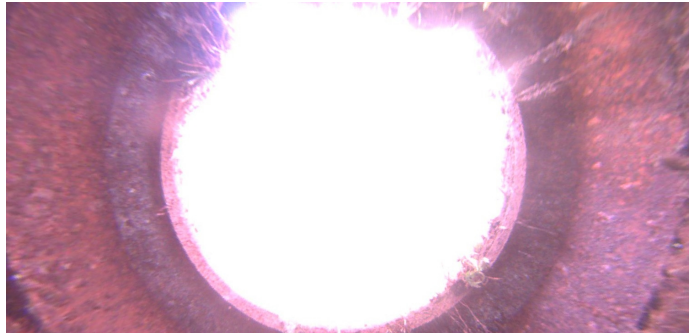
Code:	MGO
Description:	General Observation
Distance (ft):	1.4
Structural Grade:	0
O&M Grade:	0
Clock Start/From:	
Clock To:	
1st Value:	
2nd Value:	
Value Percent:	
Step:	NO
Remarks:	UNDERSIDE OF FRAME

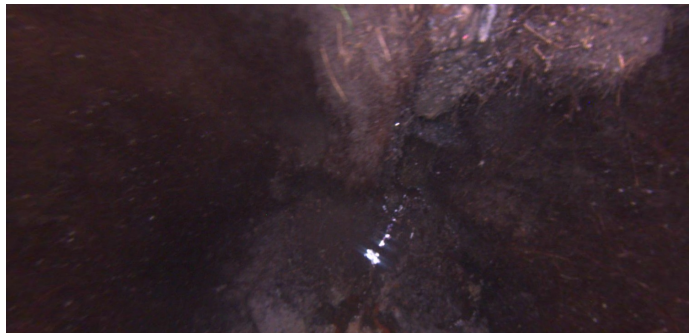
Code:	DAZ
Description:	Deposits Attached Other
Distance (ft):	2.5
Structural Grade:	0
O&M Grade:	2
Clock Start/From:	12
Clock To:	1
1st Value:	
2nd Value:	
Value Percent:	10.000
Step:	YES
Remarks:

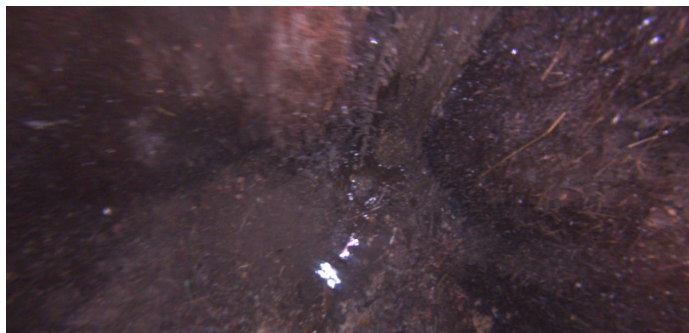
Code:	RMJ
Description:	Roots Medium Joint
Distance (ft):	3.8
Structural Grade:	0
O&M Grade:	3
Clock Start/From:	12
Clock To:	3
1st Value:	
2nd Value:	
Value Percent:	20.000
Step:	NO
Remarks:

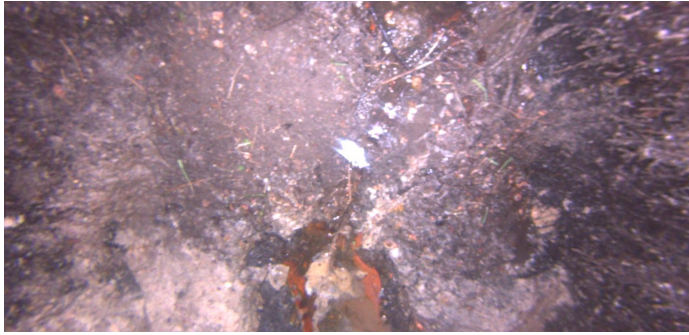
Code:	MGO
Description:	General Observation
Distance (ft):	4.4
Structural Grade:	0
O&M Grade:	0
Clock Start/From:	
Clock To:	
1st Value:	
2nd Value:	
Value Percent:	
Step:	NO
Remarks:	END SURVEY
