Manhole Inspection Report

Date:	03/25/2018	Weather:		Coding:	RZMACP
MH#:	M-208-001	Owner:	NA	Len. Surveyed:	7.9
P.O.#:		Surveyor:	John Kuglmaier	Rim to Invert:	8.4
Customer:		Cert. #:	U-1215-07002349	Wall Material:	Concrete (reinforced)

Street:	North of 61st Ave. 141' East of Minn	Project:	Hobart, IN
City:	Hobart, IN	GPS Northing:	0.0
Location:		GPS Easting:	0.0
Drain Area:	Southwest	GPS Accuracy:	Nearest Meter
Cover Shape:	Circular	Evidence of Surcharge:	No
Cover Size:	22.5	Potential for Runoff:	None
Comments:

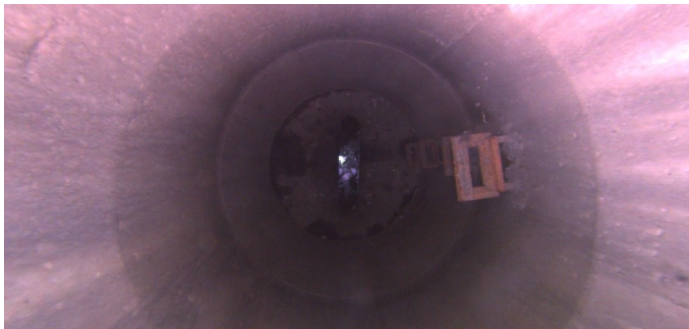
Code: **MGP**
Description: **General Photo**

Distance (ft): **.0**
Structural Grade: **0**
O&M Grade: **0**
Clock Start/From:
Clock To:
1st Value:
2nd Value:
Value Percent:
Step: **NO**
Remarks:

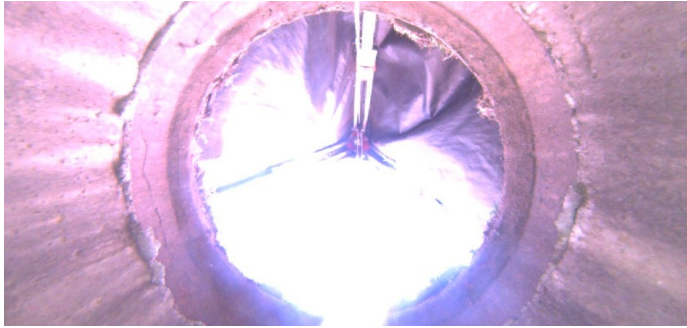
Code: **MGP**
Description: **General Photo**

Distance (ft): **2.1**
Structural Grade: **0**
O&M Grade: **0**
Clock Start/From:
Clock To:
1st Value:
2nd Value:
Value Percent:
Step: **NO**
Remarks:

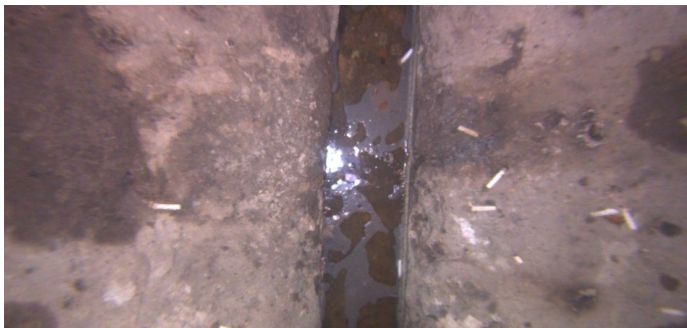
Code: **MGO**
Description: **General Observation**

Distance (ft): **6.4**
Structural Grade: **0**
O&M Grade: **0**
Clock Start/From:
Clock To:
1st Value:
2nd Value:
Value Percent:
Step: **NO**
Remarks: **Ins. Comp.**
