Manhole Inspection Report

| MH#: | M-208-003 | Owner: | NA | Len. Surveyed: | 10.2 |

| Street: | Between 58th Pl. and 59th Pl. 147' E | Project: | Hobart, IN |

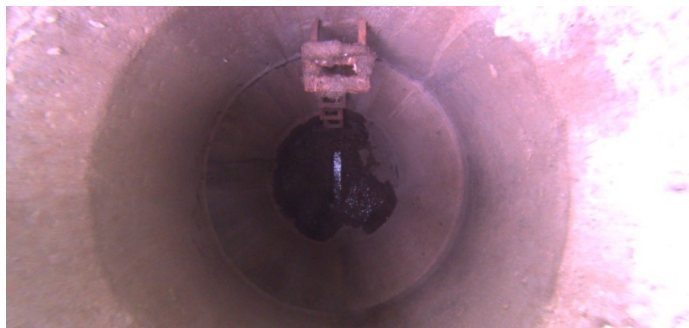
Code: **MGP**
Description: **General Photo**

Distance (ft): **.0**
Structural Grade: **0**
O&M Grade: **0**
Clock Start/From:
Clock To:
1st Value:
2nd Value:
Value Percent:
Step: **NO**
Remarks:

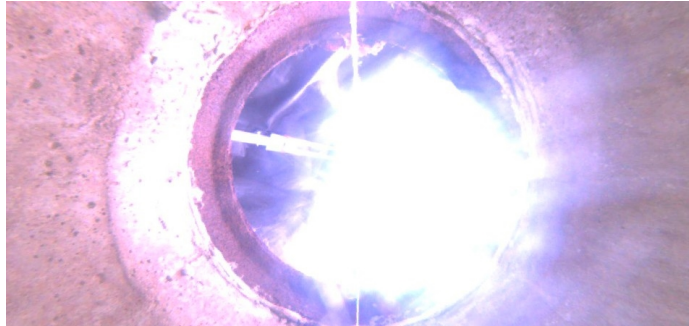
Code: **MGP**
Description: **General Photo**

Distance (ft): **2.6**
Structural Grade: **0**
O&M Grade: **0**
Clock Start/From:
Clock To:
1st Value:
2nd Value:
Value Percent:
Step: **NO**
Remarks:

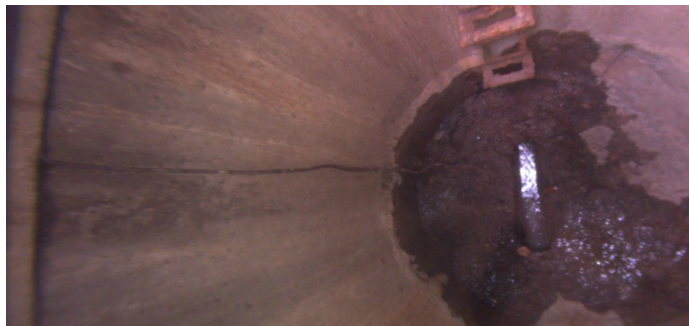
Code: **RFJ**
Description: **Roots Fine Joint**

Distance (ft): **4.3**
Structural Grade: **0**
O&M Grade: **1**
Clock Start/From: **9**
Clock To:
1st Value:
2nd Value:
Value Percent:
Step: **NO**
Remarks:

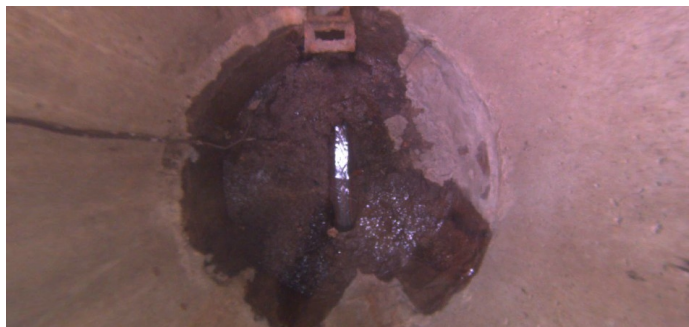
Code: **IS**
Description: **Infil Stain**

Distance (ft): **5.1**
Structural Grade: **0**
O&M Grade: **0**
Clock Start/From: **4**
Clock To: **1**
1st Value:
2nd Value:
Value Percent:
Step: **NO**
Remarks:

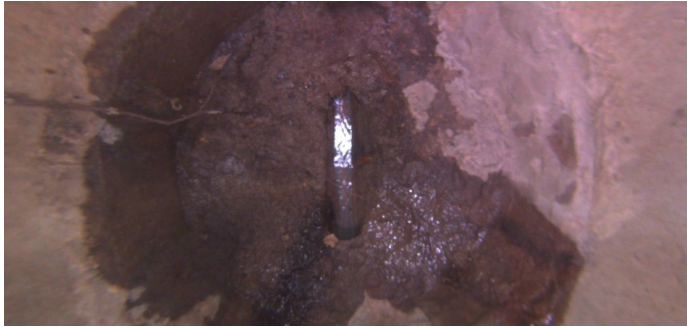
| Code: | DSF |
| Description: | Deposits Settled Fine |
| Distance (ft): | 6.5 |
| O&M Grade: | 3 |
| Value Percent: | 15.000 |

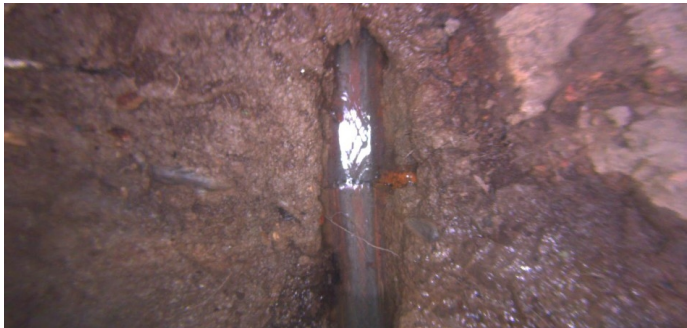
| Code: | MGO |
| Description: | General Observation |
| Distance (ft): | 8.4 |
| Remarks: | Ins. Comp. |
