Manhole Inspection Report

Date:	03/26/2018	Weather:		Coding:	RZMACP
MH#:	M-208-004	Owner:	NA	Len. Surveyed:	12.9
P.O.#:		Surveyor:	John Kuglmaier	Rim to Invert:	13.0
Customer:		Cert. #:	U-1215-07002349	Wall Material:	Concrete (reinforced)

Street:	58th Pl. Minnesota St. to the East.	Project:	Hobart, IN
City:	Hobart, IN	GPS Northing:	0.0
Location:		GPS Easting:	0.0
Drain Area:	Southwest	GPS Accuracy:	Nearest Meter
Cover Shape:	Circular	Evidence of Surcharge:	No
Cover Size:	22.5	Potential for Runoff:	None
Comments:

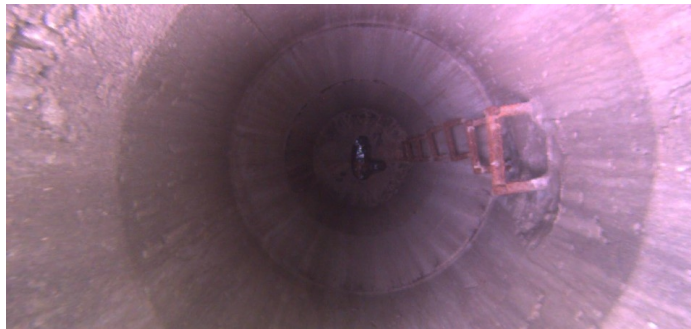
Code: **MGP**
Description: **General Photo**

Distance (ft): **.0**
Structural Grade: **0**
O&M Grade: **0**
Clock Start/From:
Clock To:
1st Value:
2nd Value:
Value Percent:
Step: **NO**
Remarks:

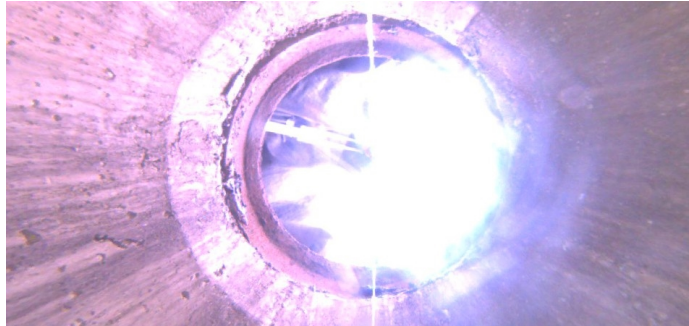
Code: **MGP**
Description: **General Photo**

Distance (ft): **2.8**
Structural Grade: **0**
O&M Grade: **0**
Clock Start/From:
Clock To:
1st Value:
2nd Value:
Value Percent:
Step: **NO**
Remarks:

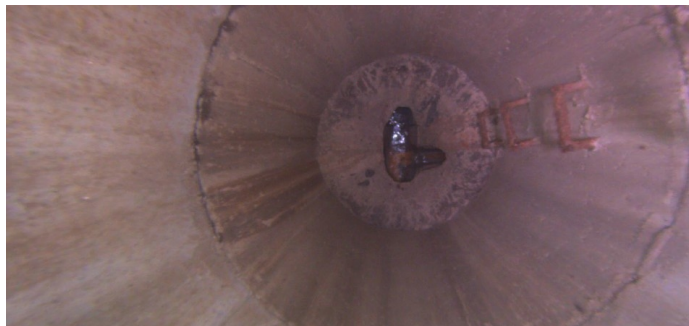
Code: **IS**
Description: **Infil Stain**

Distance (ft): **5.2**
Structural Grade: **0**
O&M Grade: **0**
Clock Start/From: **8**
Clock To: **9**
1st Value:
2nd Value:
Value Percent:
Step: **NO**
Remarks:

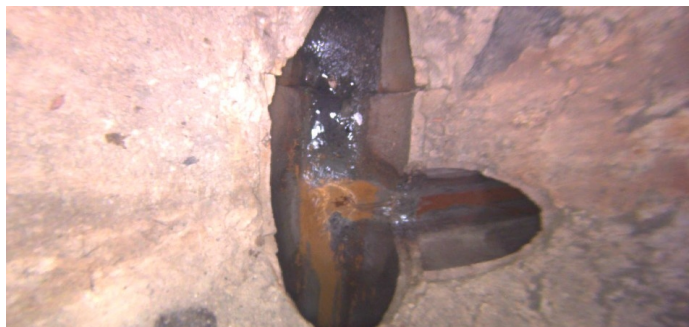
Code: **MGO**
Description: **General Observation**

Distance (ft): **10.8**
Structural Grade: **0**
O&M Grade: **0**
Clock Start/From:
Clock To:
1st Value:
2nd Value:
Value Percent:
Step: **NO**
Remarks: **Ins. Comp.**
