Manhole Inspection Report

Date:	03/26/2018	Weather:		Coding:	RZMACP
MH#:	M-208-006	Owner:	NA	Len. Surveyed:	8.9
P.O.#:		Surveyor:	John Kuglmaier	Rim to Invert:	9.5
Customer:		Cert. #:	U-1215-07002349	Wall Material:	Concrete (reinforced)

Street:	335' North of 59th Pl. East of Vine Ct	Project:	Hobart, IN
City:	Hobart, IN	GPS Northing:	0.0
Location:		GPS Easting:	0.0
Drain Area:	Southwest	GPS Accuracy:	Nearest Meter
Cover Shape:	Circular	Evidence of Surcharge:	Yes
Cover Size:	22.5	Potential for Runoff:	None
Comments:

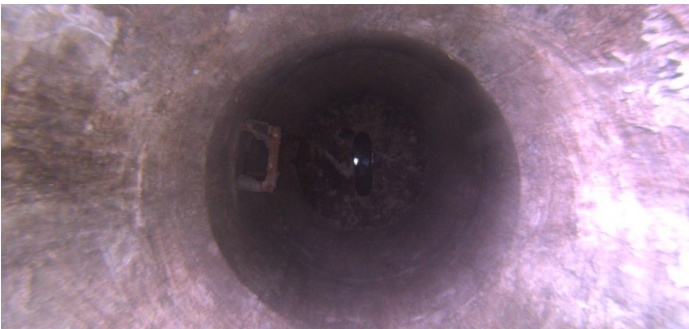
Code: **MGP**
 Description: **General Photo**

Distance (ft): **.0**
 Structural Grade: **0**
 O&M Grade: **0**
 Clock Start/From:
 Clock To:
 1st Value:
 2nd Value:
 Value Percent:
 Step: **NO**
 Remarks:

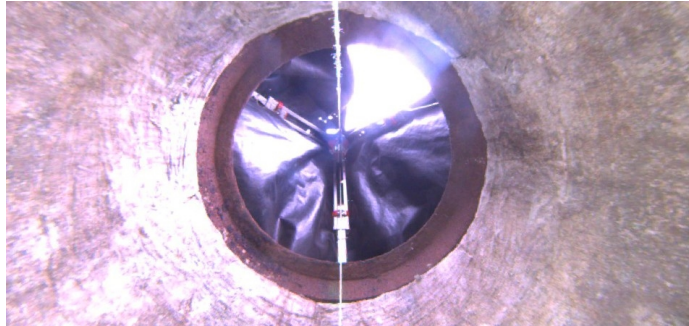
Code: **MGP**
Description: **General Photo**

Distance (ft): **2.7**
Structural Grade: **0**
O&M Grade: **0**
Clock Start/From:
Clock To:
1st Value:
2nd Value:
Value Percent:
Step: **NO**
Remarks:

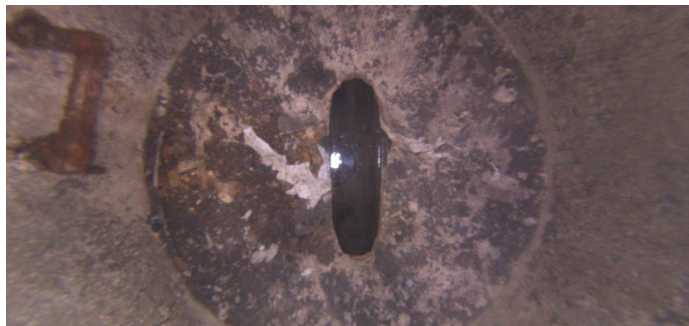
Code: **DAZ**
Description: **Deposits Attached Other**

Distance (ft): **5.9**
Structural Grade: **0**
O&M Grade: **2**
Clock Start/From: **12**
Clock To: **12**
1st Value:
2nd Value:
Value Percent: **5.000**
Step: **NO**
Remarks: **Mixed materials**

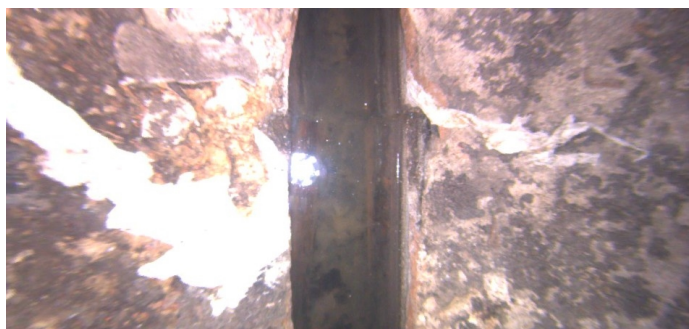
Code: **MGO**
Description: **General Observation**

Distance (ft): **7.9**
Structural Grade: **0**
O&M Grade: **0**
Clock Start/From:
Clock To:
1st Value:
2nd Value:
Value Percent:
Step: **NO**
Remarks: **Ins. Comp.**
