Manhole Inspection Report

Date:	03/26/2018	Weather:		Coding:	RZMACP
MH#:	M-208-018	Owner:	NA	Len. Surveyed:	12.8
P.O.#:		Surveyor:	John Kuglmaier	Rim to Invert:	12.9
Customer:		Cert. #:	U-1215-07002349	Wall Material:	Concrete (reinforced)

Street:	59th Pl. Brookview Ct. to the North	Project:	Hobart, IN
City:	Hobart, IN	GPS Northing:	0.0
Location:		GPS Easting:	0.0
Drain Area:	Southwest	GPS Accuracy:	Nearest Meter
Cover Shape:	Circular	Evidence of Surcharge:	No
Cover Size:	22.5	Potential for Runoff:	None
Comments:

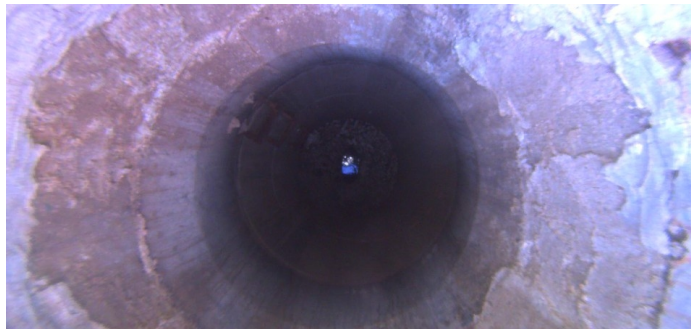
Code: **MGP**
Description: **General Photo**

Distance (ft): **.0**
Structural Grade: **0**
O&M Grade: **0**
Clock Start/From:
Clock To:
1st Value:
2nd Value:
Value Percent:
Step: **NO**
Remarks:

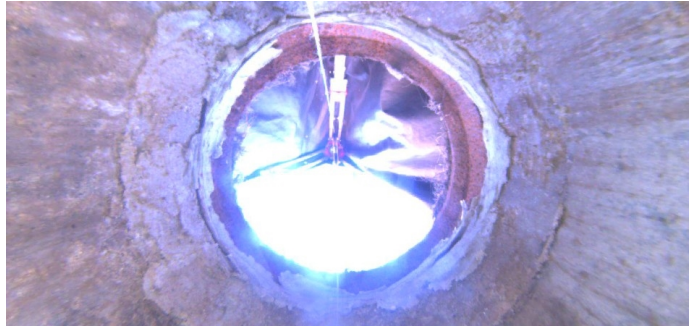
Code: **MGP**
Description: **General Photo**

Distance (ft): **2.8**
Structural Grade: **0**
O&M Grade: **0**
Clock Start/From:
Clock To:
1st Value:
2nd Value:
Value Percent:
Step: **NO**
Remarks:

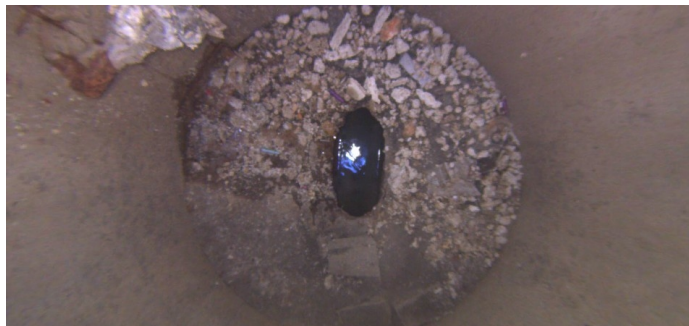
Code: **DAZ**
Description: **Deposits Attached Other**

Distance (ft): **7.9**
Structural Grade: **0**
O&M Grade: **3**
Clock Start/From: **12**
Clock To: **12**
1st Value:
2nd Value:
Value Percent: **15.000**
Step: **NO**
Remarks: **Mixed materials**

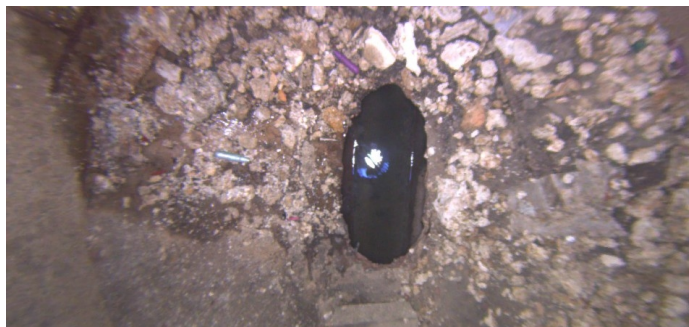
Code: **MGO**
Description: **General Observation**

Distance (ft): **9.5**
Structural Grade: **0**
O&M Grade: **0**
Clock Start/From:
Clock To:
1st Value:
2nd Value:
Value Percent:
Step: **NO**
Remarks: **Ins. Comp.**
