Manhole Inspection Report

Date:	03/26/2018	Weather:		Coding:	RZMACP
MH#:	M-208-019	Owner:	NA	Len. Surveyed:	11.7
P.O.#:		Surveyor:	John Kuglmaier	Rim to Invert:	13.1
Customer:		Cert. #:	U-1215-07002349	Wall Material:	Concrete (reinforced)

Street:	266' South of 58th Pl. West of Brook	Project:	Hobart, IN
City:	Hobart, IN	GPS Northing:	0.0
Location:		GPS Easting:	0.0
Drain Area:	Southwest	GPS Accuracy:	Nearest Meter
Cover Shape:	Circular	Evidence of Surcharge:	Yes
Cover Size:	22.5	Potential for Runoff:	None
Comments:

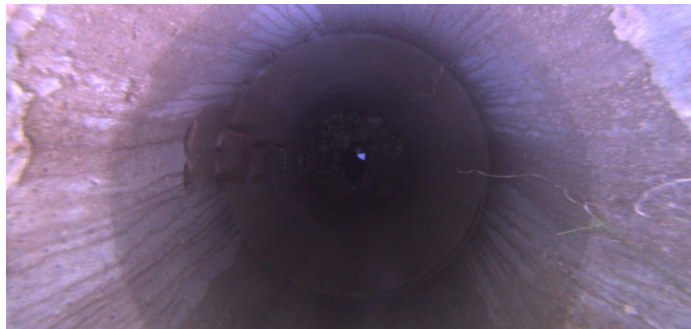
Code: **MGP**
Description: **General Photo**

Distance (ft): **.0**
Structural Grade: **0**
O&M Grade: **0**
Clock Start/From:
Clock To:
1st Value:
2nd Value:
Value Percent:
Step: **NO**
Remarks:

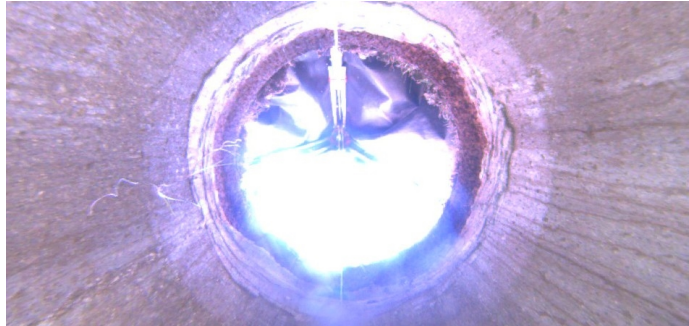
Code: **MGP**
Description: **General Photo**

Distance (ft): **2.8**
Structural Grade: **0**
O&M Grade: **0**
Clock Start/From:
Clock To:
1st Value:
2nd Value:
Value Percent:
Step: **NO**
Remarks:

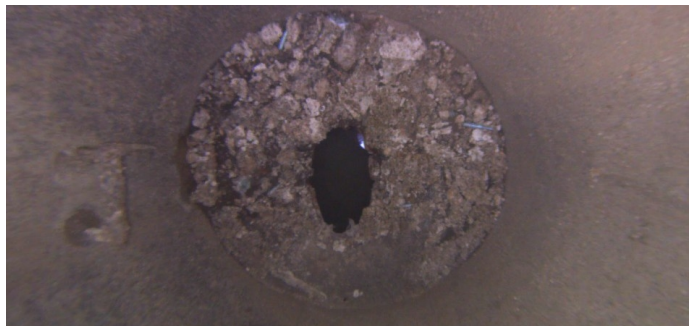
Code: **DAZ**
Description: **Deposits Attached Other**

Distance (ft): **8.1**
Structural Grade: **0**
O&M Grade: **3**
Clock Start/From: **12**
Clock To: **12**
1st Value:
2nd Value:
Value Percent: **15.000**
Step: **NO**
Remarks: **Mixed materials**

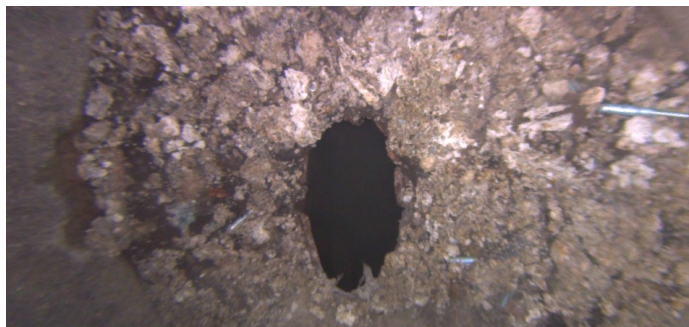
Code: **MGO**
Description: **General Observation**

Distance (ft): **9.8**
Structural Grade: **0**
O&M Grade: **0**
Clock Start/From:
Clock To:
1st Value:
2nd Value:
Value Percent:
Step: **NO**
Remarks: **Ins. Comp.**
