# Manhole Inspection Report

Date:	<b>03/21/2018</b>	Weather:		Coding:	<b>RZMACP</b>
MH#:	<b>M-208-020</b>	Owner:	<b>NA</b>	Len. Surveyed:	<b>6.3</b>
P.O.#:		Surveyor:	<b>John Kuglmaier</b>	Rim to Invert:	<b>6.4</b>
Customer:		Cert. #:	<b>U-1215-07002349</b>	Wall Material:	<b>Concrete (reinforced)</b>

Street:	<b>58th Pl. Liverpool Rd. 1 Manhole So</b>	Project:	<b>Hobart, IN</b>
City:	<b>Hobart, IN</b>	GPS Northing:	<b>0.0</b>
Location:		GPS Easting:	<b>0.0</b>
Drain Area:	<b>Southwest</b>	GPS Accuracy:	<b>Nearest Meter</b>
Cover Shape:	<b>Circular</b>	Evidence of Surcharge:	<b>No</b>
Cover Size:	<b>22.5</b>	Potential for Runoff:	<b>None</b>
Comments:

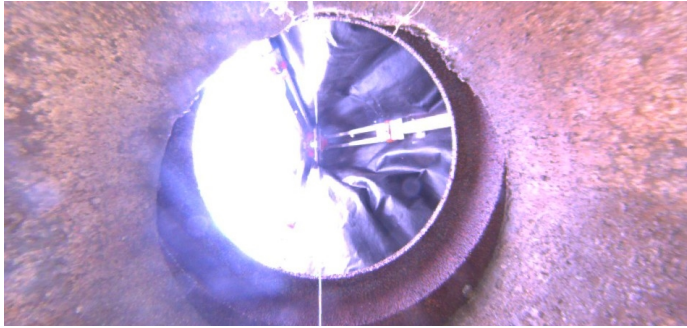
Code: **MGP**  
Description: **General Photo**

Distance (ft): **2.7**  
Structural Grade: **0**  
O&M Grade: **0**  
Clock Start/From:  
Clock To:  
1st Value:  
2nd Value:  
Value Percent:  
Step: **NO**  
Remarks:

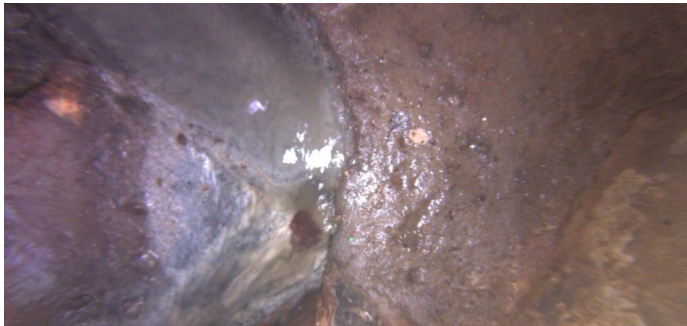
Code: **MGO**  
Description: **General Observation**

Distance (ft): **5.1**  
Structural Grade: **0**  
O&M Grade: **0**  
Clock Start/From:  
Clock To:  
1st Value:  
2nd Value:  
Value Percent:  
Step: **NO**  
Remarks: **Ins. Comp.**
