# Manhole Inspection Report

| MH#: | M-208-021 | Owner: | NA | Len. Surveyed: | 12.3 |

| Street: | Intersection of 61st Ave. and Liverp | Project: | Hobart, IN |

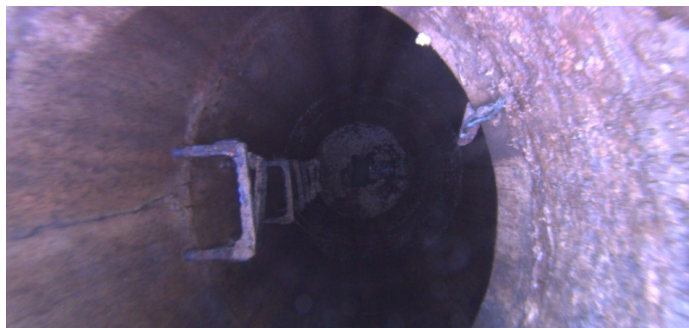
Code: **MGP**  
Description: **General Photo**

Distance (ft): **.0**  
Structural Grade: **0**  
O&M Grade: **0**  
Clock Start/From:  
Clock To:  
1st Value:  
2nd Value:  
Value Percent:  
Step: **NO**  
Remarks:

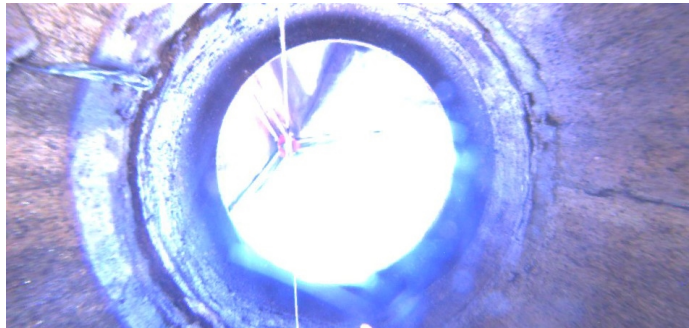
Code: **MGP**  
Description: **General Photo**

Distance (ft): **2.5**  
Structural Grade: **0**  
O&M Grade: **0**  
Clock Start/From:  
Clock To:  
1st Value:  
2nd Value:  
Value Percent:  
Step: **NO**  
Remarks:

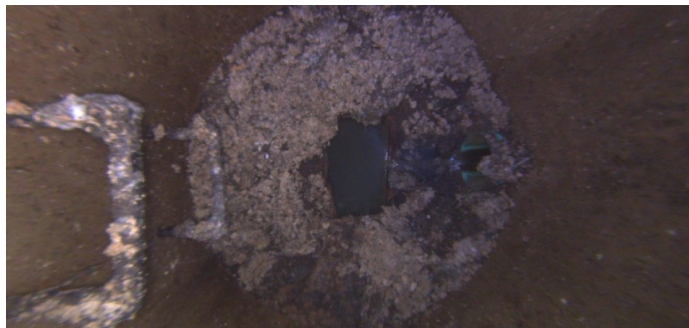
| | Position | Code | Observation | Video (sec) | Grade |
|--|---|---|---|---|---|
| | 8.7 | DAZ | Deposits Attached Other | 54 | M 3 |

Code: **DAZ**  
Description: **Deposits Attached Other**

Distance (ft): **8.7**  
Structural Grade: **0**  
O&M Grade: **3**  
Clock Start/From: **12**  
Clock To: **12**  
1st Value:  
2nd Value:  
Value Percent: **15.000**  
Step: **NO**  
Remarks: **Mixed materials**

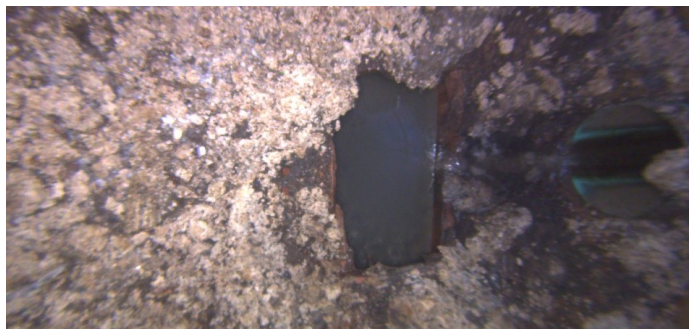
Code: **MGO**  
Description: **General Observation**

Distance (ft): **10.6**  
Structural Grade: **0**  
O&M Grade: **0**  
Clock Start/From:  
Clock To:  
1st Value:  
2nd Value:  
Value Percent:  
Step: **NO**  
Remarks: **Ins. Comp.**
