Manhole Inspection Report

Date:	03/22/2018	Weather:		Coding:	RZMACP
MH#:	M-208-022A	Owner:	NA	Len. Surveyed:	8.6
P.O.#:		Surveyor:	John Kuglmaier	Rim to Invert:	9.1
Customer:		Cert. #:	U-1215-07002349	Wall Material:	Concrete (reinforced)

Street:	Liverpool Rd. ACROSS FROM W 60T	Project:	Hobart, IN
City:	Hobart, IN	GPS Northing:	0.0
Location:		GPS Easting:	0.0
Drain Area:	Southwest	GPS Accuracy:	Nearest Meter
Cover Shape:	Circular	Evidence of Surcharge:	Yes
Cover Size:	22.5	Potential for Runoff:	None
Comments:	NEW MANHOLE

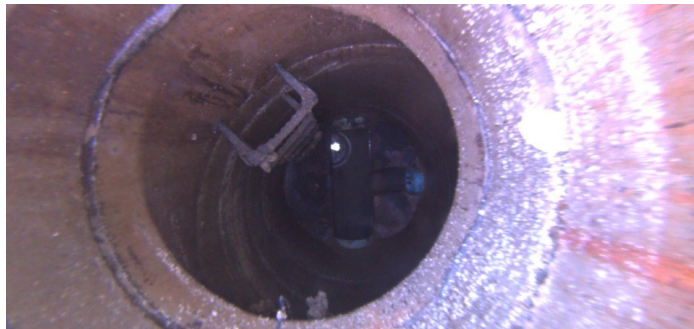
Code: **MGP**
Description: **General Photo**

Distance (ft): **.0**
Structural Grade: **0**
O&M Grade: **0**
Clock Start/From:
Clock To:
1st Value:
2nd Value:
Value Percent:
Step: **NO**
Remarks:

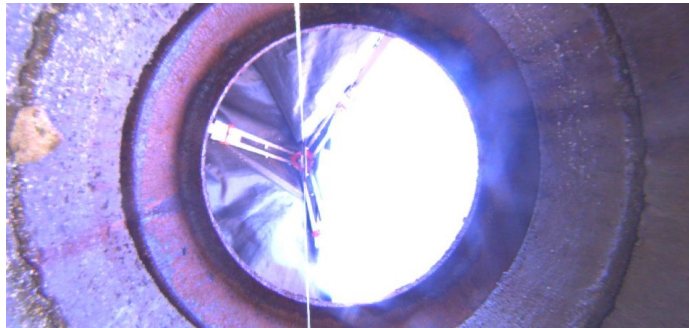
Code: **MGP**
Description: **General Photo**

Distance (ft): **2.1**
Structural Grade: **0**
O&M Grade: **0**
Clock Start/From:
Clock To:
1st Value:
2nd Value:
Value Percent:
Step: **NO**
Remarks:

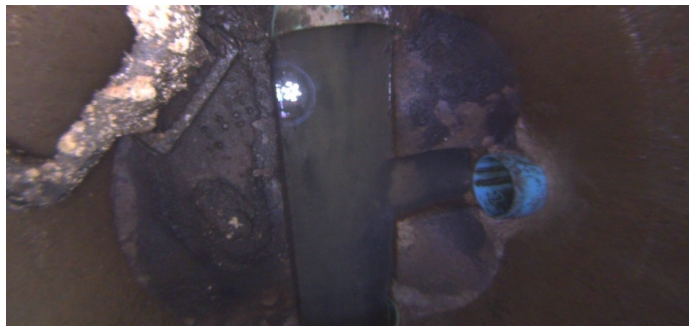
Code: **DSF**
Description: **Deposits Settled Fine**

Distance (ft): **5.8**
Structural Grade: **0**
O&M Grade: **2**
Clock Start/From: **12**
Clock To: **12**
1st Value:
2nd Value:
Value Percent: **10.000**
Step: **NO**
Remarks:

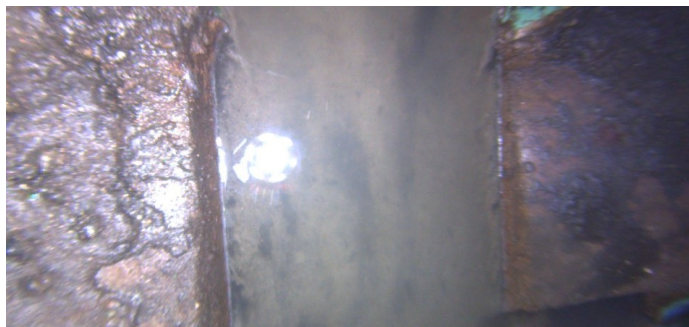
Code: **MGO**
Description: **General Observation**

Distance (ft): **7.9**
Structural Grade: **0**
O&M Grade: **0**
Clock Start/From:
Clock To:
1st Value:
2nd Value:
Value Percent:
Step: **NO**
Remarks: **Ins. Comp.**
