Manhole Inspection Report

Date:	03/23/2018	Weather:		Coding:	RZMACP
MH#:	M-208-025	Owner:	NA	Len. Surveyed:	8.0
P.O.#:		Surveyor:	John Kuglmaier	Rim to Invert:	8.5
Customer:		Cert. #:	U-1215-07002349	Wall Material:	Concrete (reinforced)

Street:	North of 61st Ave. 252' East of Minn	Project:	Hobart, IN
City:	Hobart, IN	GPS Northing:	0.0
Location:		GPS Easting:	0.0
Drain Area:	Southwest	GPS Accuracy:	Nearest Meter
Cover Shape:	Circular	Evidence of Surcharge:	No
Cover Size:	22.5	Potential for Runoff:	None
Comments:

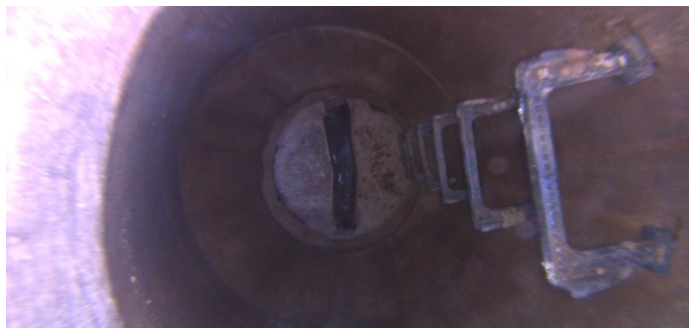
Code: **MGP**
Description: **General Photo**

Distance (ft): **.0**
Structural Grade: **0**
O&M Grade: **0**
Clock Start/From:
Clock To:
1st Value:
2nd Value:
Value Percent:
Step: **NO**
Remarks:

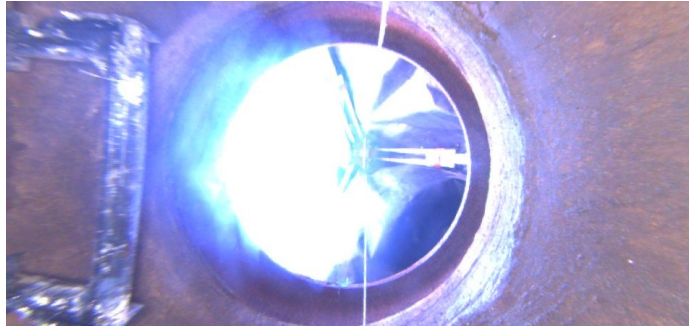
Code: **MGP**
Description: **General Photo**

Distance (ft): **2.2**
Structural Grade: **0**
O&M Grade: **0**
Clock Start/From:
Clock To:
1st Value:
2nd Value:
Value Percent:
Step: **NO**
Remarks:

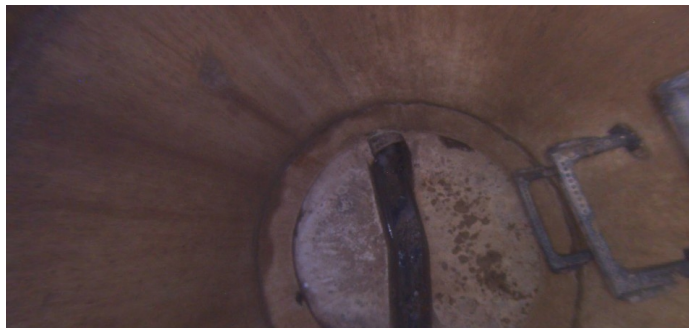
Code: **IS**
Description: **Infil Stain**

Distance (ft): **3.3**
Structural Grade: **0**
O&M Grade: **0**
Clock Start/From: **10**
Clock To:
1st Value:
2nd Value:
Value Percent:
Step: **NO**
Remarks:

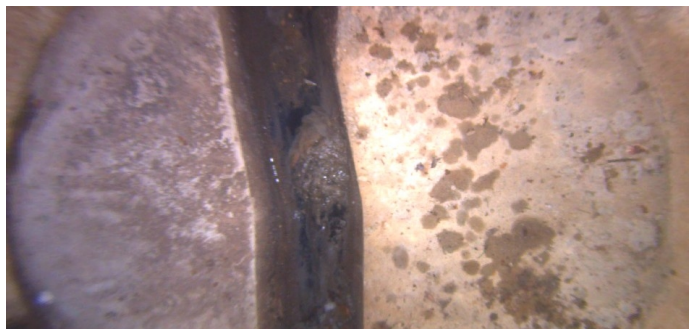
Code: **MGO**
Description: **General Observation**

Distance (ft): **6.6**
Structural Grade: **0**
O&M Grade: **0**
Clock Start/From:
Clock To:
1st Value:
2nd Value:
Value Percent:
Step: **NO**
Remarks: **Ins. Comp.**
