Manhole Inspection Report

Date:	03/23/2018	Weather:		Coding:	RZMACP
MH#:	M-208-026	Owner:	NA	Len. Surveyed:	6.8
P.O.#:		Surveyor:	John Kuglmaier	Rim to Invert:	7.4
Customer:		Cert. #:	U-1215-07002349	Wall Material:	Concrete (reinforced)

Street:	North of 61st Ave. 262' East of Minn	Project:	Hobart, IN
City:	Hobart, IN	GPS Northing:	0.0
Location:		GPS Easting:	0.0
Drain Area:	Southwest	GPS Accuracy:	Nearest Meter
Cover Shape:	Circular	Evidence of Surcharge:	No
Cover Size:	22.5	Potential for Runoff:	None
Comments:

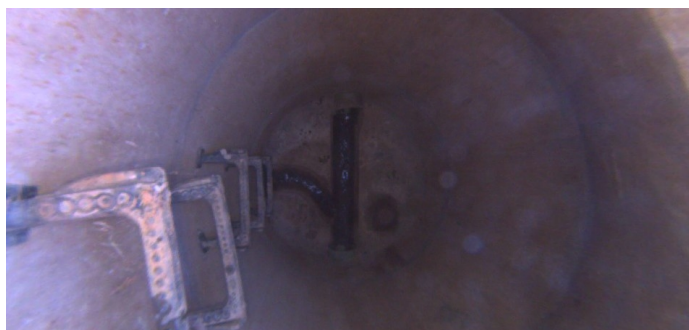
Code: **MGP**
Description: **General Photo**

Distance (ft): **.0**
Structural Grade: **0**
O&M Grade: **0**
Clock Start/From:
Clock To:
1st Value:
2nd Value:
Value Percent:
Step: **NO**
Remarks:

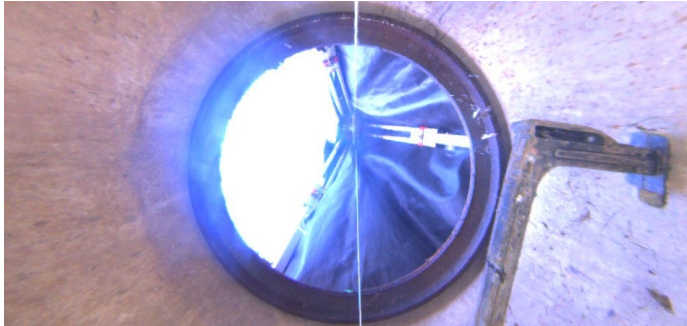
Code: **MGP**
Description: **General Photo**

Distance (ft): **2.1**
Structural Grade: **0**
O&M Grade: **0**
Clock Start/From:
Clock To:
1st Value:
2nd Value:
Value Percent:
Step: **NO**
Remarks:

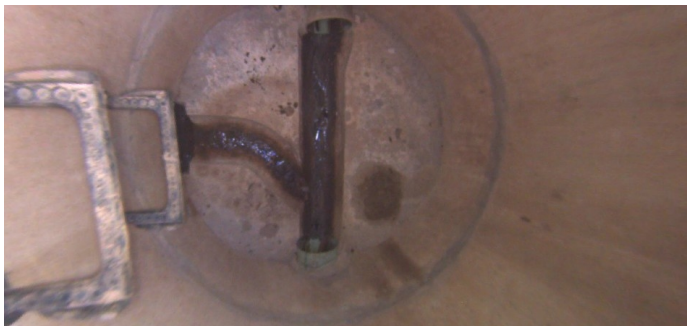
Code: **IS**
Description: **Infil Stain**

Distance (ft): **2.8**
Structural Grade: **0**
O&M Grade: **0**
Clock Start/From: **5**
Clock To:
1st Value:
2nd Value:
Value Percent:
Step: **NO**
Remarks:

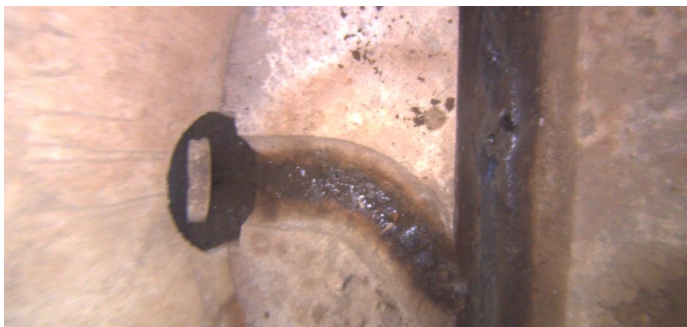
Code: **HSV**
Description: **Hole Soil Visible**

Distance (ft): **5.1**
Structural Grade: **5**
O&M Grade: **0**
Clock Start/From: **9**
Clock To:
1st Value:
2nd Value:
Value Percent:
Step: **NO**
Remarks:

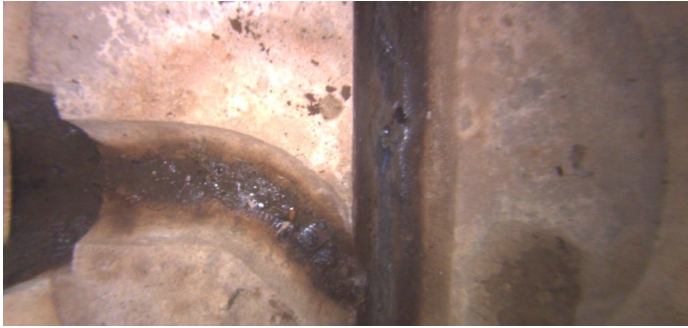
Code:	MGO
Description:	General Observation
Distance (ft):	5.4
Structural Grade:	0
O&M Grade:	0
Clock Start/From:	
Clock To:	
1st Value:	
2nd Value:	
Value Percent:	
Step:	NO
Remarks:	Ins. Comp.
