Manhole Inspection Report

Date:	03/21/2018	Weather:		Coding:	RZMACP
MH#:	M-208-029	Owner:	NA	Len. Surveyed:	6.8
P.O.#:		Surveyor:	John Kuglmaier	Rim to Invert:	7.1
Customer:		Cert. #:	U-1215-07002349	Wall Material:	Concrete (reinforced)

Street:	58th Pl. 209' East of Liverpool Rd.	Project:	Hobart, IN
City:	Hobart, IN	GPS Northing:	0.0
Location:		GPS Easting:	0.0
Drain Area:	Southwest	GPS Accuracy:	Nearest Meter
Cover Shape:	Circular	Evidence of Surcharge:	Yes
Cover Size:	22.5	Potential for Runoff:	None
Comments:

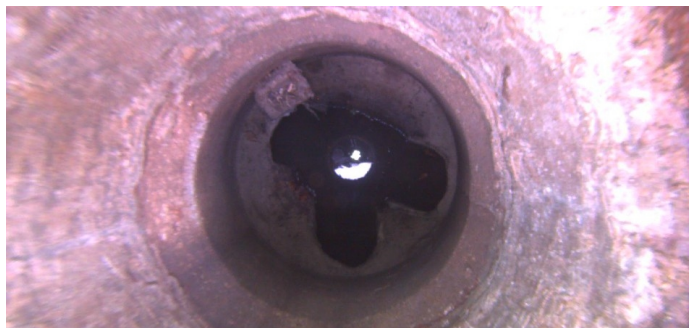
Code: **MGP**
Description: **General Photo**

Distance (ft): **.0**
Structural Grade: **0**
O&M Grade: **0**
Clock Start/From:
Clock To:
1st Value:
2nd Value:
Value Percent:
Step: **NO**
Remarks:

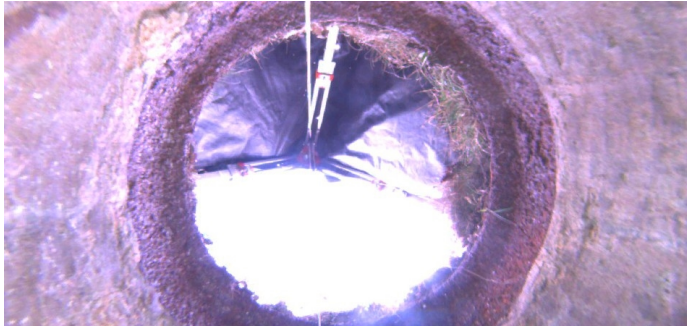
Code: **MGP**
Description: **General Photo**

Distance (ft): **2.5**
Structural Grade: **0**
O&M Grade: **0**
Clock Start/From:
Clock To:
1st Value:
2nd Value:
Value Percent:
Step: **NO**
Remarks:

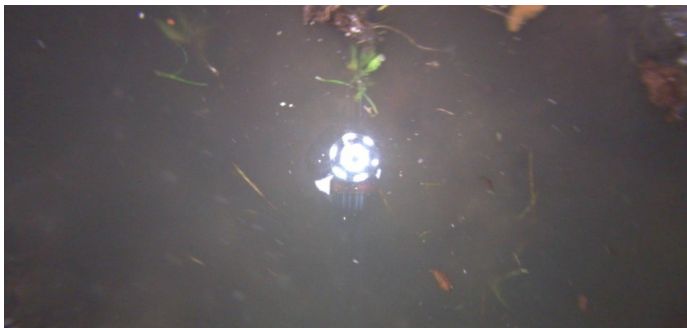
Code: **MGO**
Description: **General Observation**

Distance (ft): **5.9**
Structural Grade: **0**
O&M Grade: **0**
Clock Start/From:
Clock To:
1st Value:
2nd Value:
Value Percent:
Step: **NO**
Remarks: **Ins. Comp.**
