Manhole Inspection Report

Date:	03/26/2018	Weather:		Coding:	RZMACP
MH#:	M-208-031	Owner:	NA	Len. Surveyed:	7.2
P.O.#:		Surveyor:	Jen Costello	Rim to Invert:	12.1
Customer:		Cert. #:	U-907-5518	Wall Material:	Concrete (reinforced)

Street:	61st Ave. and Colorado St. To the N	Project:	Hobart, IN
City:	Hobart, IN	GPS Northing:	0.0
Location:		GPS Easting:	0.0
Drain Area:	Southwest	GPS Accuracy:	Nearest Meter
Cover Shape:	Circular	Evidence of Surcharge:	No
Cover Size:	22.5	Potential for Runoff:	None
Comments:

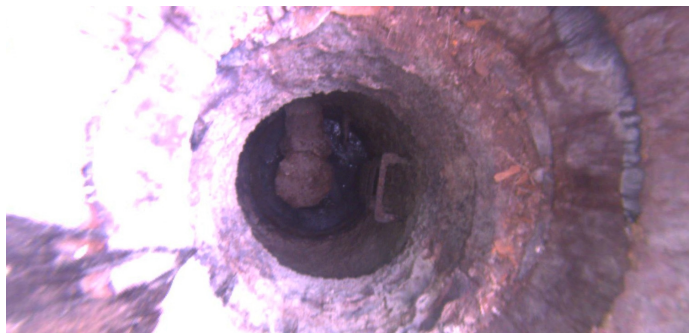
Code: **MGO**
Description: **General Observation**

Distance (ft): **.0**
Structural Grade: **0**
O&M Grade: **0**
Clock Start/From:
Clock To:
1st Value:
2nd Value:
Value Percent:
Step: **NO**
Remarks: **ACCESS MH**

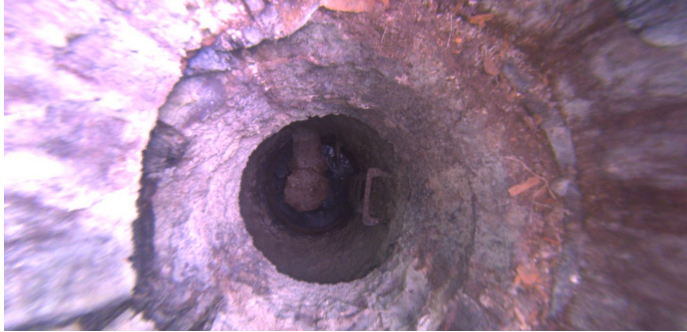
Code: **RFB**
Description: **Roots Fine Barrel**

Distance (ft): **.7**
Structural Grade: **0**
O&M Grade: **2**
Clock Start/From: **12**
Clock To: **12**
1st Value:
2nd Value:
Value Percent:
Step: **NO**
Remarks:

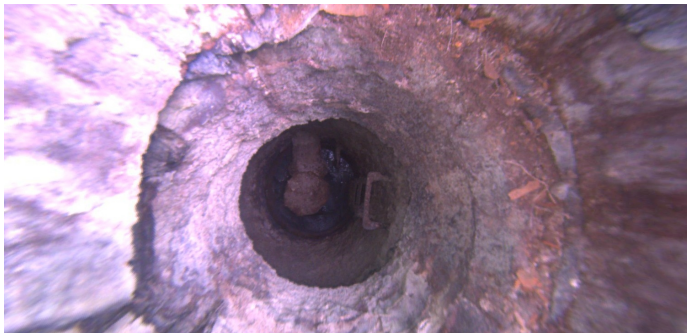
Code: **SSS**
Description: **Surface Spalling**

Distance (ft): **.7**
Structural Grade: **2**
O&M Grade: **0**
Clock Start/From: **12**
Clock To: **12**
1st Value:
2nd Value:
Value Percent:
Step: **NO**
Remarks:

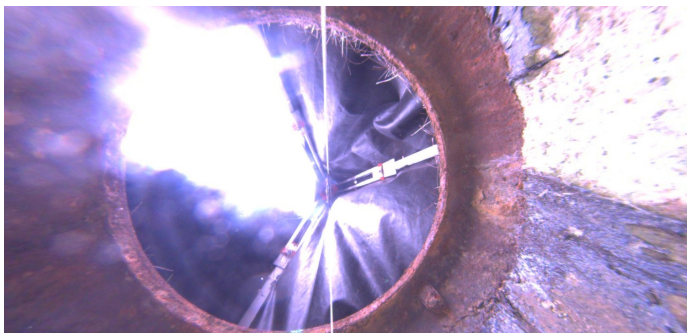
Code: **MGP**
Description: **General Photo**

Distance (ft): **1.5**
Structural Grade: **0**
O&M Grade: **0**
Clock Start/From:
Clock To:
1st Value:
2nd Value:
Value Percent:
Step: **NO**
Remarks: **UNDERSIDE OF FRAME**

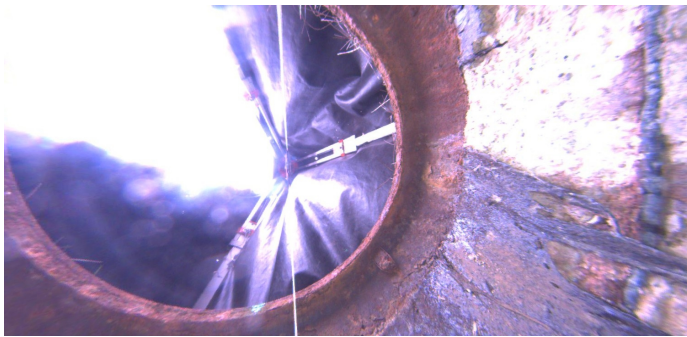
Code: **RFJ**
Description: **Roots Fine Joint**

Distance (ft): **1.5**
Structural Grade: **0**
O&M Grade: **1**
Clock Start/From: **6**
Clock To: **12**
1st Value:
2nd Value:
Value Percent:
Step: **NO**
Remarks:

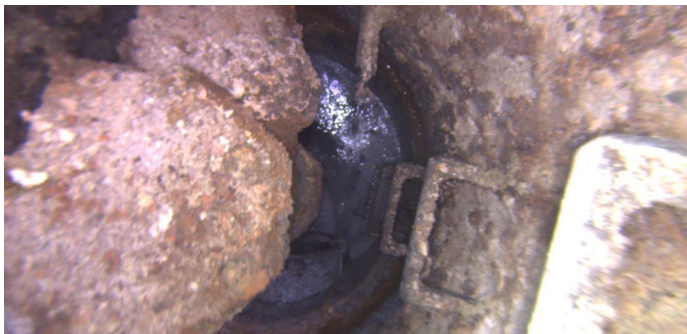
Code: **OBS**
Description: **Obstacle Built Into Structure**

Distance (ft): **6.0**
Structural Grade: **0**
O&M Grade: **5**
Clock Start/From: **12**
Clock To: **12**
1st Value:
2nd Value:
Value Percent: **60.000**
Step: **NO**
Remarks:

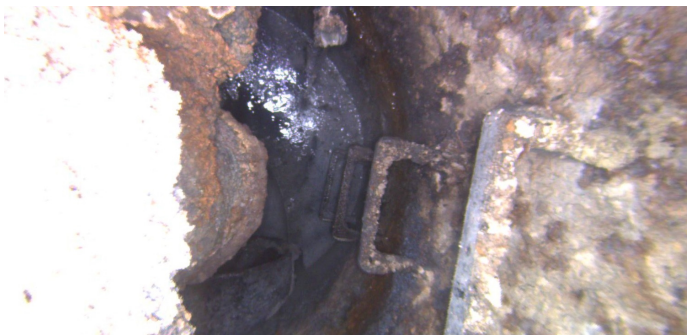
Code: **MSA**
Description: **Abandoned Survey**

Distance (ft): **7.2**
Structural Grade: **0**
O&M Grade: **0**
Clock Start/From:
Clock To:
1st Value:
2nd Value:
Value Percent:
Step: **NO**
Remarks: **BLOCKED BY OBS**
