Manhole Inspection Report

Date:	03/23/2018	Weather:		Coding:	RZMACP
MH#:	M-208-032	Owner:	NA	Len. Surveyed:	2.9
P.O.#:		Surveyor:	John Kuglmaier	Rim to Invert:	3.1
Customer:		Cert. #:	U-1215-07002349	Wall Material:	Concrete (reinforced)

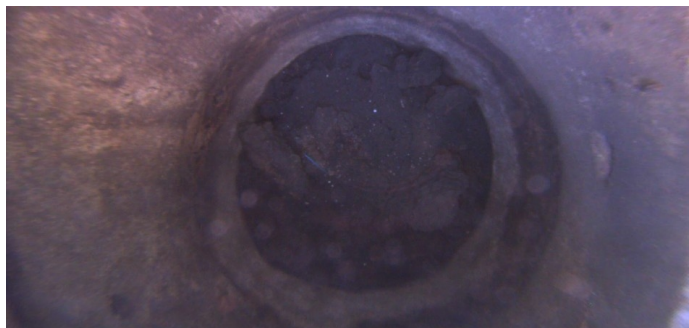
Code: **MGP**
Description: **General Photo**

Distance (ft): **.0**
Structural Grade: **0**
O&M Grade: **0**
Clock Start/From:
Clock To:
1st Value:
2nd Value:
Value Percent:
Step: **NO**
Remarks:

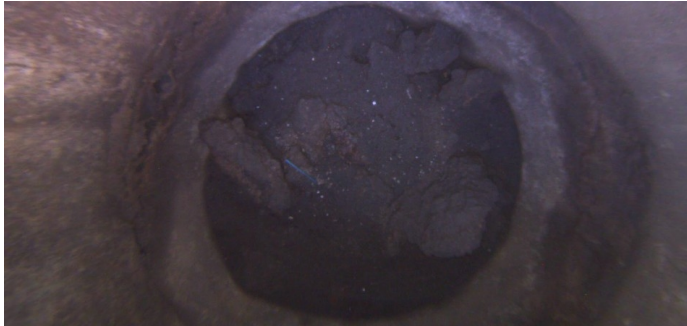
Code: **DSF**
Description: **Deposits Settled Fine**

Distance (ft): **.7**
Structural Grade: **0**
O&M Grade: **4**
Clock Start/From: **12**
Clock To: **12**
1st Value:
2nd Value:
Value Percent: **30.000**
Step: **NO**
Remarks:

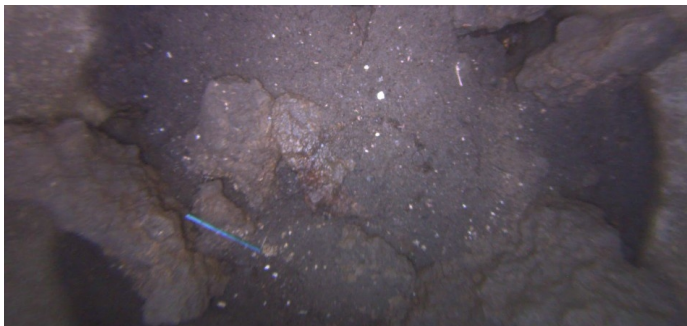
Code: **MSA**
Description: **Abandoned Survey**

Distance (ft): **2.1**
Structural Grade: **0**
O&M Grade: **0**
Clock Start/From:
Clock To:
1st Value:
2nd Value:
Value Percent:
Step: **NO**
Remarks: **DSF**
