Manhole Inspection Report

Date:	03/25/2018	Weather:		Coding:	RZMACP
MH#:	M-209-003	Owner:	NA	Len. Surveyed:	7.4
P.O.#:		Surveyor:	John Kuglmaier	Rim to Invert:	8.3
Customer:		Cert. #:	U-1215-07002349	Wall Material:	Concrete (reinforced)

Street:	North of 61st Ln. 420' East of Orego	Project:	Hobart, IN
City:	Hobart, IN	GPS Northing:	0.0
Location:		GPS Easting:	0.0
Drain Area:	Southwest	GPS Accuracy:	Nearest Meter
Cover Shape:	Circular	Evidence of Surcharge:	No
Cover Size:	22.5	Potential for Runoff:	None
Comments:

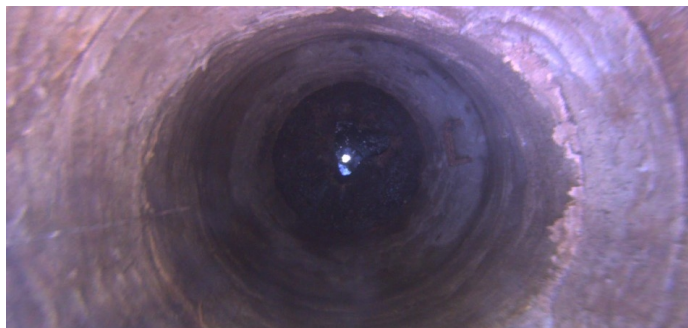
Code: **MGP**
Description: **General Photo**

Distance (ft): **.0**
Structural Grade: **0**
O&M Grade: **0**
Clock Start/From:
Clock To:
1st Value:
2nd Value:
Value Percent:
Step: **NO**
Remarks:

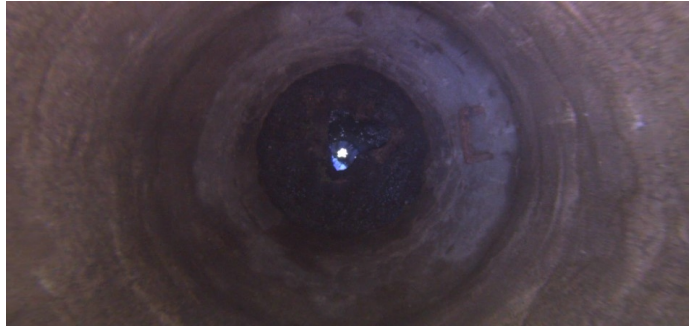
Code: **IS**
Description: **Infil Stain**

Distance (ft): **.9**
Structural Grade: **0**
O&M Grade: **0**
Clock Start/From: **12**
Clock To: **12**
1st Value:
2nd Value:
Value Percent:
Step: **NO**
Remarks:

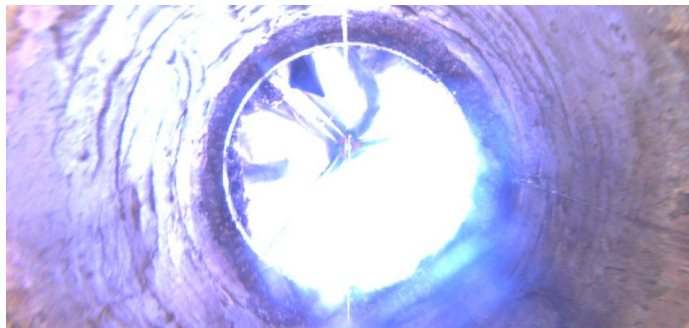
Code: **MGP**
Description: **General Photo**

Distance (ft): **2.3**
Structural Grade: **0**
O&M Grade: **0**
Clock Start/From:
Clock To:
1st Value:
2nd Value:
Value Percent:
Step: **NO**
Remarks:

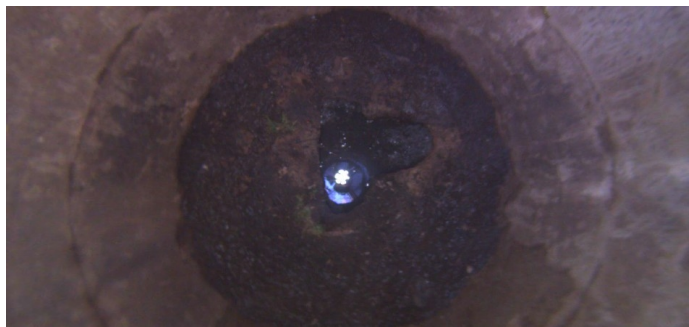
Code: **DSF**
Description: **Deposits Settled Fine**

Distance (ft): **4.2**
Structural Grade: **0**
O&M Grade: **3**
Clock Start/From: **12**
Clock To: **12**
1st Value:
2nd Value:
Value Percent: **15.000**
Step: **NO**
Remarks:

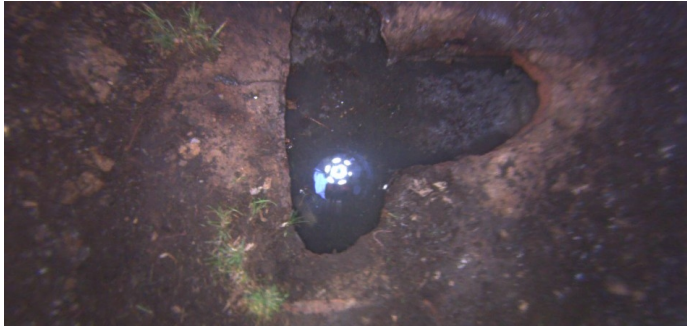
Code:	MGO
Description:	General Observation
Distance (ft):	6.1
Structural Grade:	0
O&M Grade:	0
Clock Start/From:	
Clock To:	
1st Value:	
2nd Value:	
Value Percent:	
Step:	NO
Remarks:	Ins. Comp.
