Manhole Inspection Report

Date:	03/25/2018	Weather:		Coding:	RZMACP
MH#:	M-209-006	Owner:	NA	Len. Surveyed:	7.2
P.O.#:		Surveyor:	John Kuglmaier	Rim to Invert:	9.0
Customer:		Cert. #:	U-1215-07002349	Wall Material:	Concrete (reinforced)

Street:	South of 61st Ln. 134' West of Orego	Project:	Hobart, IN
City:	Hobart, IN	GPS Northing:	0.0
Location:		GPS Easting:	0.0
Drain Area:	Southwest	GPS Accuracy:	Nearest Meter
Cover Shape:	Circular	Evidence of Surcharge:	Yes
Cover Size:	22.5	Potential for Runoff:	None
Comments:

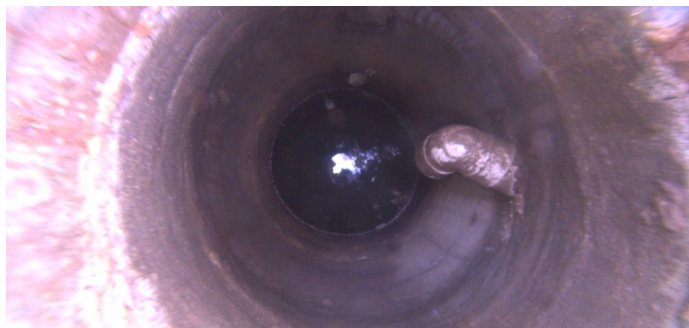
Code: **MGP**
Description: **General Photo**

Distance (ft): **.0**
Structural Grade: **0**
O&M Grade: **0**
Clock Start/From:
Clock To:
1st Value:
2nd Value:
Value Percent:
Step: **NO**
Remarks:

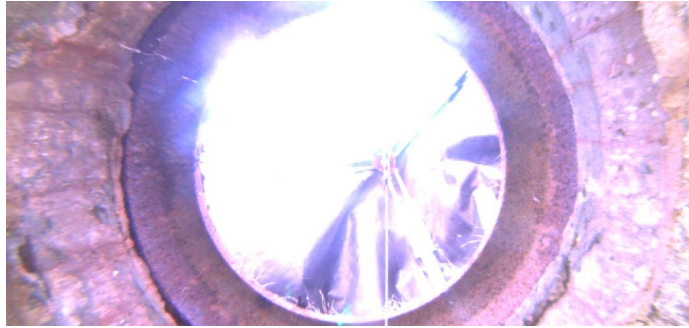
Code: **MGP**
Description: **General Photo**

Distance (ft): **1.9**
Structural Grade: **0**
O&M Grade: **0**
Clock Start/From:
Clock To:
1st Value:
2nd Value:
Value Percent:
Step: **NO**
Remarks:

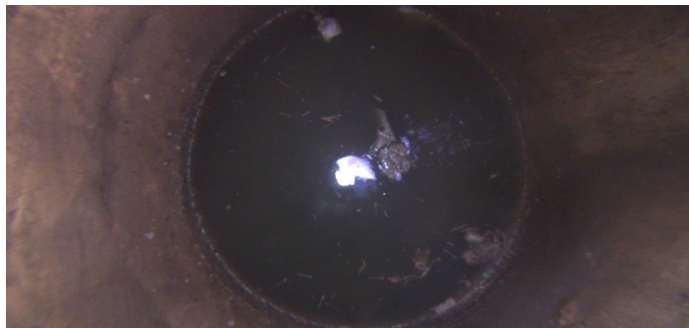
Code: **MGO**
Description: **General Observation**

Distance (ft): **4.3**
Structural Grade: **0**
O&M Grade: **0**
Clock Start/From:
Clock To:
1st Value:
2nd Value:
Value Percent:
Step: **NO**
Remarks: **Surcharge**

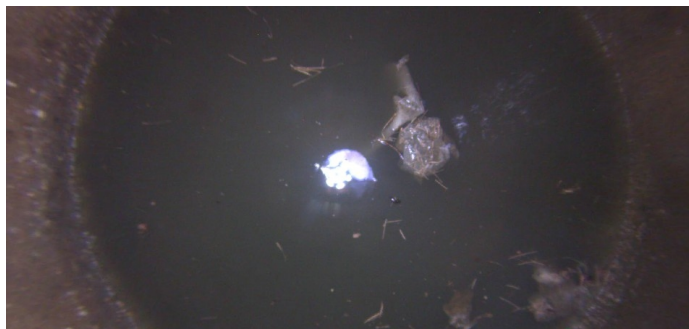
Code: **MSA**
Description: **Abandoned Survey**

Distance (ft): **5.8**
Structural Grade: **0**
O&M Grade: **0**
Clock Start/From:
Clock To:
1st Value:
2nd Value:
Value Percent:
Step: **NO**
Remarks: **Surcharge**
