Manhole Inspection Report

Date:	03/24/2018	Weather:		Coding:	RZMACP
MH#:	M-209-011	Owner:	NA	Len. Surveyed:	2.8
P.O.#:		Surveyor:	John Kuglmaier	Rim to Invert:	3.3
Customer:		Cert. #:	U-1215-07002349	Wall Material:	Concrete (reinforced)

Street:	65' North of 62nd Pl. West of Minne	Project:	Hobart, IN
City:	Hobart, IN	GPS Northing:	0.0
Location:		GPS Easting:	0.0
Drain Area:	Southwest	GPS Accuracy:	Nearest Meter
Cover Shape:	Circular	Evidence of Surcharge:	No
Cover Size:	22.5	Potential for Runoff:	None
Comments:

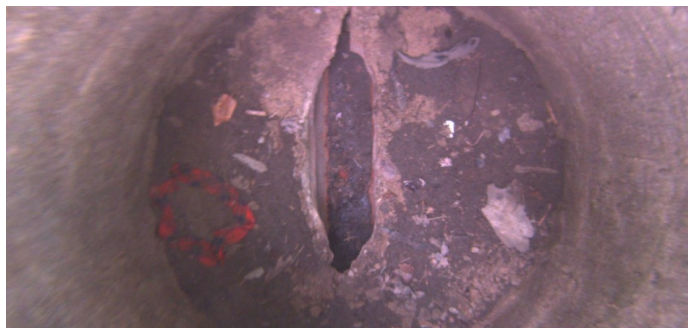
Code: **MGP**
Description: **General Photo**

Distance (ft): **.0**
Structural Grade: **0**
O&M Grade: **0**
Clock Start/From:
Clock To:
1st Value:
2nd Value:
Value Percent:
Step: **NO**
Remarks:

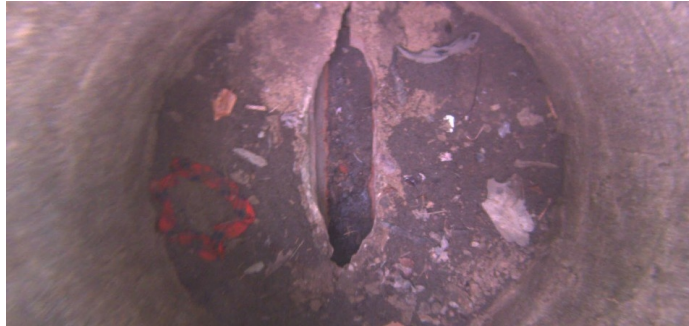
Code:	DAZ
Description:	Deposits Attached Other
Distance (ft):	.1
Structural Grade:	0
O&M Grade:	2
Clock Start/From:	12
Clock To:	12
1st Value:	
2nd Value:	
Value Percent:	10.000
Step:	NO
Remarks:	Mixed materials

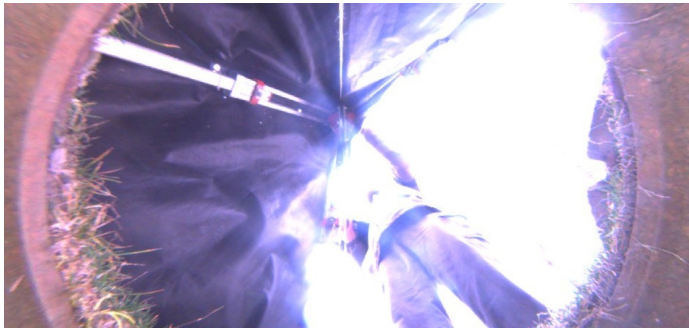
Code:	MGP
Description:	General Photo
Distance (ft):	1.1
Structural Grade:	0
O&M Grade:	0
Clock Start/From:	
Clock To:	
1st Value:	
2nd Value:	
Value Percent:	
Step:	NO
Remarks:

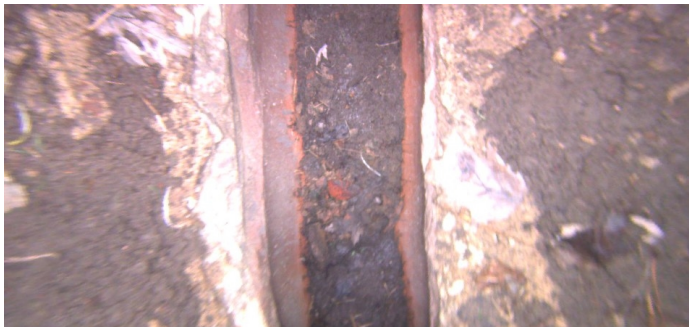
Code:	MGO
Description:	General Observation
Distance (ft):	2.0
Structural Grade:	0
O&M Grade:	0
Clock Start/From:	
Clock To:	
1st Value:	
2nd Value:	
Value Percent:	
Step:	NO
Remarks:	Ins. Comp.
