Manhole Inspection Report

Date:	03/24/2018	Weather:		Coding:	RZMACP
MH#:	M-209-015	Owner:	NA	Len. Surveyed:	4.8
P.O.#:		Surveyor:	John Kuglmaier	Rim to Invert:	5.4
Customer:		Cert. #:	U-1215-07002349	Wall Material:	Concrete (reinforced)

Street:	62nd Pl. California St. to the Southe	Project:	Hobart, IN
City:	Hobart, IN	GPS Northing:	0.0
Location:		GPS Easting:	0.0
Drain Area:	Southwest	GPS Accuracy:	Nearest Meter
Cover Shape:	Circular	Evidence of Surcharge:	No
Cover Size:	22.5	Potential for Runoff:	None
Comments:

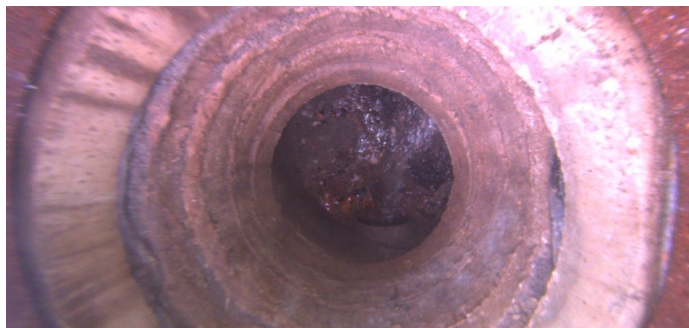
Code: **MGP**
Description: **General Photo**

Distance (ft): **.0**
Structural Grade: **0**
O&M Grade: **0**
Clock Start/From:
Clock To:
1st Value:
2nd Value:
Value Percent:
Step: **NO**
Remarks:

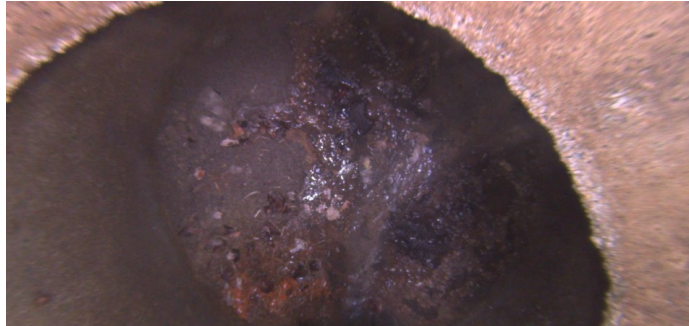
Code:	DAZ
Description:	Deposits Attached Other
Distance (ft):	2.3
Structural Grade:	0
O&M Grade:	2
Clock Start/From:	12
Clock To:	12
1st Value:	
2nd Value:	
Value Percent:	10.000
Step:	NO
Remarks:	Mixed materials

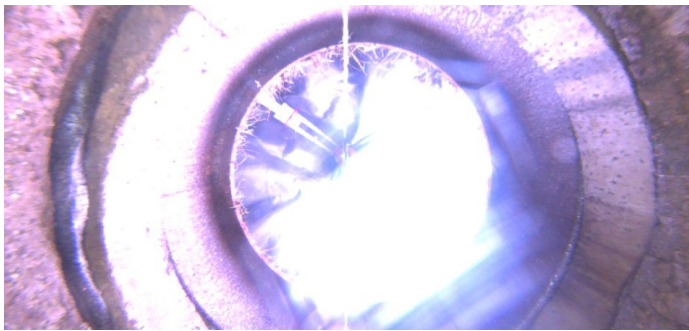
Code:	MGP
Description:	General Photo
Distance (ft):	2.4
Structural Grade:	0
O&M Grade:	0
Clock Start/From:	
Clock To:	
1st Value:	
2nd Value:	
Value Percent:	
Step:	NO
Remarks:

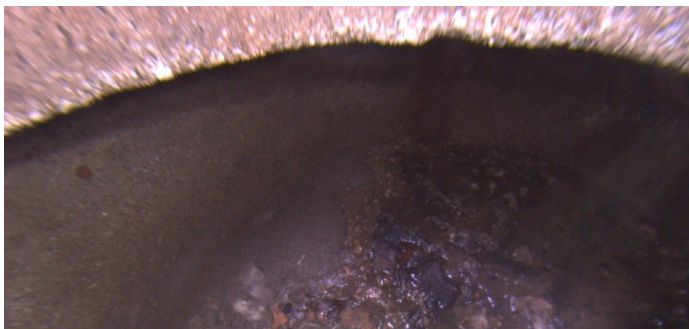
Code:	IS
Description:	Infil Stain
Distance (ft):	2.9
Structural Grade:	0
O&M Grade:	0
Clock Start/From:	12
Clock To:	
1st Value:	
2nd Value:	
Value Percent:	
Step:	NO
Remarks:

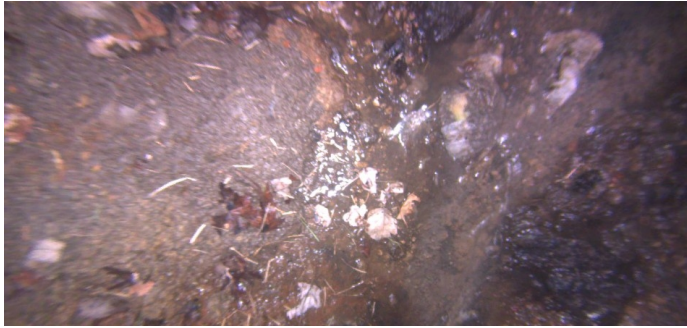
Code:	MGO
Description:	General Observation
Distance (ft):	3.9
Structural Grade:	0
O&M Grade:	0
Clock Start/From:	
Clock To:	
1st Value:	
2nd Value:	
Value Percent:	
Step:	NO
Remarks:	Ins. Comp.
